Preliminary Evaluation of the Steam
Generator Localized Tube Diameter Reduction
Phenomenon and its Safety Impact

December, 1975

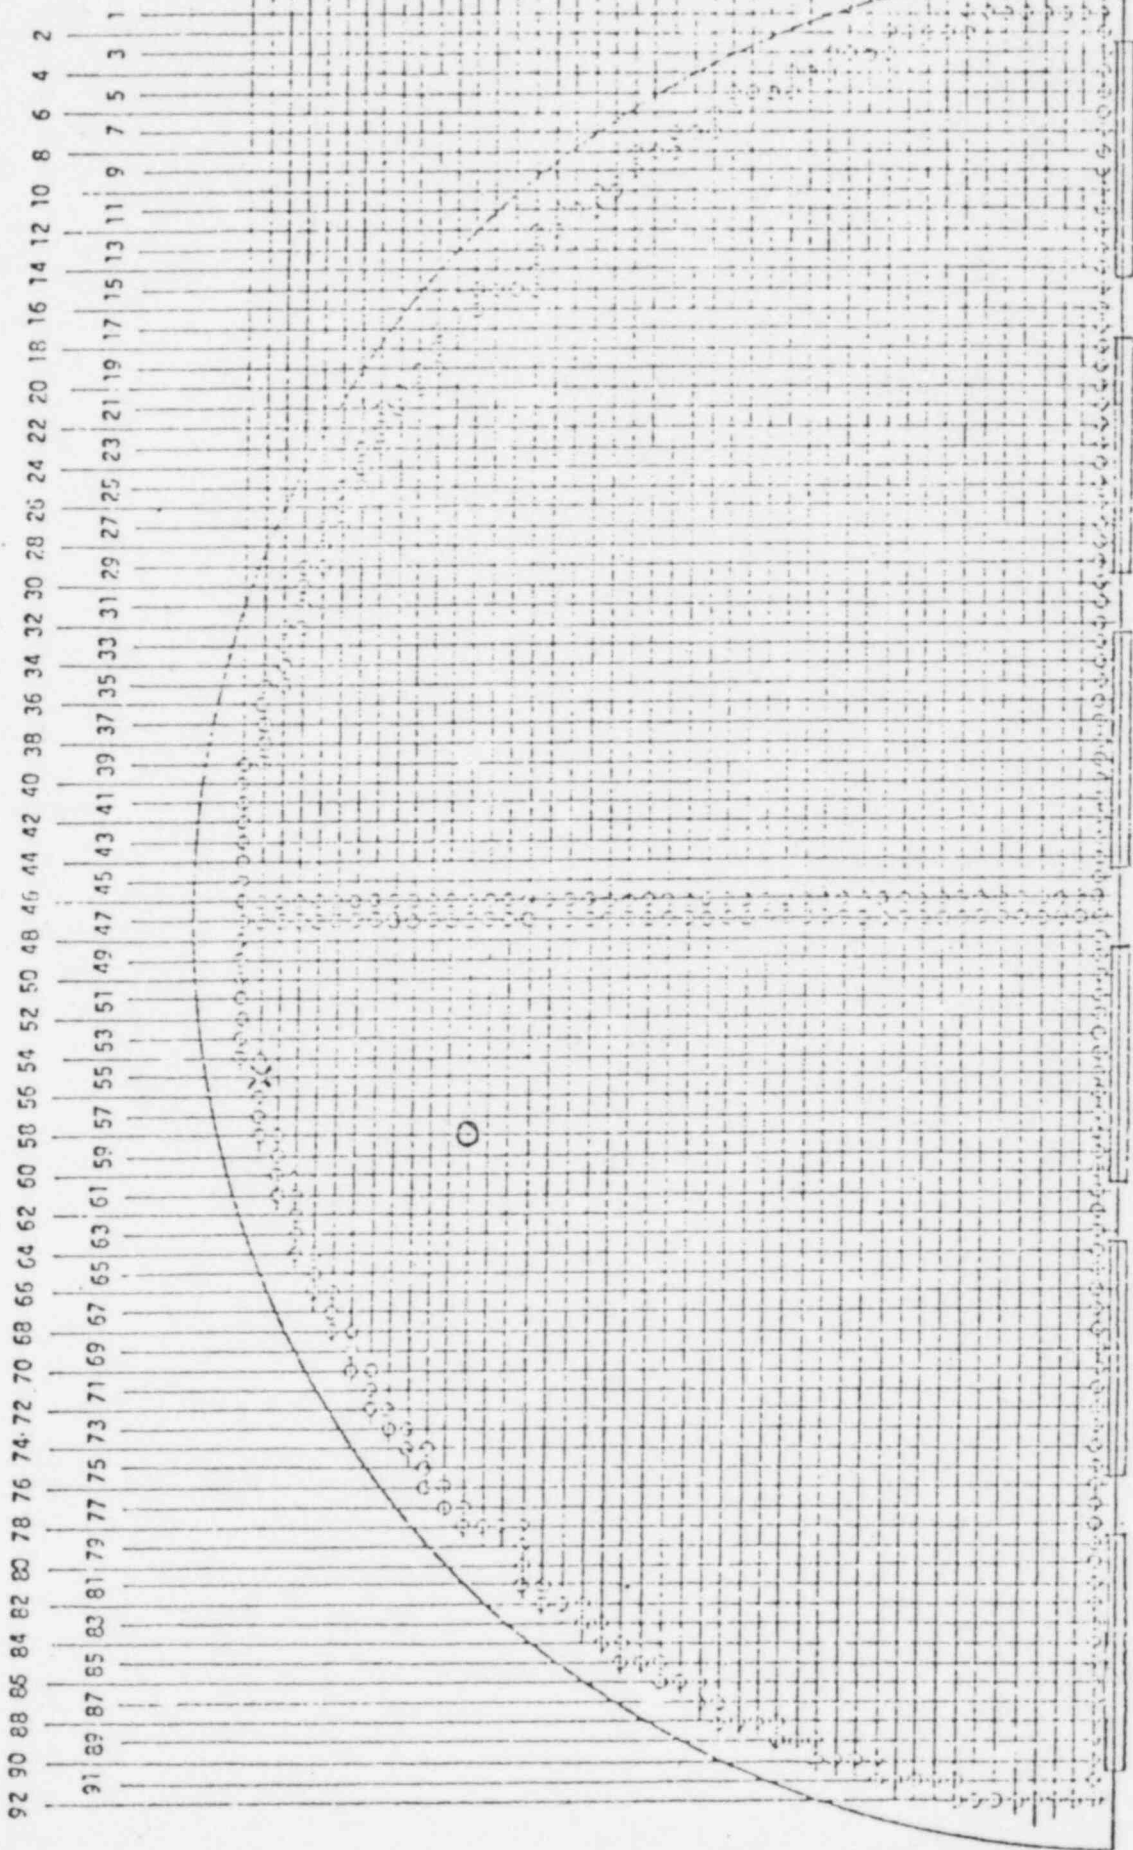
Following refueling, Turkey Point Unit 4 returned to full power in late June. On July 28, 1975, a primary to secondary leak of 50 gallons per day was detected in steam generator B. On August 23, 1975, the plant was shut down to repair the leak, at which time the measured leak rate was 72 gallons per day. The leak was located in a peripheral tube (R44C55) on the hot leg side somewhere between the second and fifth tube support plates. (See Figure 2) This tube was plugged. Another hot leg tube (R33C58) having an indication of localized diameter reduction of the tube wall was removed to just above the first

TURKEY POINT UNIT 4
 SG B HOT LEG
 X - LEAKING TUBE 8/75
 O - REMOVED TUBE 8/75

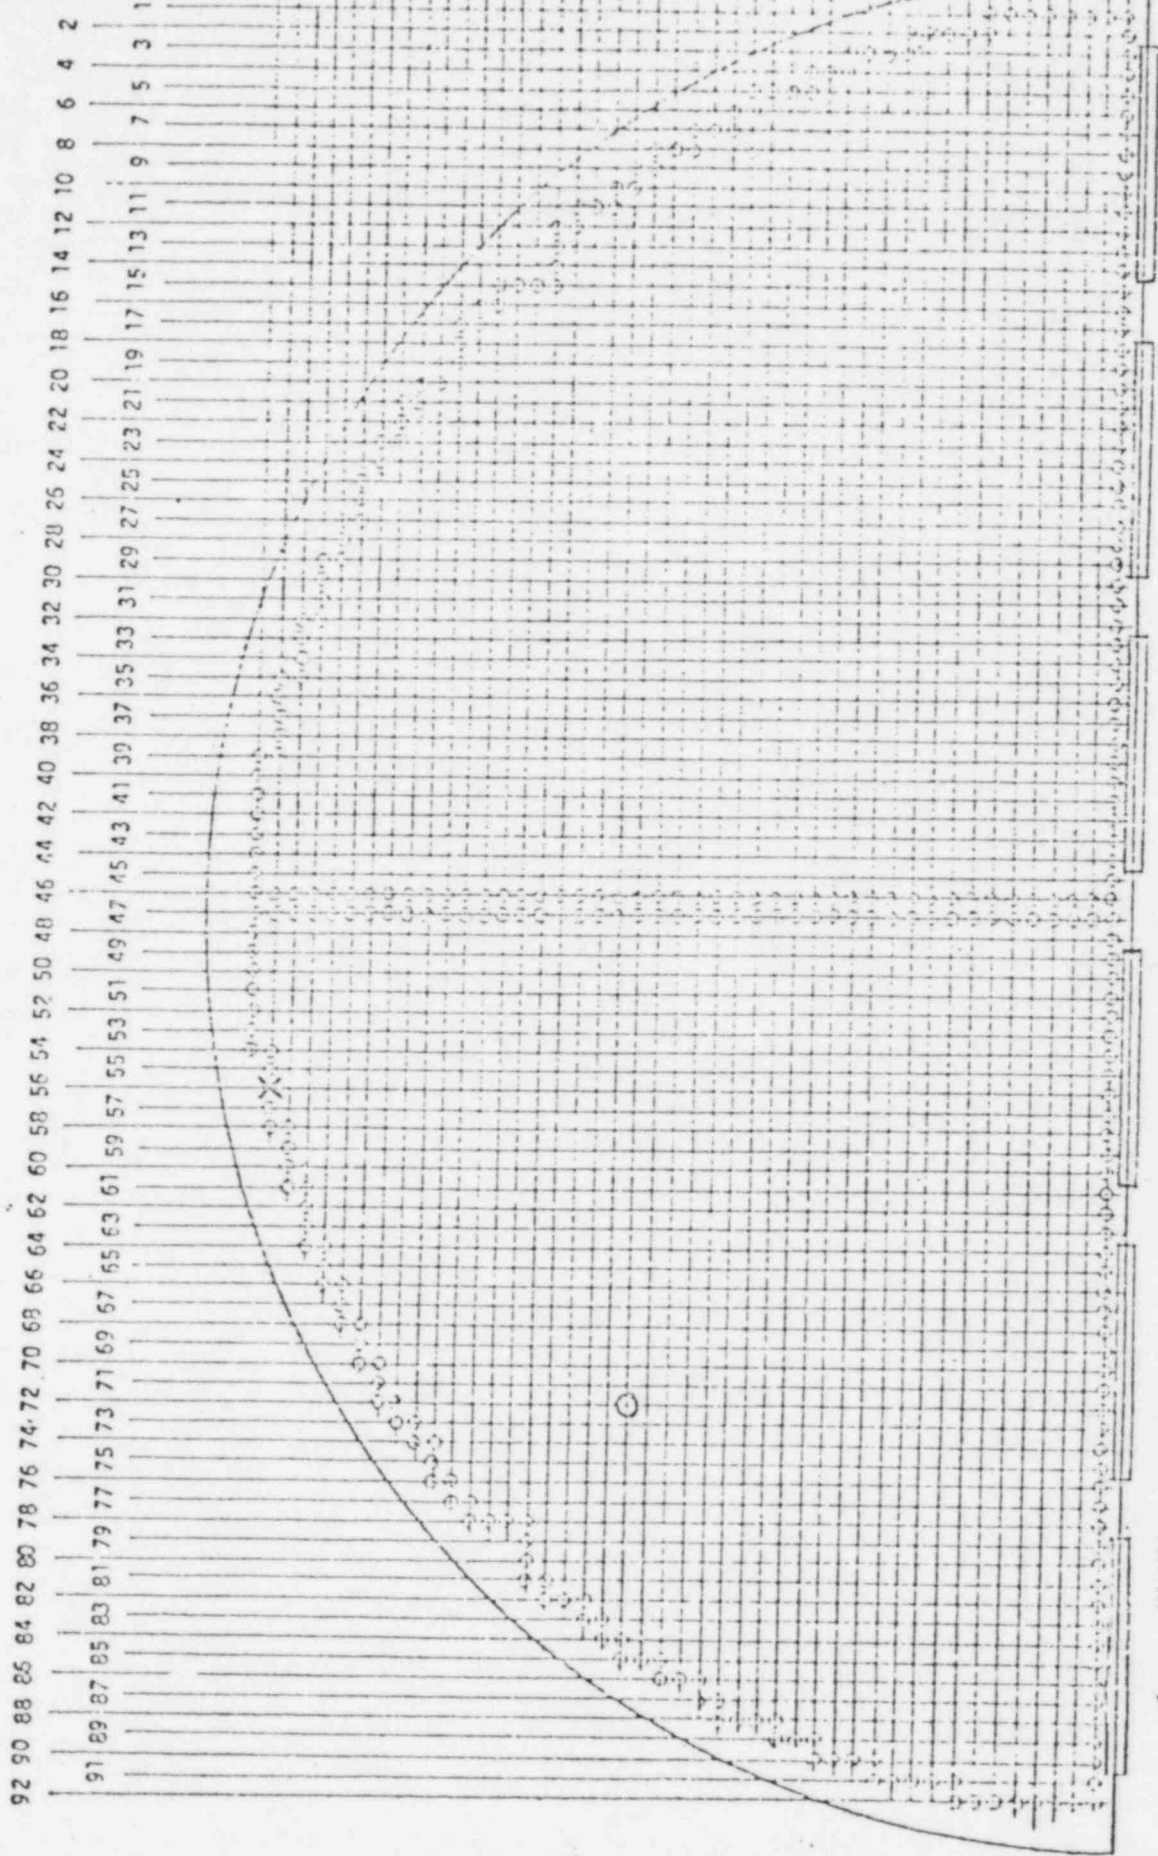
The plant resumed operation in August after the steam generator repairs were completed. On August 23, 1975, a 60 gpd primary to secondary leak was detected in steam generator B. On September 1 the measured leak rate was 84 gpd; on September 12, 84 gpd, and on September 17, 96 gpd. The plant was shut down for steam generator repairs on September 21, 1975. The leak was located in a peripheral tube (R44C56) on the hot leg side adjacent to the leaking tube plugged in August. (See Figure 3) The leak was in the region of the second support plate, and the tube was plugged. During the shutdown a tube (R25C72) exhibiting diameter reduction indications was removed to just above the fifth support plate on both the hot and cold leg sides for laboratory examination. (See Figure 3) A limited eddy current inspection of B steam generator using a cross shaped inspection pattern confirmed widespread localized tube diameter reductions in both the hot and cold legs. In addition, the diameter reductions appeared to have progressed to the regions of additional support plates on the cold leg side. The eddy current inspection was performed to obtain a baseline reading on the size of the diameter reductions for comparison to future measurements. The unit resumed operation in late September and has been in operation since.

X - LEAKING TUBE 9/75

O - REMOVED TUBE (ALSO REMOVED ON COLD LEG) 9/75

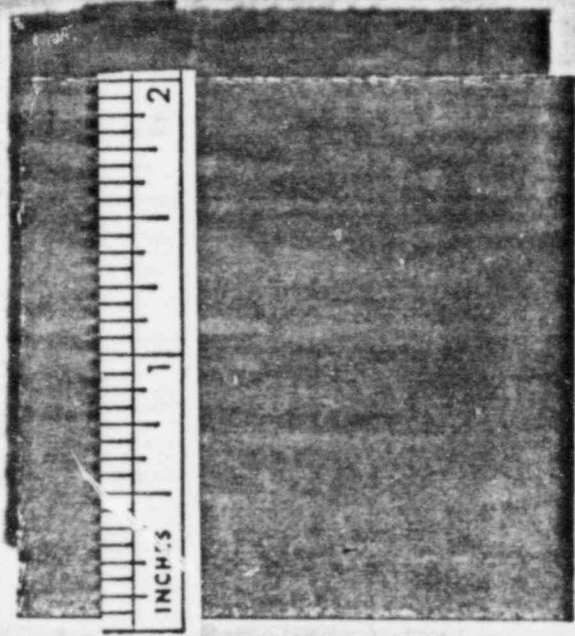
VIEW OF SECTION FROM TUBE R25C72 SGB TURKEY POINT UNIT 4
COLD LEG 4TH SUPPORT LOCATION

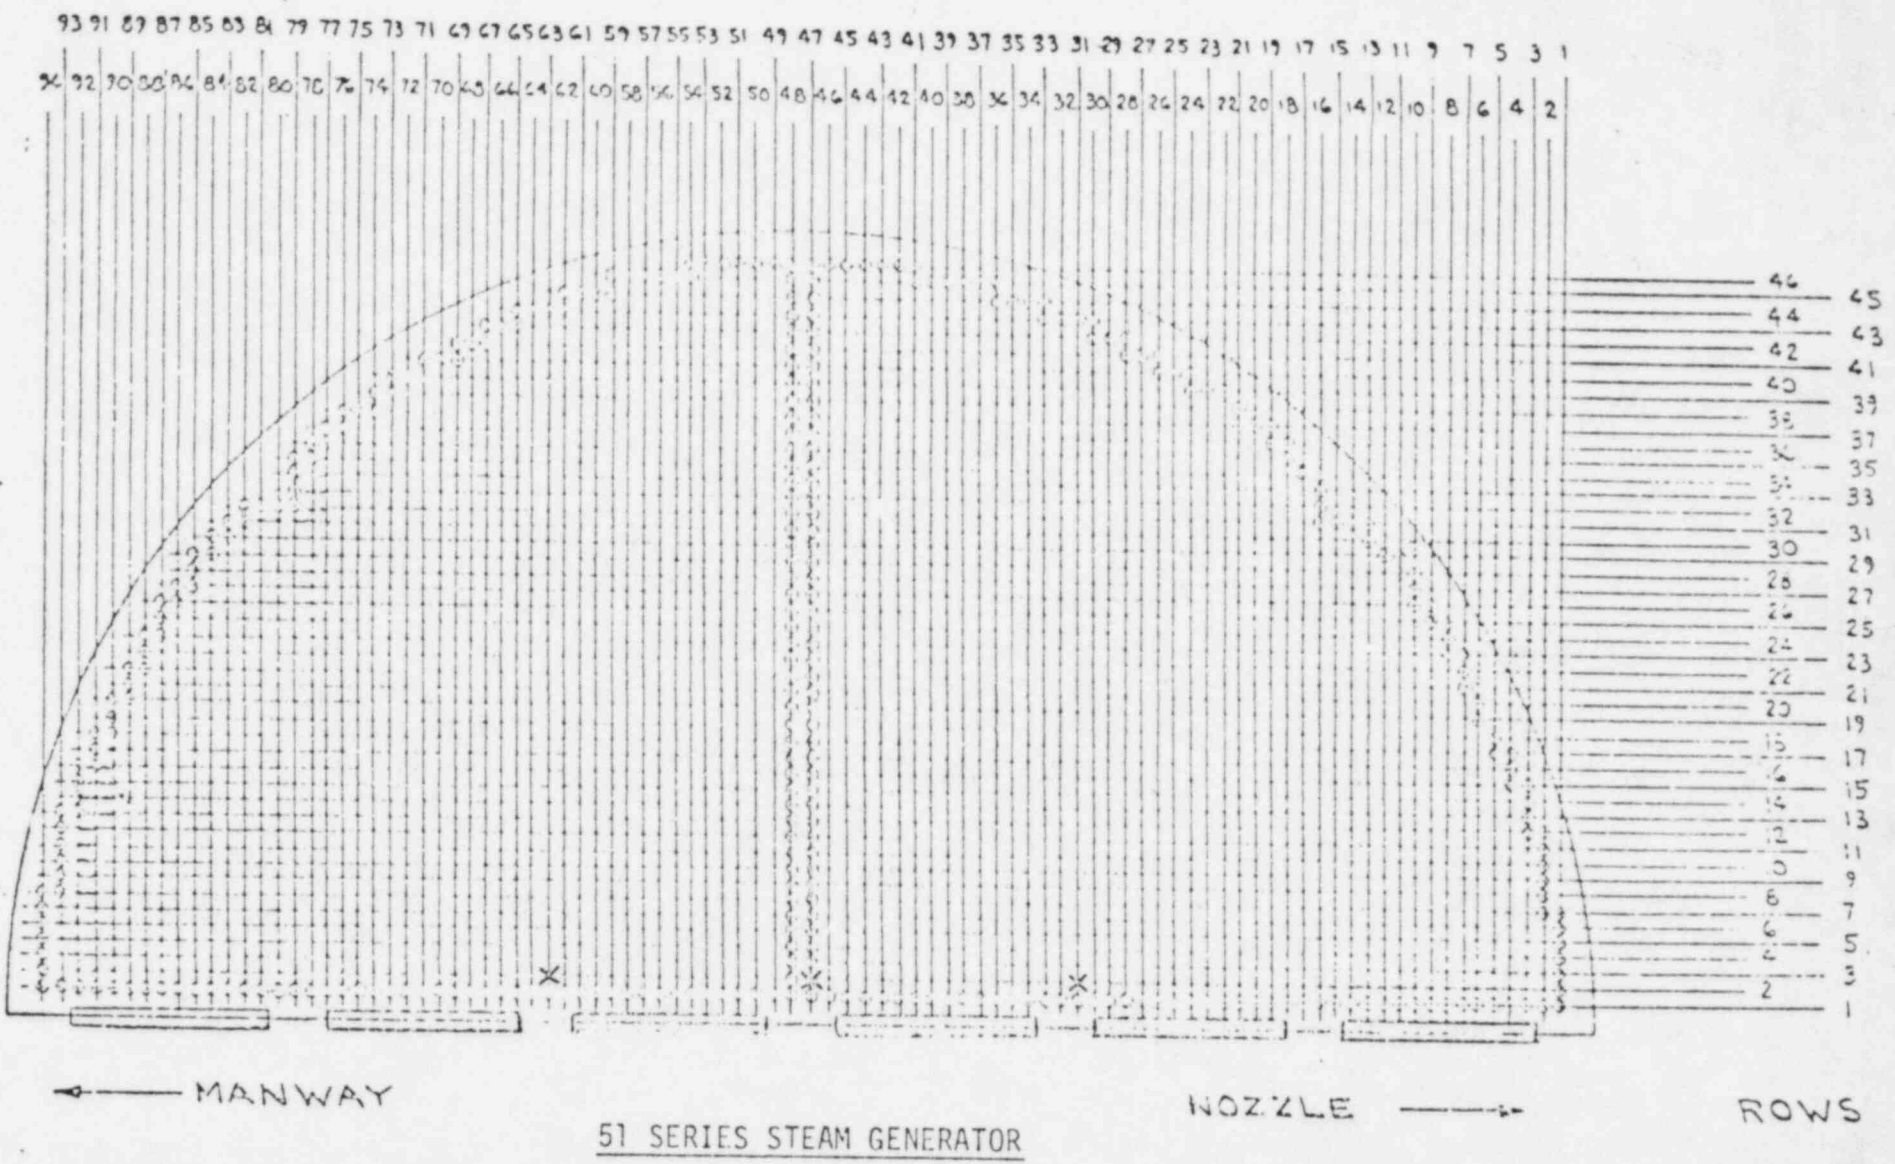
FIGURE 5

III. Surry Unit 1 Experience

SURRY UNIT 1
 SG A HOT LEG
 X - LEAKING TUBES 9/75

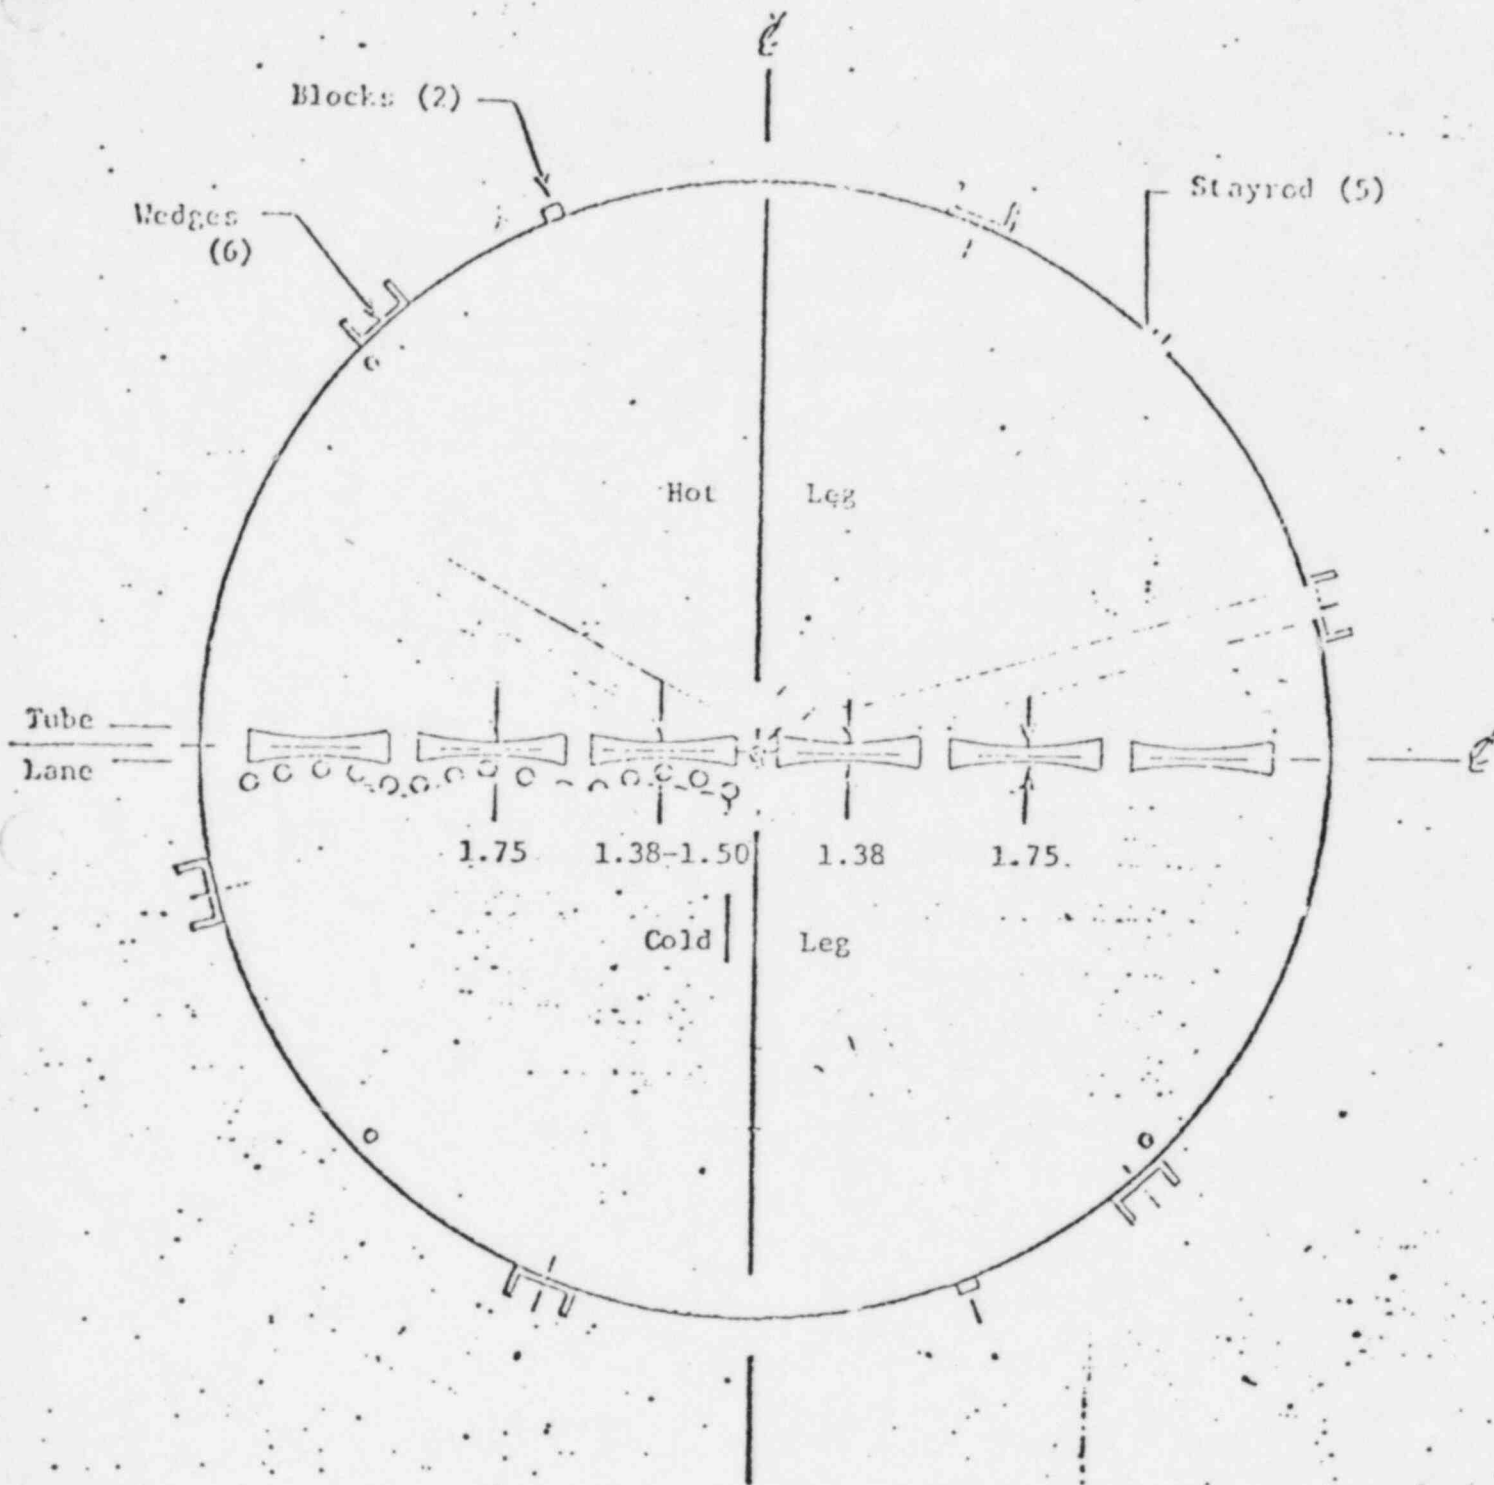
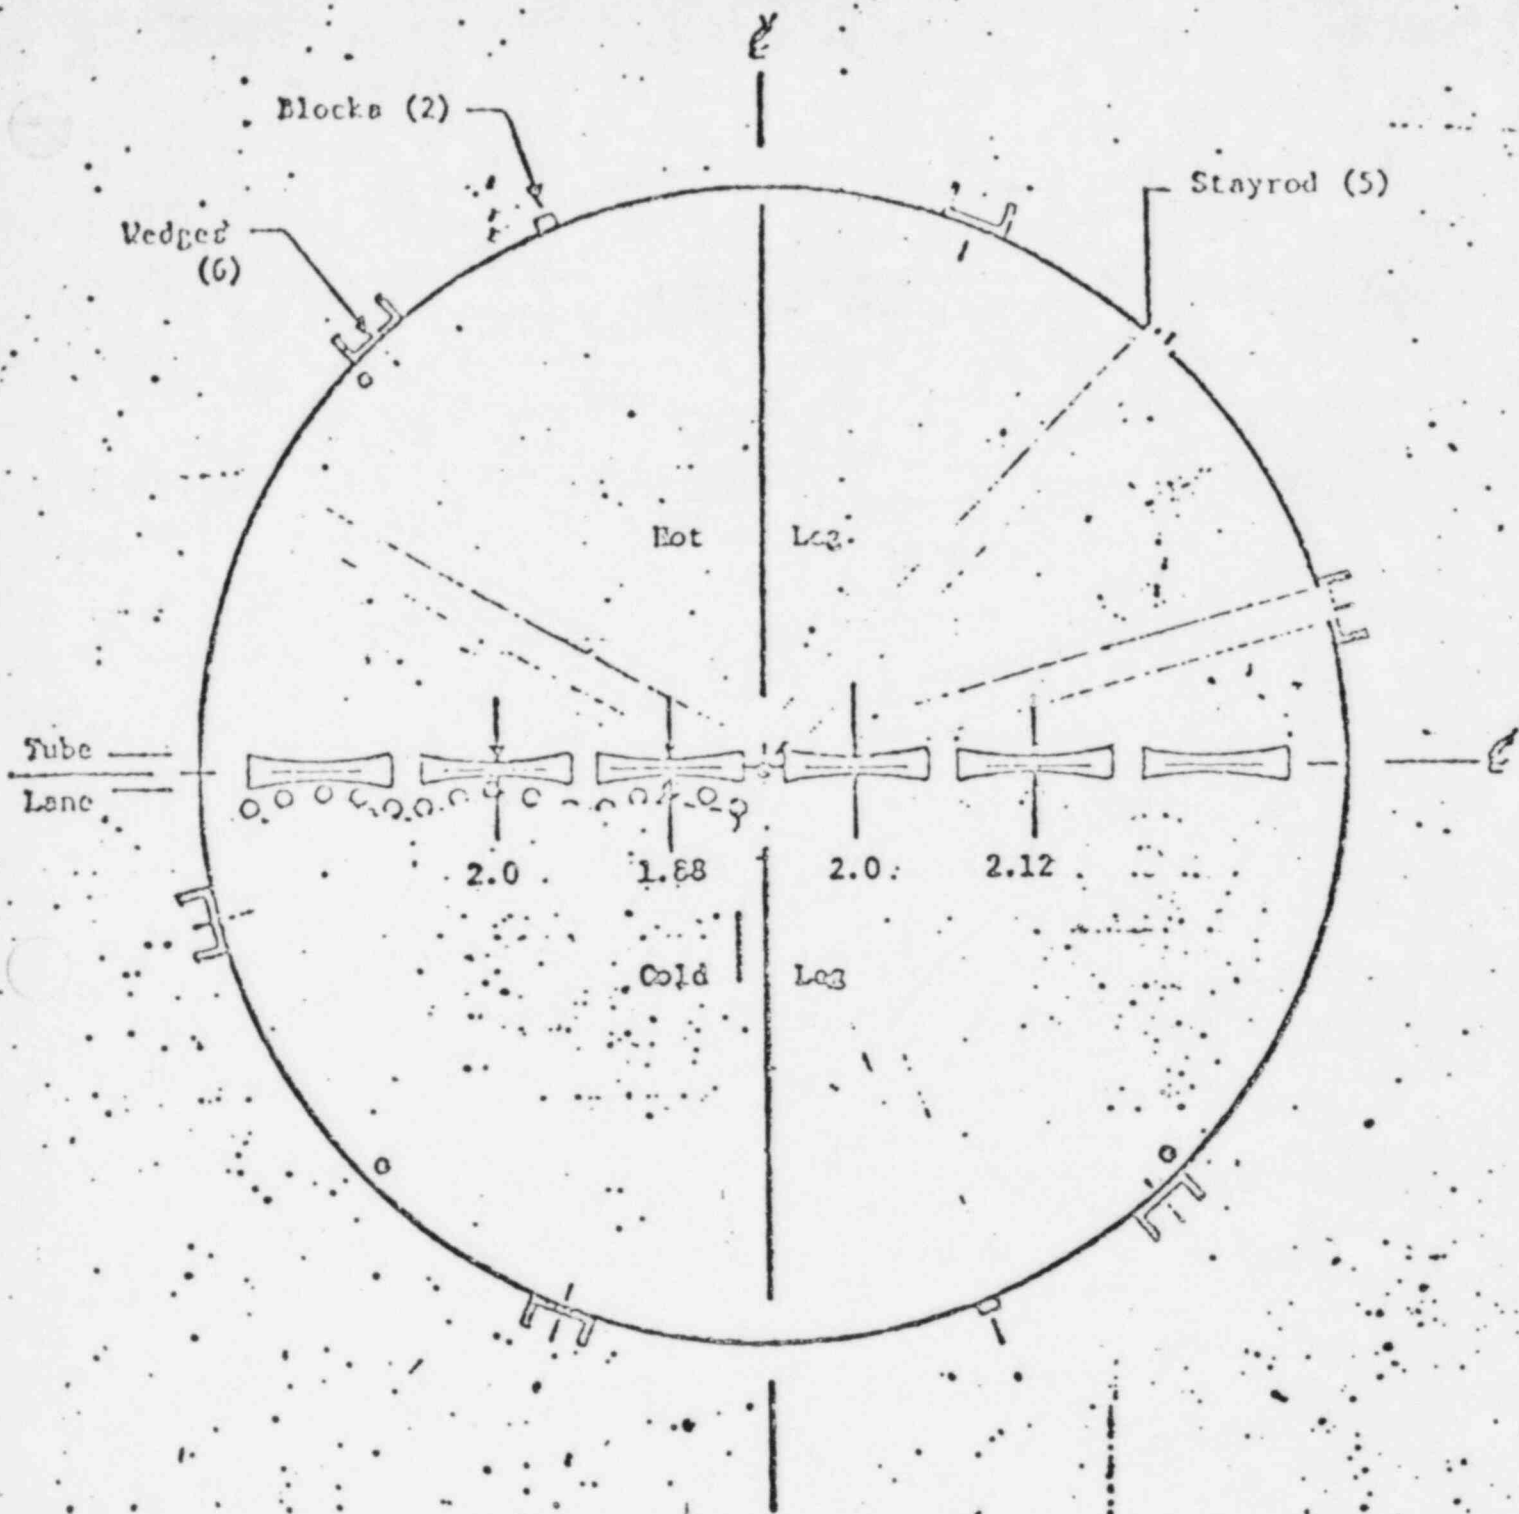
Surry 1 - S/G 'A' Cutouts

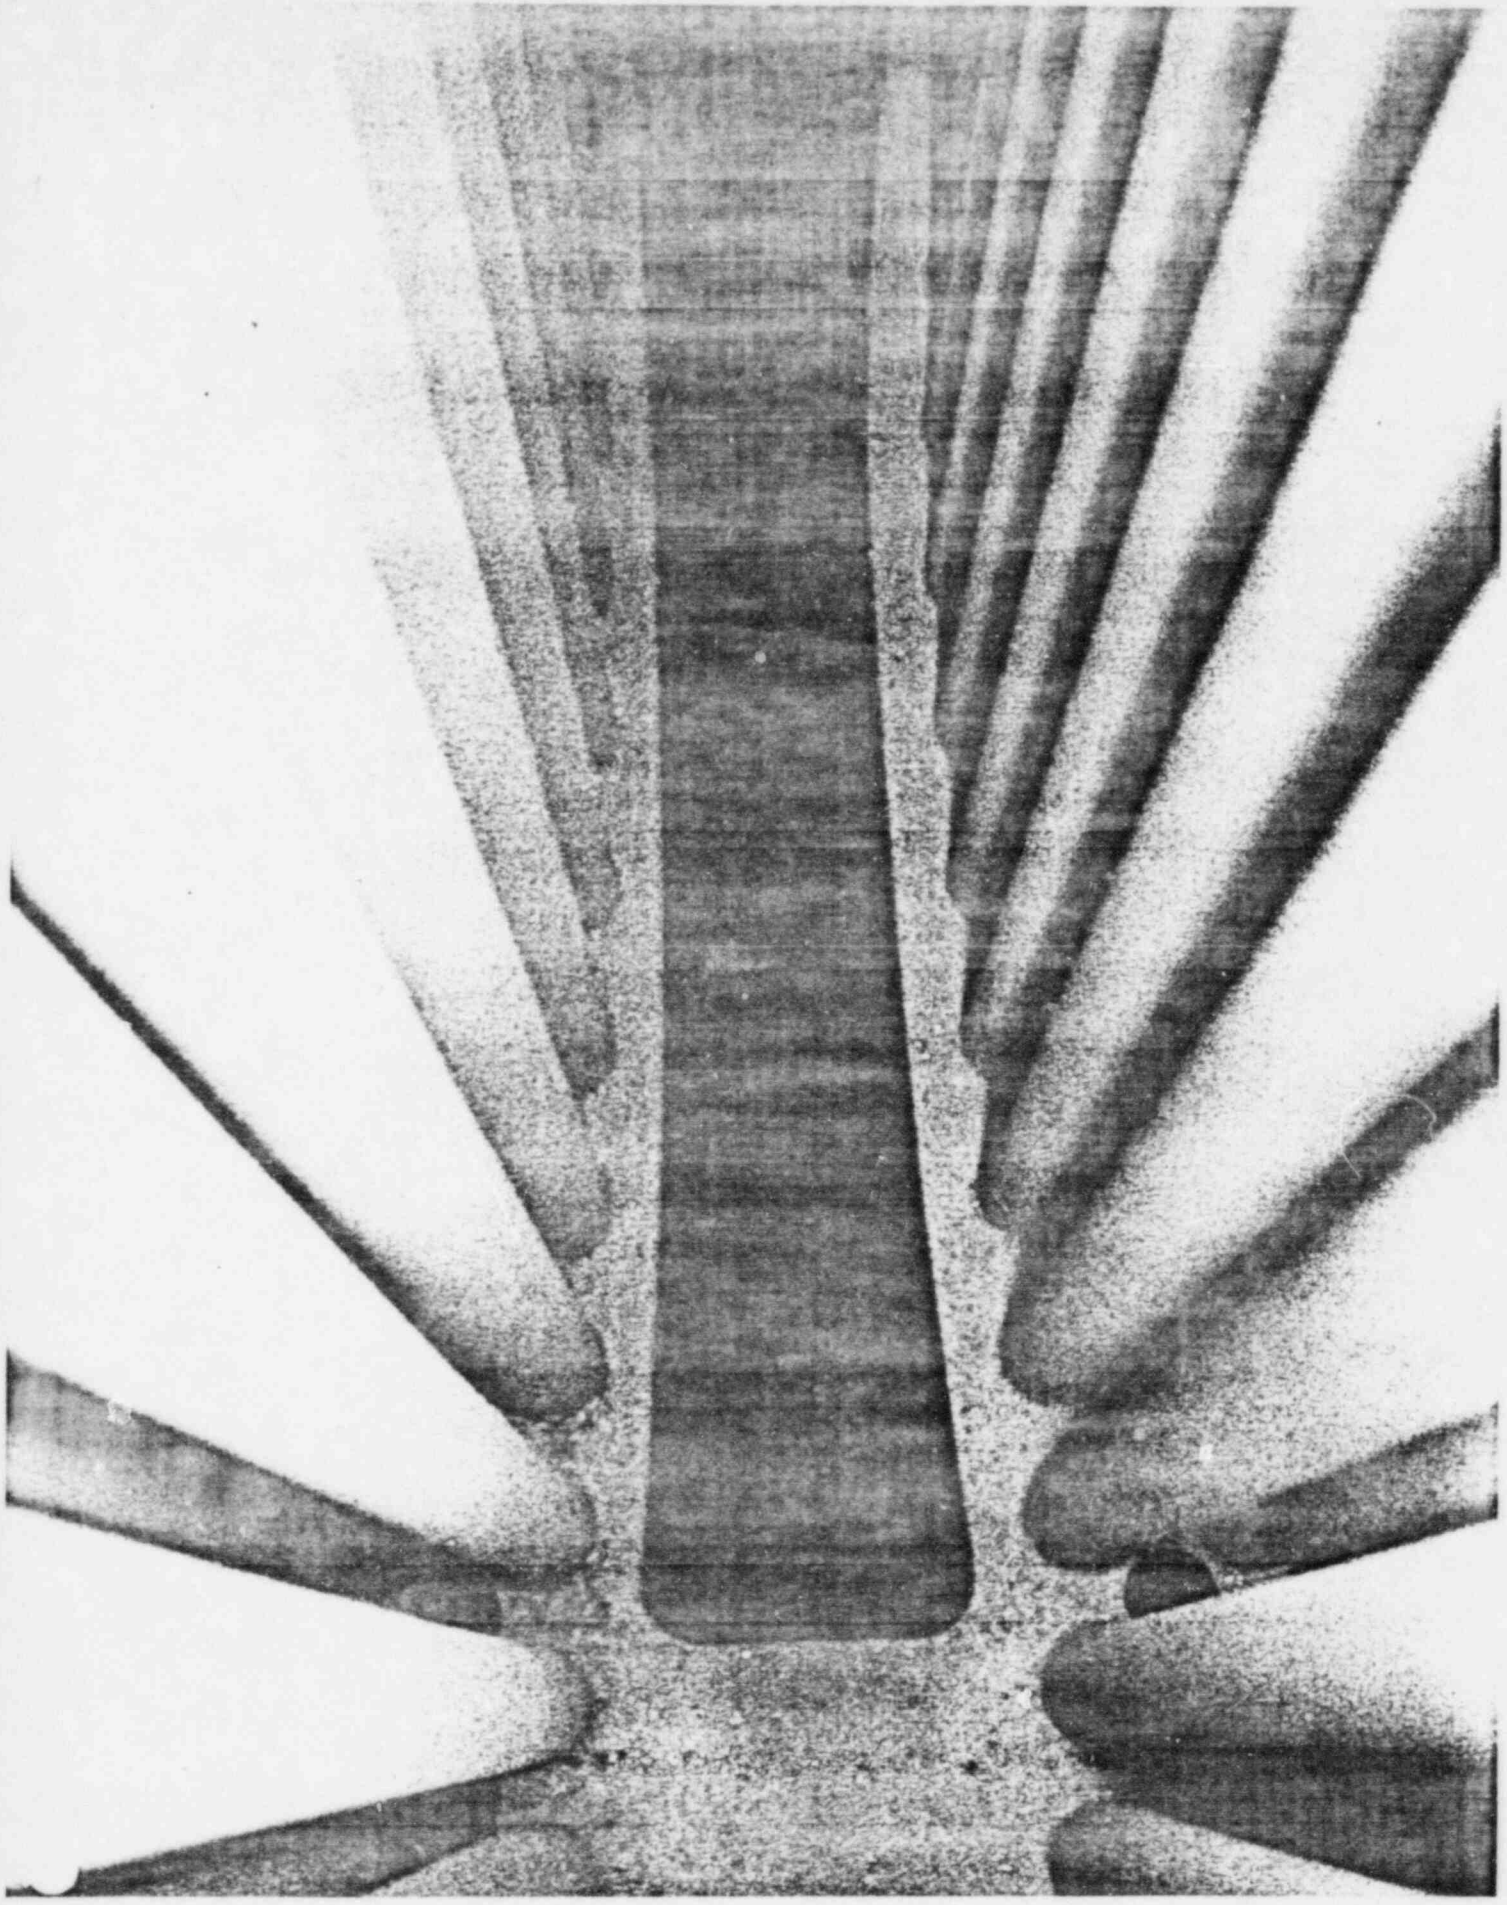
Additional visual inspections through hand holes and "hillside" ports of A, B and C steam generators were conducted. In-plane "hour-glassing" of the rectangular flow slots in the support plates in all three steam generators was noted with the least amount occurring in steam generator B. (See Figures 7, 8, and 9). No signs of abnormal surface scale, deformation, cracks, or out of plane distortion were evident. Deposits were evident in the spaces between the tubes and tube support plates with no clearance between the tube and tube supports indicated. Looking down the divider lane, the tubes appear straight from the top of the tube sheet to approximately 15 to 20 inches below the first support plate with gradual bowing from there to follow the contour of "hour-glassing" in the support plate flow slots. (Figure 9) Uniform spacing was observed between adjacent columns of tubes.

VRA S/G A OCTOBER 31, 1975
FIRST SUPPORT PLATE AND INNERMOST TUBE ROWS

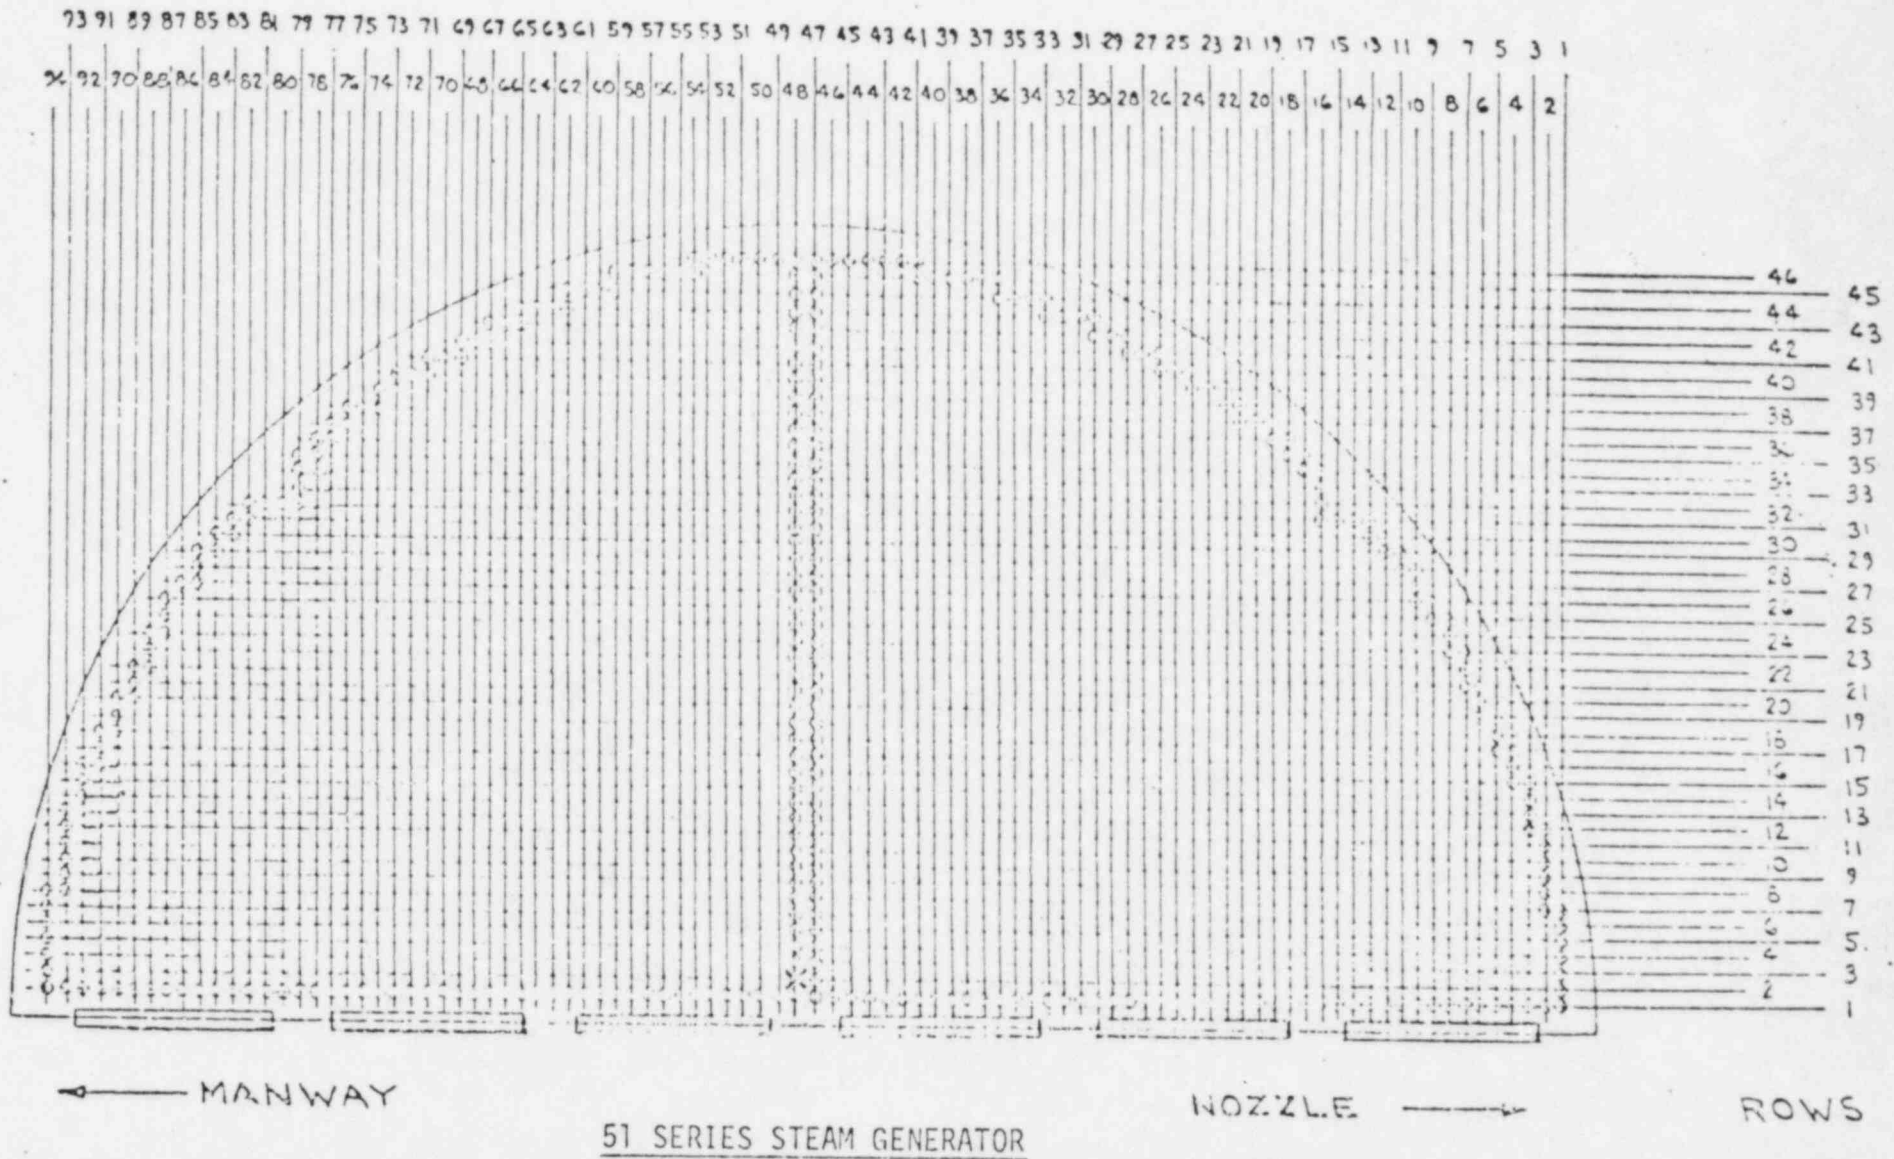
FIGURE 10

Surry Unit 1 resumed operation on December 8, 1975. A low level (less than 1 gpm) primary to secondary leak was detected in steam generator A on December 10, 1975 and the plant was shut down for repairs on that date. The leaking tube (R2C48) was adjacent to one of the tubes which was leaking and plugged in September. (See Figure 10) The leak was located in the region of the second tube support plate. Plant operation resumed following completion of steam generator repairs, with power level escalated to 100% on December 17, 1975.

SURRY UNIT 1
SG A HOT LEG
X - LEAKING TUBE 12/75

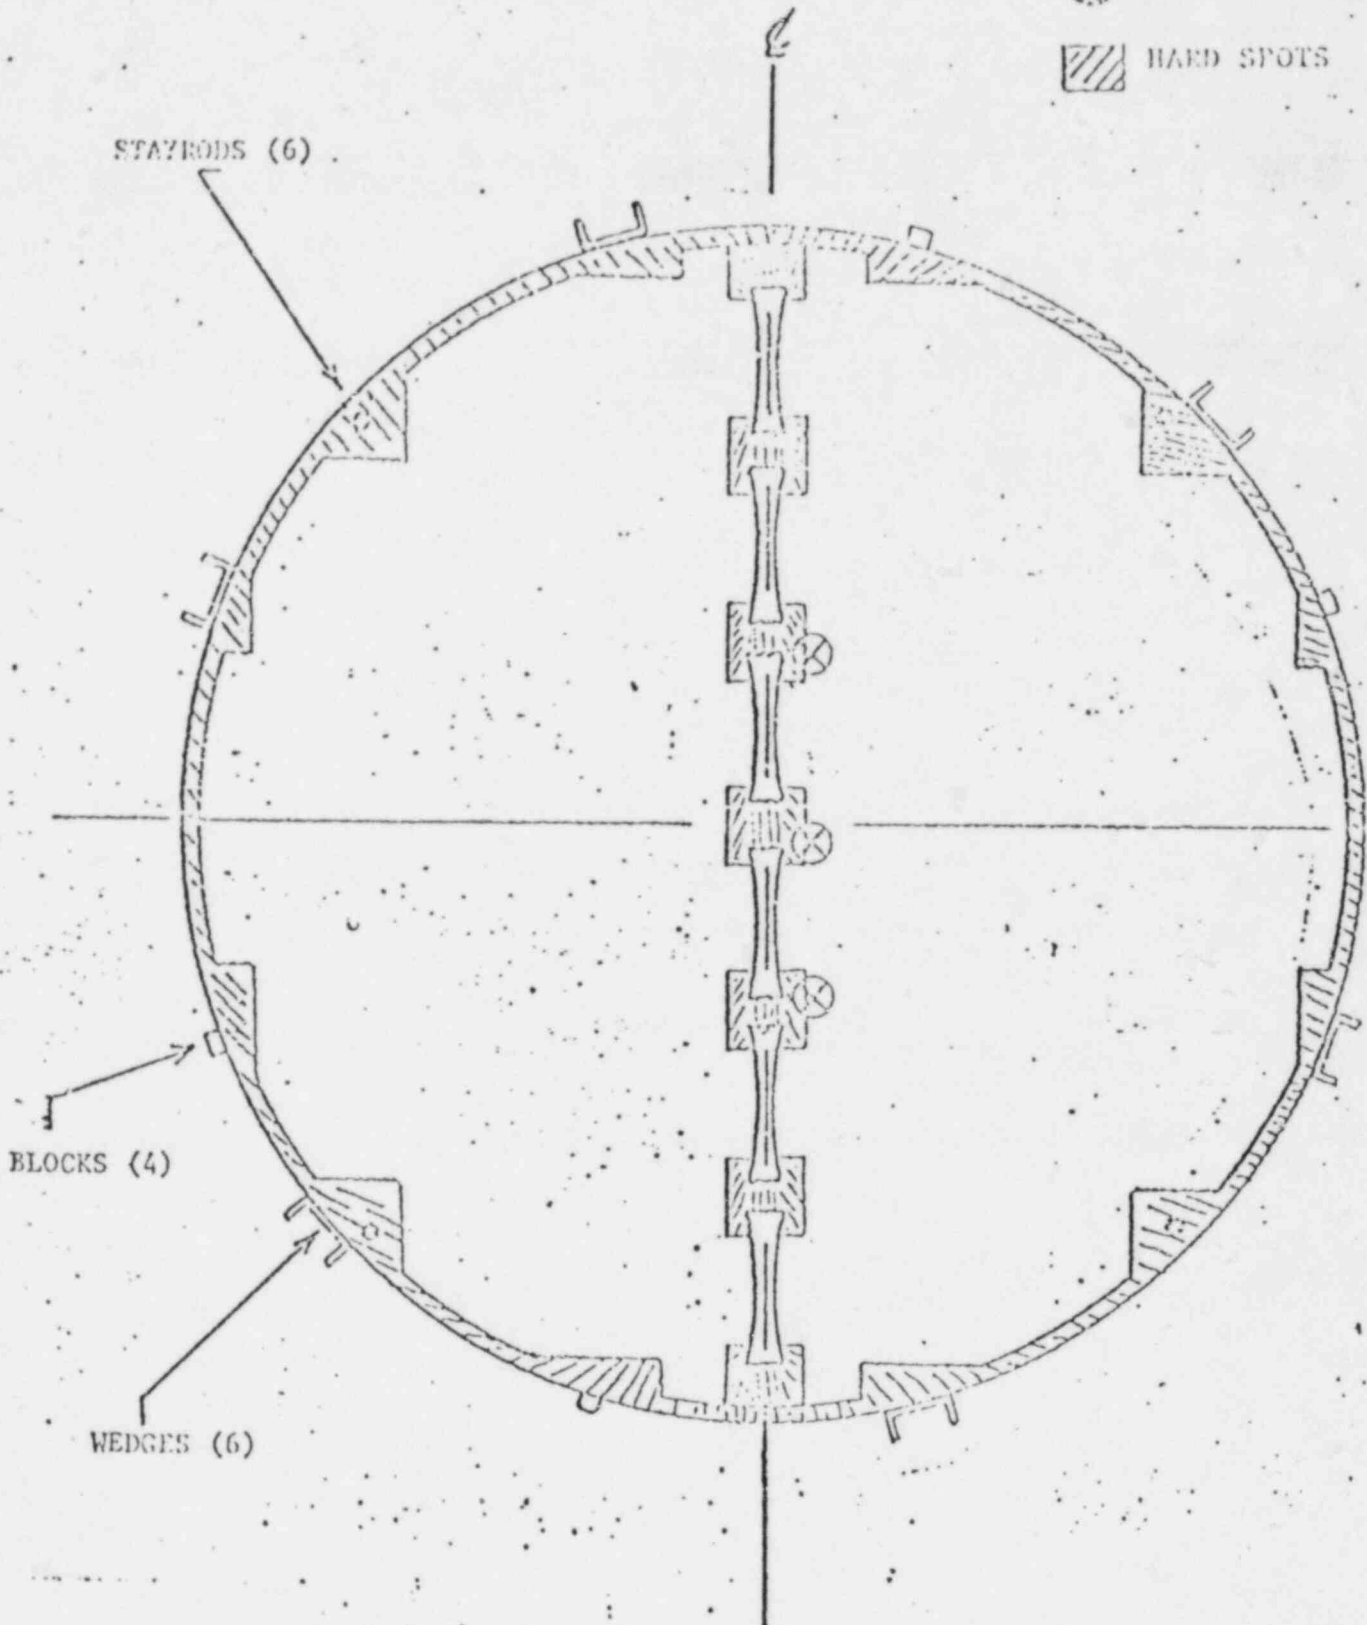
FIGURE 11

LEAKER

HARD SPOTS

TYPICAL TUBE SUPPORT PLATE HARD SPOTS

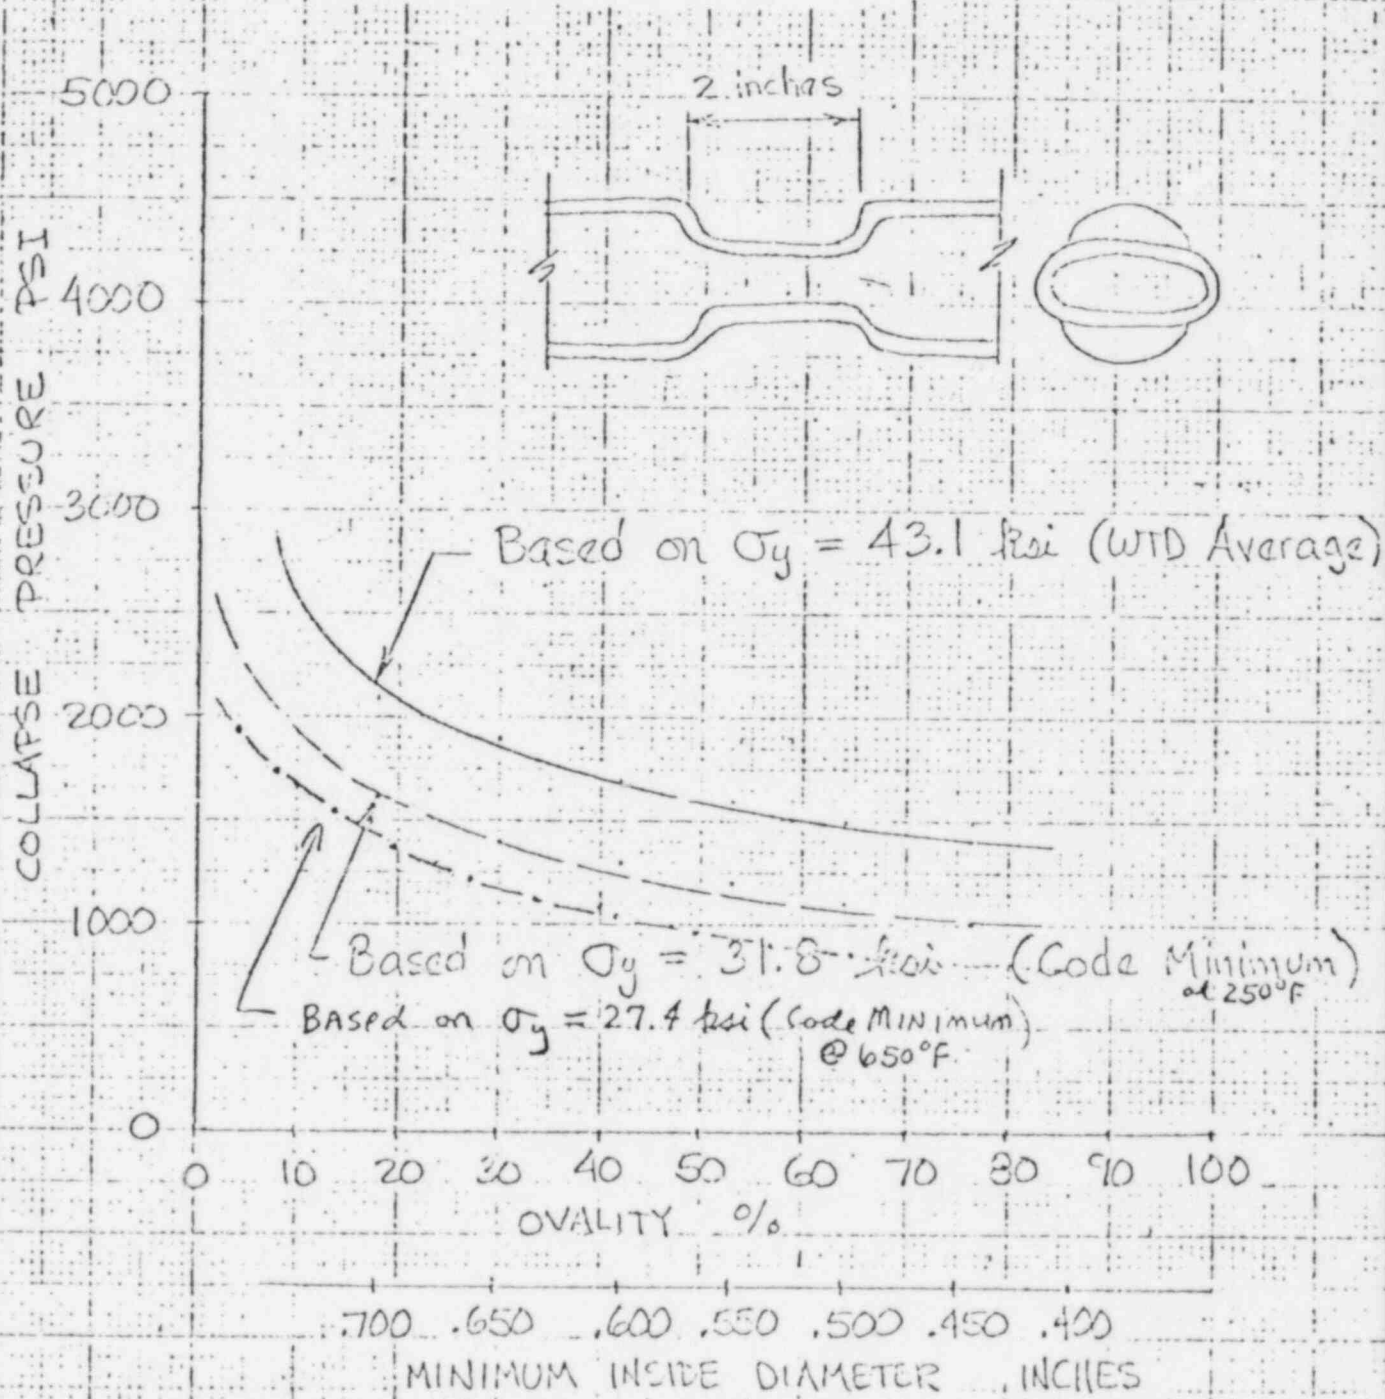
FIGURE 15

Based on these results, it is apparent that the tubes can be severely distorted and still maintain sufficient collapse strength to withstand the external pressure differential which develops in the latter stages of a LOCA.

Collapse Pressures of Dented $\frac{7}{8}$ " Tubes
