DOCKET NUMBER 50-483
CALLAWAY PLANT UNIT 1
FACILITY OPERATING LICENSE NPF-30
LICENSEE EVENT REPORT 90-015-00
ENGINEERED SAFETY FEATURE ACTUATION DUE TO A SPURIOUS
MAIN GENERATOR BREAKER PROTECTIVE FLASHOVER RELAY ACTUATION

FACILITY NAME (1) Callaway Plant Unit 1
DOCKET NUMBER (2) 050004831 OF 05
PAGE (3) 1 OF 05

TITLE (4) Engineered Safety Feature Actuation Due To A Spurious Main Generator Breaker Flashover Relay Actuation

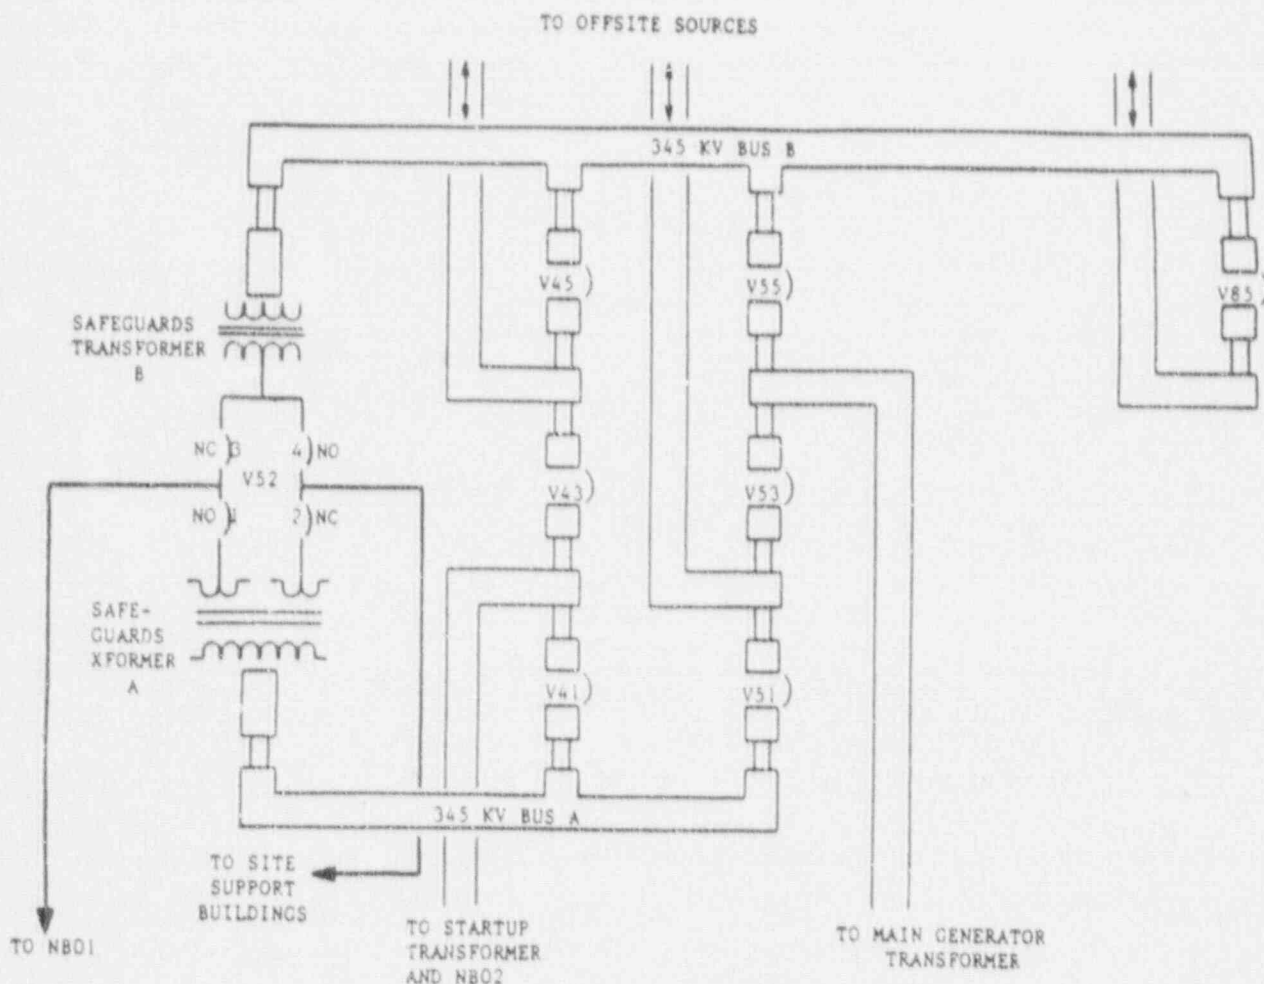
CALLAWAY PLANT SWITCHYARD

At 2219, a protective flashover relay, 50FO-V55, associated with generator output breaker V55⁽⁴⁾ actuated and cleared the 345KV switchyard bus 'B' by opening the offsite feeder breakers V45 and V85 (see attached drawing). The loss of power to switchyard bus 'B' resulted in a loss of power to the 4.16KV Class 1E Safeguards Bus, NB01. The undervoltage on NB01 caused the 'A' Diesel Generator⁽⁵⁾ to successfully start and load NB01, the shutdown sequencer to actuate, and initiation of an AFAS which started the Turbine-Driven Auxiliary Feedwater Pump.⁽⁶⁾ On 11/19/90 at 2355, the normal NB01 power lineup was restored and the above ESF systems were restored to their standby lineup. The Mode 1 power ascension was continued.
