Public Service Electric and Gas Company P.O. Box 236 Hancocks Bridge, New Jersey 08038  
Hope Creek Generating Station

HOPE CREEK GENERATING STATION  
DOCKET NO. 50-354  
UNIT NO. 1  
LICENSEE EVENT REPORT 90-029-00

TITLE (4): EMERGENCY CORE COOLING SYSTEMS ACTUATION - ELECTRICAL SPIKE ON CHANNEL "A" LOGIC RESULTS IN AUTO START OF CHANNEL "A" COMPONENTS - MULTIPLE CAUSES

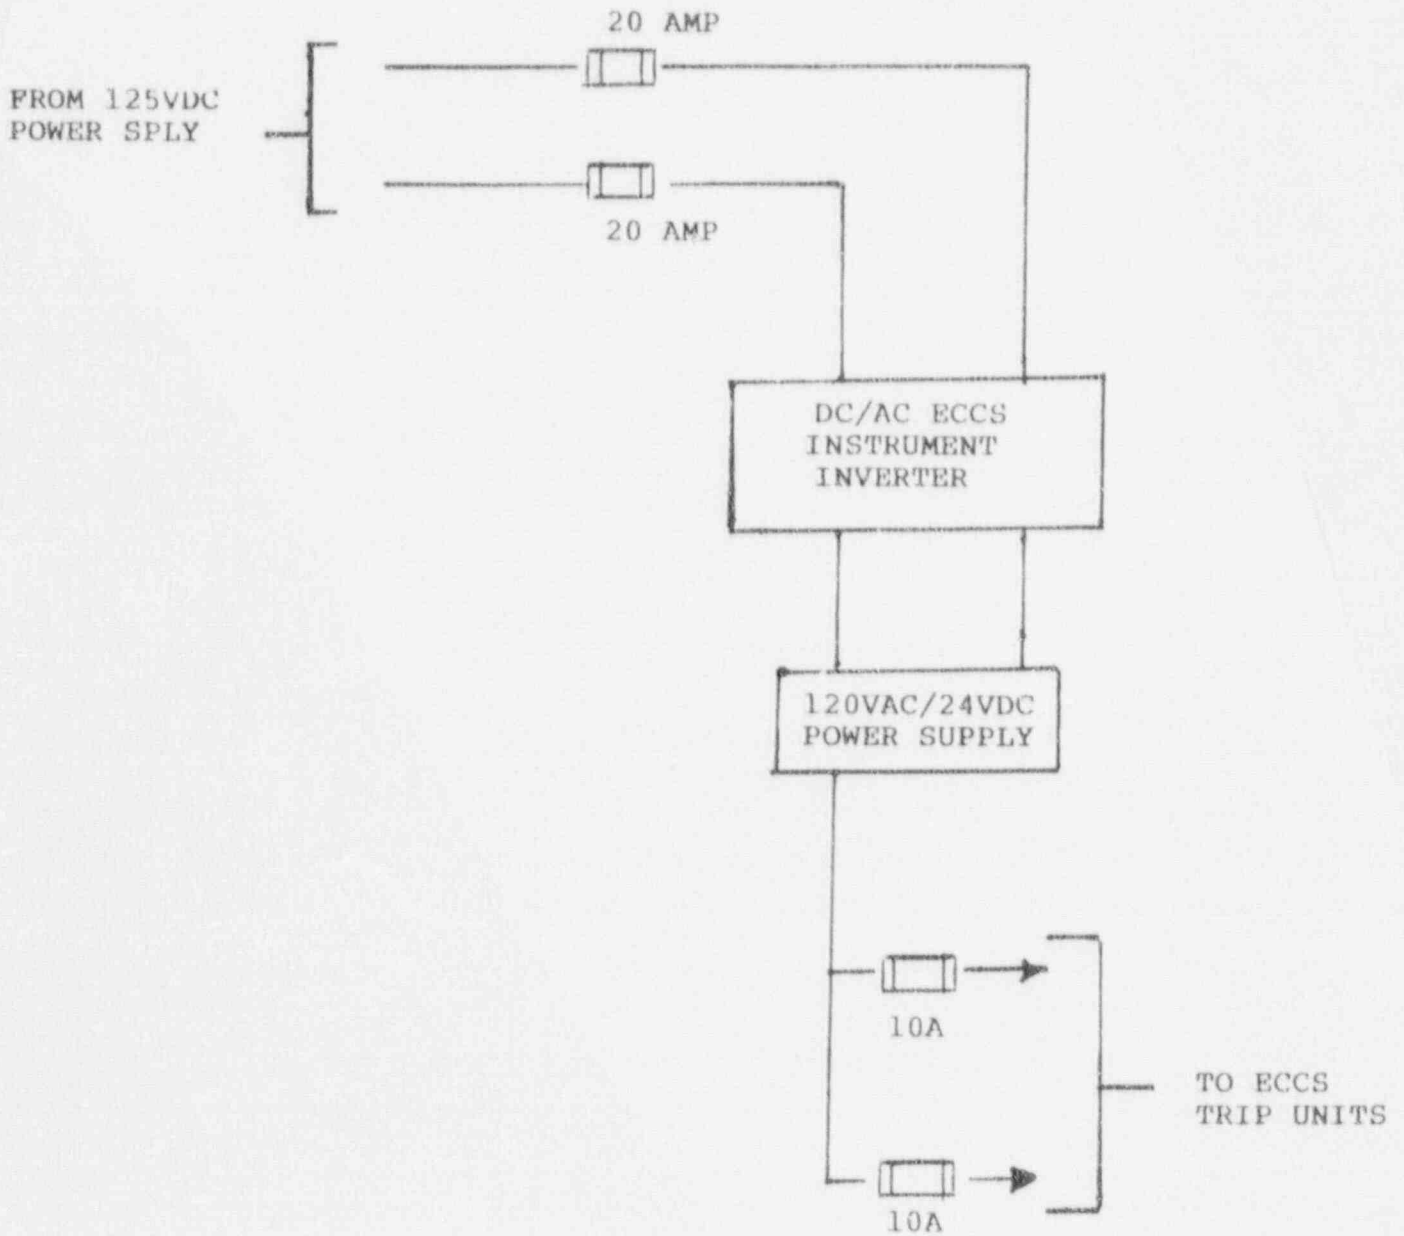
TYPICAL ECCS ACTUATION INSTRUMENTATION POWER SUPPLY DISTRIBUTION SCHEMATIC

Refer to Attachment 2 for a schematic of the Channel "A" ECCS actuation instrumentation power distribution arrangement (panel H11-P617). As previously noted, power to this distribution bus is provided by the Division I Class 1E 125VDC system. The 125VDC power supply to the bus is inverted to 120VAC by a DC/AC inverter. 120VAC power is then converted to 24VDC via a power supply, and this power supply feeds the Channel "A" ECCS trip units.

The DC/AC inverter (1RLEY-K601A) tripped on overvoltage (140VDC) at the onset of this event, and momentarily de-energized Channel "A" ECCS trip units. Following the high voltage shutdown of the battery charger, 125VDC bus voltage decayed, and 1RLEY-K601A automatically reset (approx. 132VDC input voltage), re-energizing the trip units. When re-energized, the affected Channel "A" trip units recognized the change of state as a valid Channel "A" initiation signal, and initiated the various system responses. The short time duration of this entire transient (a few seconds) afforded no opportunity for operator response to defeat Channel "A" ECCS initiations prior to the affected trip units being automatically re-energized.

Subsequent to the event, Systems Engineering performed an extensive review of individual trip unit responses to the transient, and determined that all trip units responded correctly and as designed. The original vendor design of the trip units assumed a continuous, uninterruptible power supply (UPS) for the trip units.

The current electrical distribution scheme meets the intent of UPS reliability. Two redundant battery chargers, backed by a 125VDC battery, inverted and rectified to 24VDC, met the original design intent. However, Hope Creek previously recognized that the protective nature of the 1RLEY-K601A trip/reset functions render this distribution scheme susceptible to power supply perturbations, and exposes the individual ECCS Channel to unplanned actuations. A design change, identified as a result of previous similar events at Hope Creek and PSE&G's involvement in the BWR Owners Group, is scheduled to be implemented during the stations third refueling outage (scheduled to commence 12/26/90).

This design change eliminates all ECCS instrument inverters, and will power each instrument bus directly from a channelized, 120 VAC, battery backed Class 1E UPS to maintain required divisional separation. Additionally, Hope Creek will continue to pursue the review of other potential design enhancements to increase the reliability of ECCS actuation instrumentation power supplies.

2. As a result of previous similar occurrences, a design change was initiated in 1989 to remove the ECCS instrument inverters from the ECCS actuation instrumentation electrical distribution scheme. This design change is scheduled to be completed during the stations third refueling outage. Additionally, PSE&C continues to work with the BWR Owners in attempting to resolve all reliability issues associated with ECCS actuation instrumentation, including power supplies.

5. During the upcoming outage, when the ECCS instrument inverters are removed, the trip and reset setpoints of each inverter will be verified.

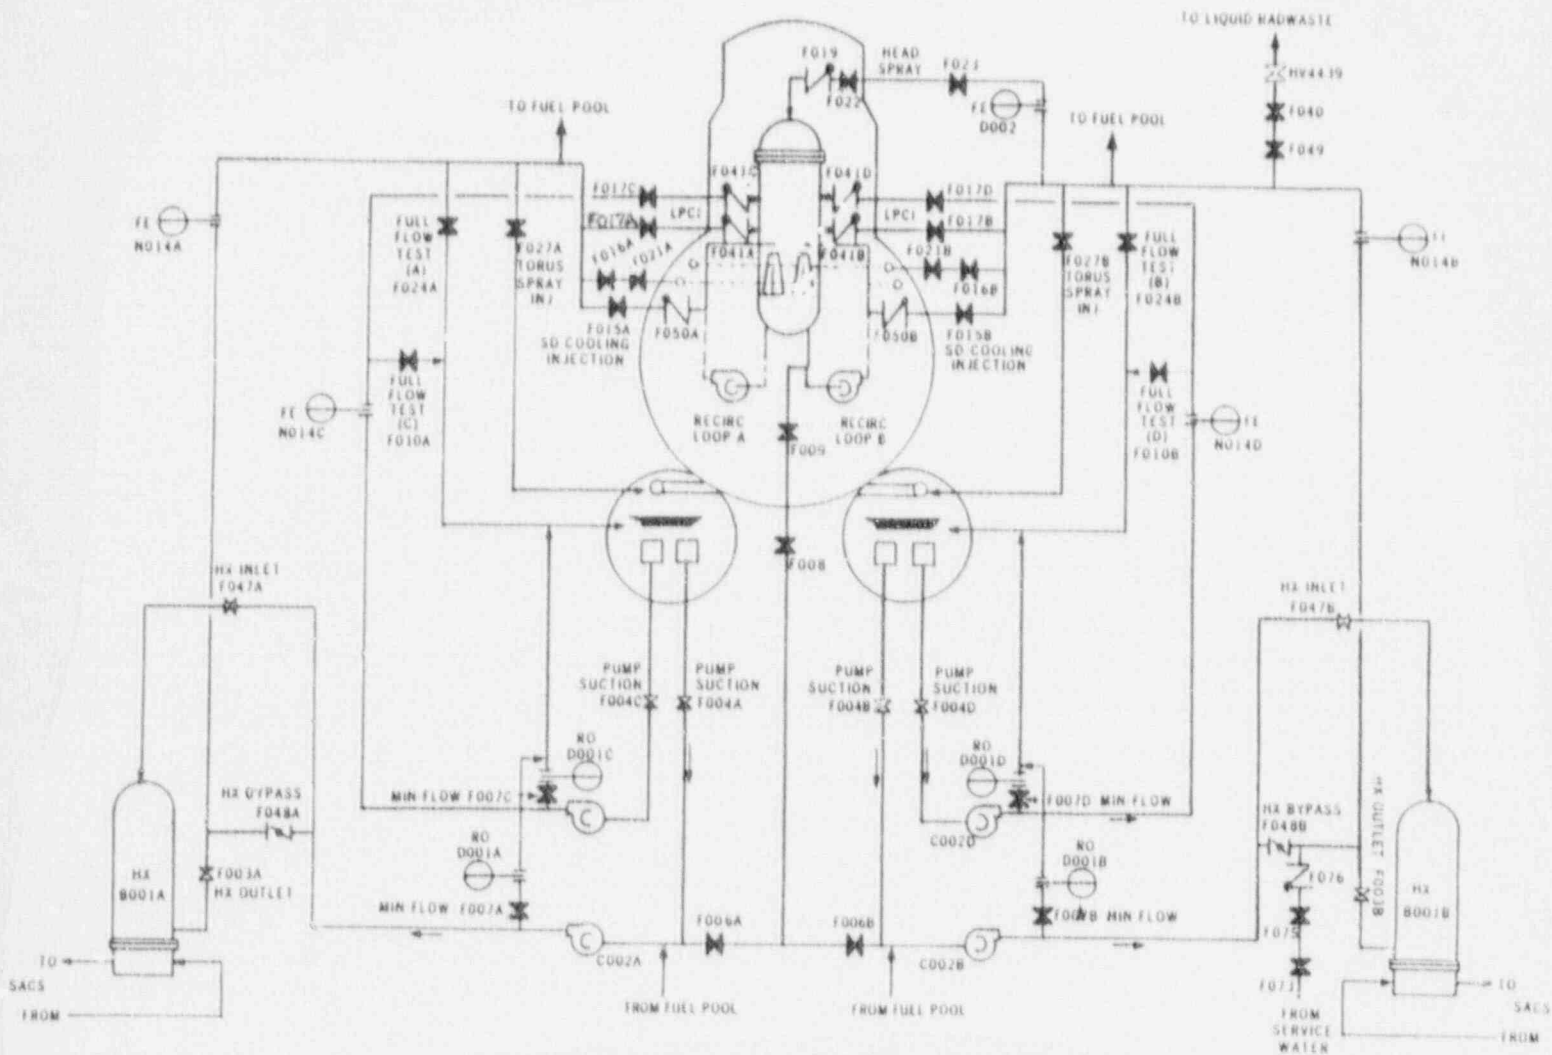
TYPICAL LPCI INJECTION SYSTEM DIAGRAM

With respect to the LPCI initiation, a post-transient review of external operating experience determined that one of the principal concerns with the event (as expressed in NRC Information Notice 90-022) centers on the opening of the LPCI Outboard Injection Valve (F017A). Refer to Attachment 3 for a one-line diagram of the "A" LPCI loop.

The F017A valve opens when the following logic sequence is satisfied:

- LPCI initiation signal (high drywell pressure, 1.68 PSIG or low vessel level, -129"). The LPCI initiation signal was satisfied by the LOCA Level 1 signal generated when the trip unit for Channel "A" ECCS instrumentation was re-energized.
- Power available to the "A" Vital Bus. This input was satisfied because the bus remained energized.
- Reactor pressure (as sensed between F017A and the inboard LPCI Injection Check Valve, F041A) is less than 450 PSIG. This logic input was satisfied as F041A is relatively leak tight. Additionally, due to the configuration of the associated ECCS trip unit, were reactor pressure greater than the permissive, it is possible an invalid permissive signal could be generated during an ECCS trip unit re-energization scenario such as described in this report.

When F017A opens, the low pressure LPCI piping is isolated from reactor pressure by F041A (a testable check valve which serves as the inboard containment isolation valve on the LPCI injection line). F041A is designed to ASME Section III, Code Class 1, and is rated for 1500 PSIG service at 575 deg.F.

Testing of the check valve to verify operability is conducted under the station ASME Section XI Inservice Testing program, and consists of verifying seat integrity (leak test), remote position indication, and valve exercising. Additionally, the integrity of F041A is verified every 8 hours by logging pressure between F017A and F041A to establish pressure fluctuation trends. This monitoring ensures the integrity of F041A, ensures that the high pressure/low pressure interface between the reactor vessel and the LPCI system is maintained, and ensures that primary containment integrity is maintained.

In summary, with F017A open and the "A" RHR pump running, the LPCI system is designed to inject to the RPV as reactor pressure decays below pump discharge pressure. In the event that F041A was not properly seated, the logic for opening F017A could not be satisfied under normal conditions (because pressure between the two valves would be greater than 450 PSIG). The integrity of F041A is continuously monitored through trending of pressure between F041A and F017A, thereby assuring LPCI system and containment integrity in the event of a spurious opening of F017A.

3. A procedure will be initiated to formally document trend analysis and review of the monitored pressures between F017A and F041A. This review is currently conducted, however, it is not formally documented.

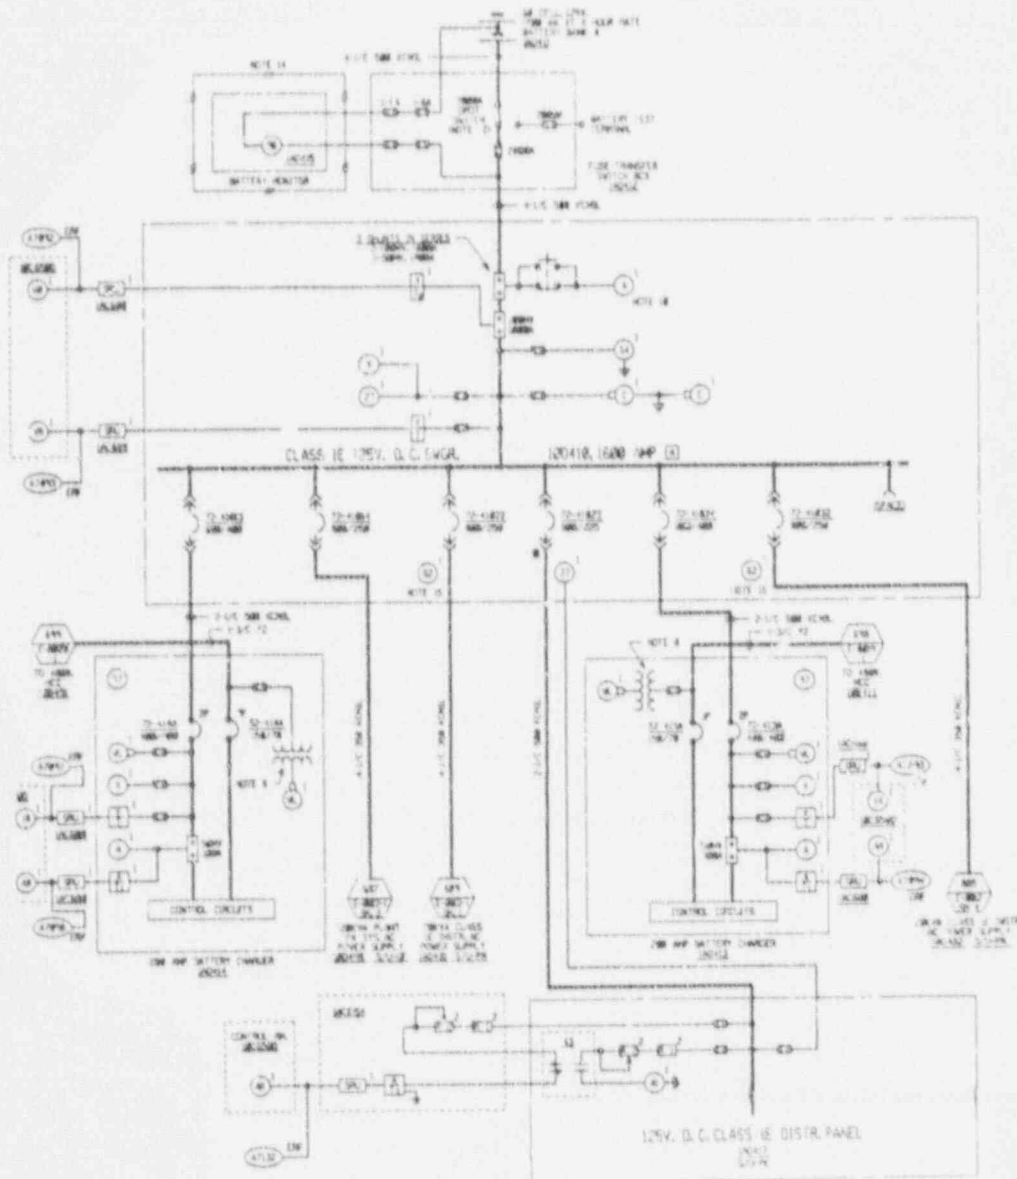
TYPICAL 125 VDC BATTERY CHARGER AND DISTRIBUTION SCHEMATIC

During the morning of 11/26/90, a Maintenance Electrician and Operations Department Equipment Operator (EO, non-licensed) were assigned the task of completing an 18 month capacity test on battery charger 1AD414. This charger and a redundant charger on the same Class 1E DC electrical bus provide 125VDC charging power to the Division I 125VDC battery, and normally supply all 125VDC loads on the associated bus. If both chargers trip for any reason, the battery supplies bus power until charger restoration. Refer to Attachment 1 for a schematic of the distribution system.

During performance of the test, while re-energizing the charger per procedure, the charger experienced a high output voltage condition, and tripped (the trip setpoint is 152 VDC). Subsequent investigation by the Maintenance Department and System Engineering determined that two factors contributed to the high voltage shutdown of 1AD414:

- Troubleshooting determined that one of three control logic cards for the charger had failed, and
- There was no electrical load on the charger when it was placed in service due to the redundant charger carrying bus loads. The normal sequence for charger restoration is to close the DC output breaker (effectively tying the charger to the bus) prior to energizing the charger by closing the 480VAC input breaker. With no load, the charger overshoot its normal output voltage when initially energized.

It is believed that a combination of these two factors resulted in the charger output voltage spiking excessively high and resulting in the high voltage shutdown of 1AD414.

1. The most probable cause of the initiating event (high voltage shutdown of battery charger 1AD414) was determined to be a failed charger control logic card. Failure of the card contributed to the magnitude of the normal charger voltage excursion when returning the charger to service. The logic card is being forwarded to the vendor for analysis to confirm this determination.
2. The root cause of the ECCS actuation instrumentation logic response is a less than optimum design of the instrument bus electrical distribution scheme. The protective nature of the instrument inverter trip/reset functions renders the distribution scheme susceptible to power supply perturbations, and exposes the individual ECCS channel to unplanned actuations.

- The failed control logic card on battery charger 1AD414 was replaced. Additionally, the logic card will be forwarded to the vendor for analysis to confirm the determination that the failed card contributed to the magnitude of the normal battery charger voltage excursion when re-energizing the charger.
