CITIZENS FOR FAIR UTILITY REGULATION
7600 Anglin
Fort Worth, Texas 76140

Request to institute a proceeding or for such other action as may be proper under 10 C.F.R., subpart B S2.206

One of the key issues of safety raised by CFUR involved the multiple failures of a number of Borg-Warner check valves in the auxiliary feedwater system (AFW) and the service water system which occurred in four separate events during hot functional testing in April and May of 1989. (Augmented Inspection Team Report, 50-445/89-30, 50-446/89-30, July 10, 1989, Attachment C.)

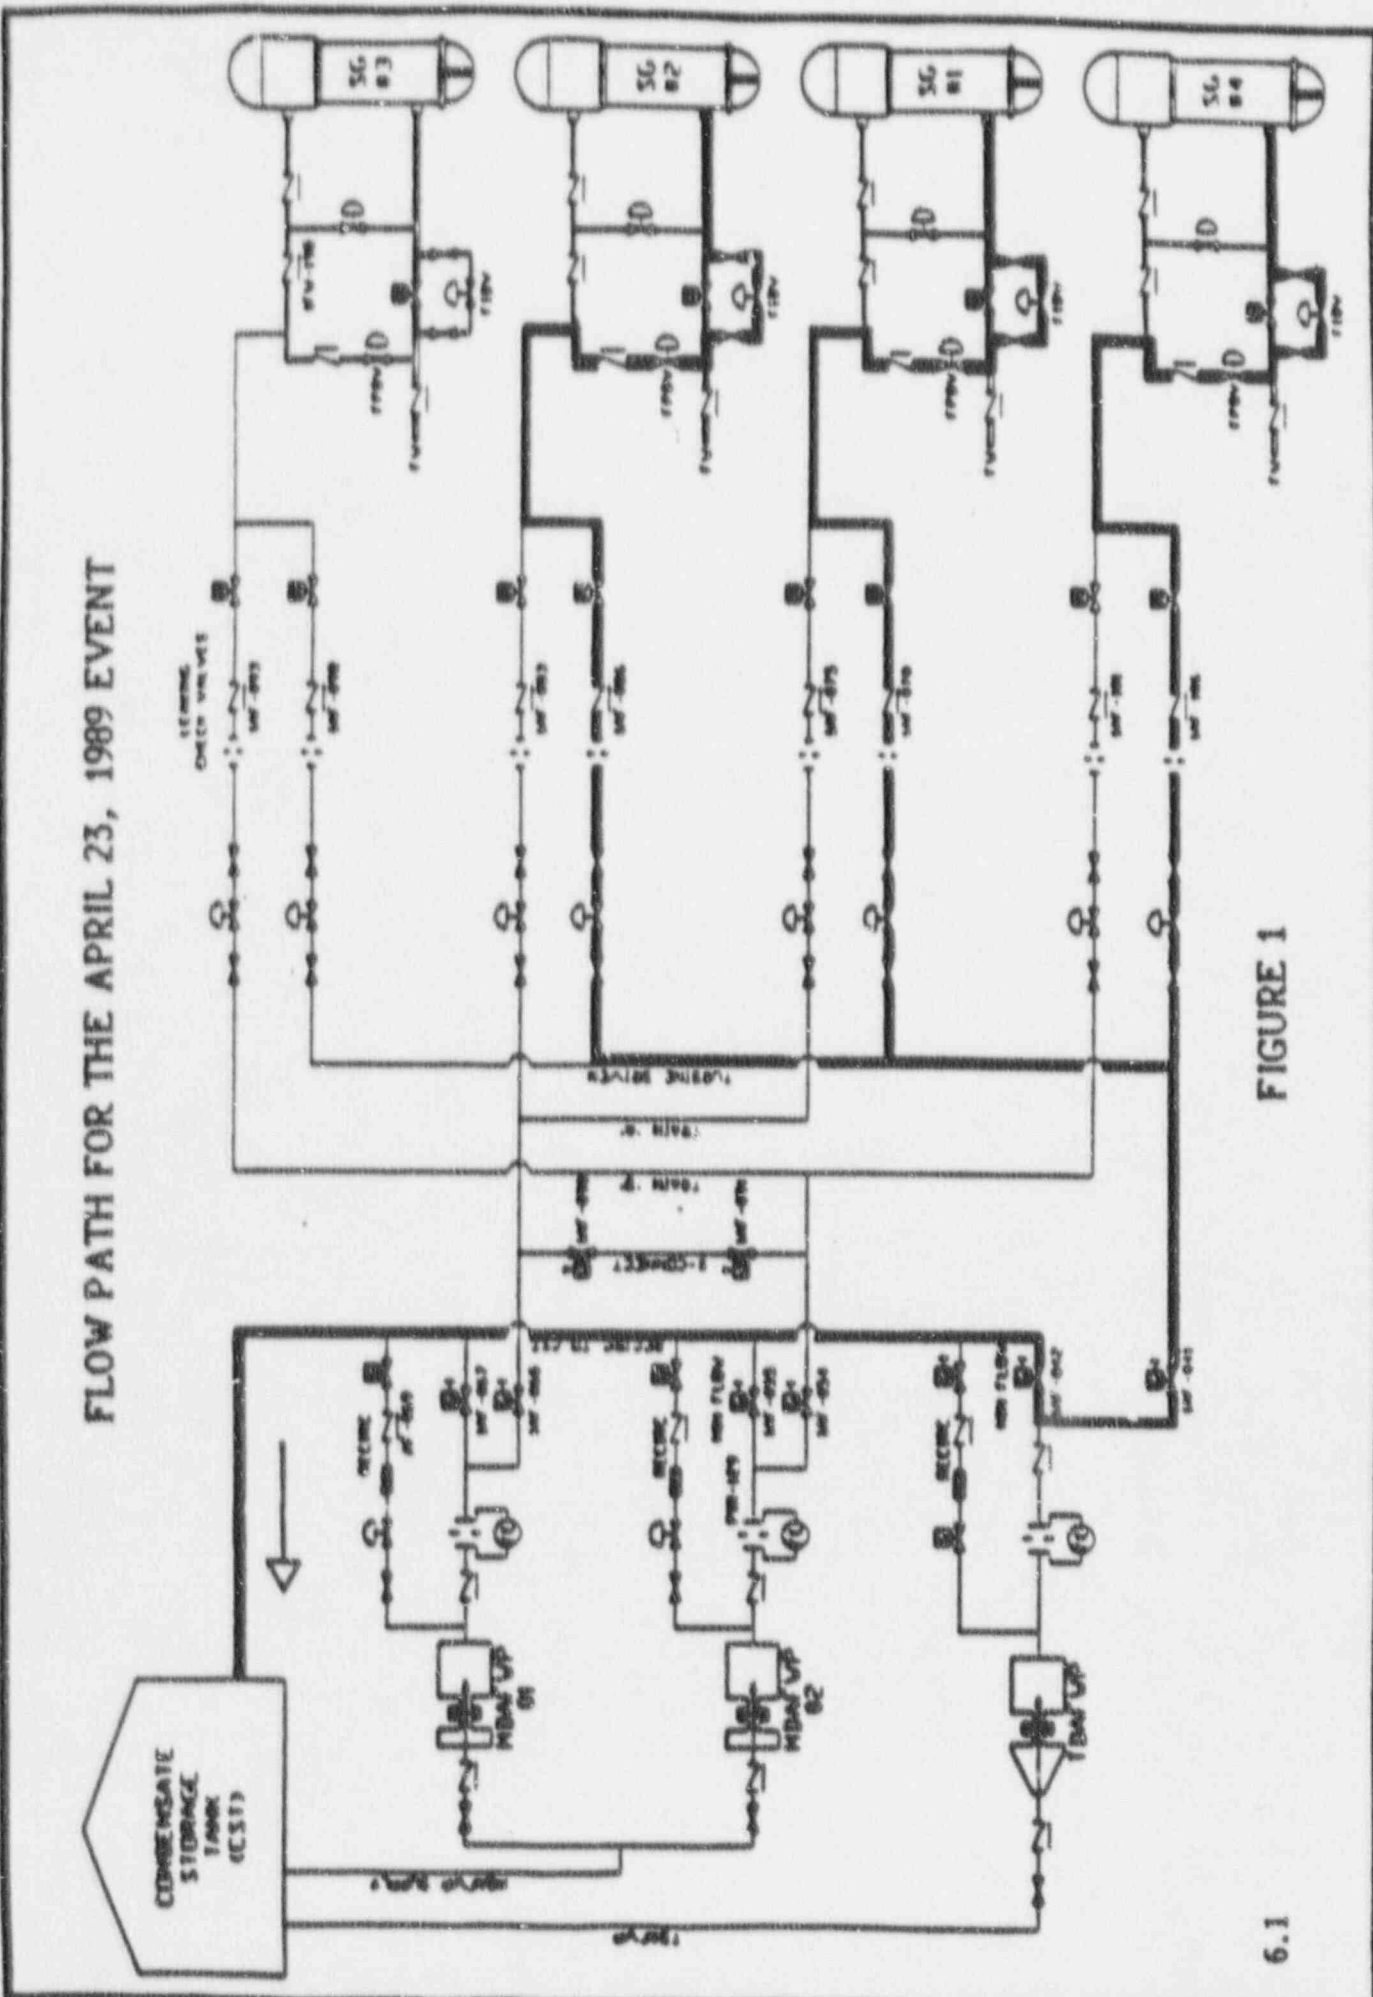
FIGURE 1

FLOW PATH FOR THE APRIL 23, 1989 EVENT

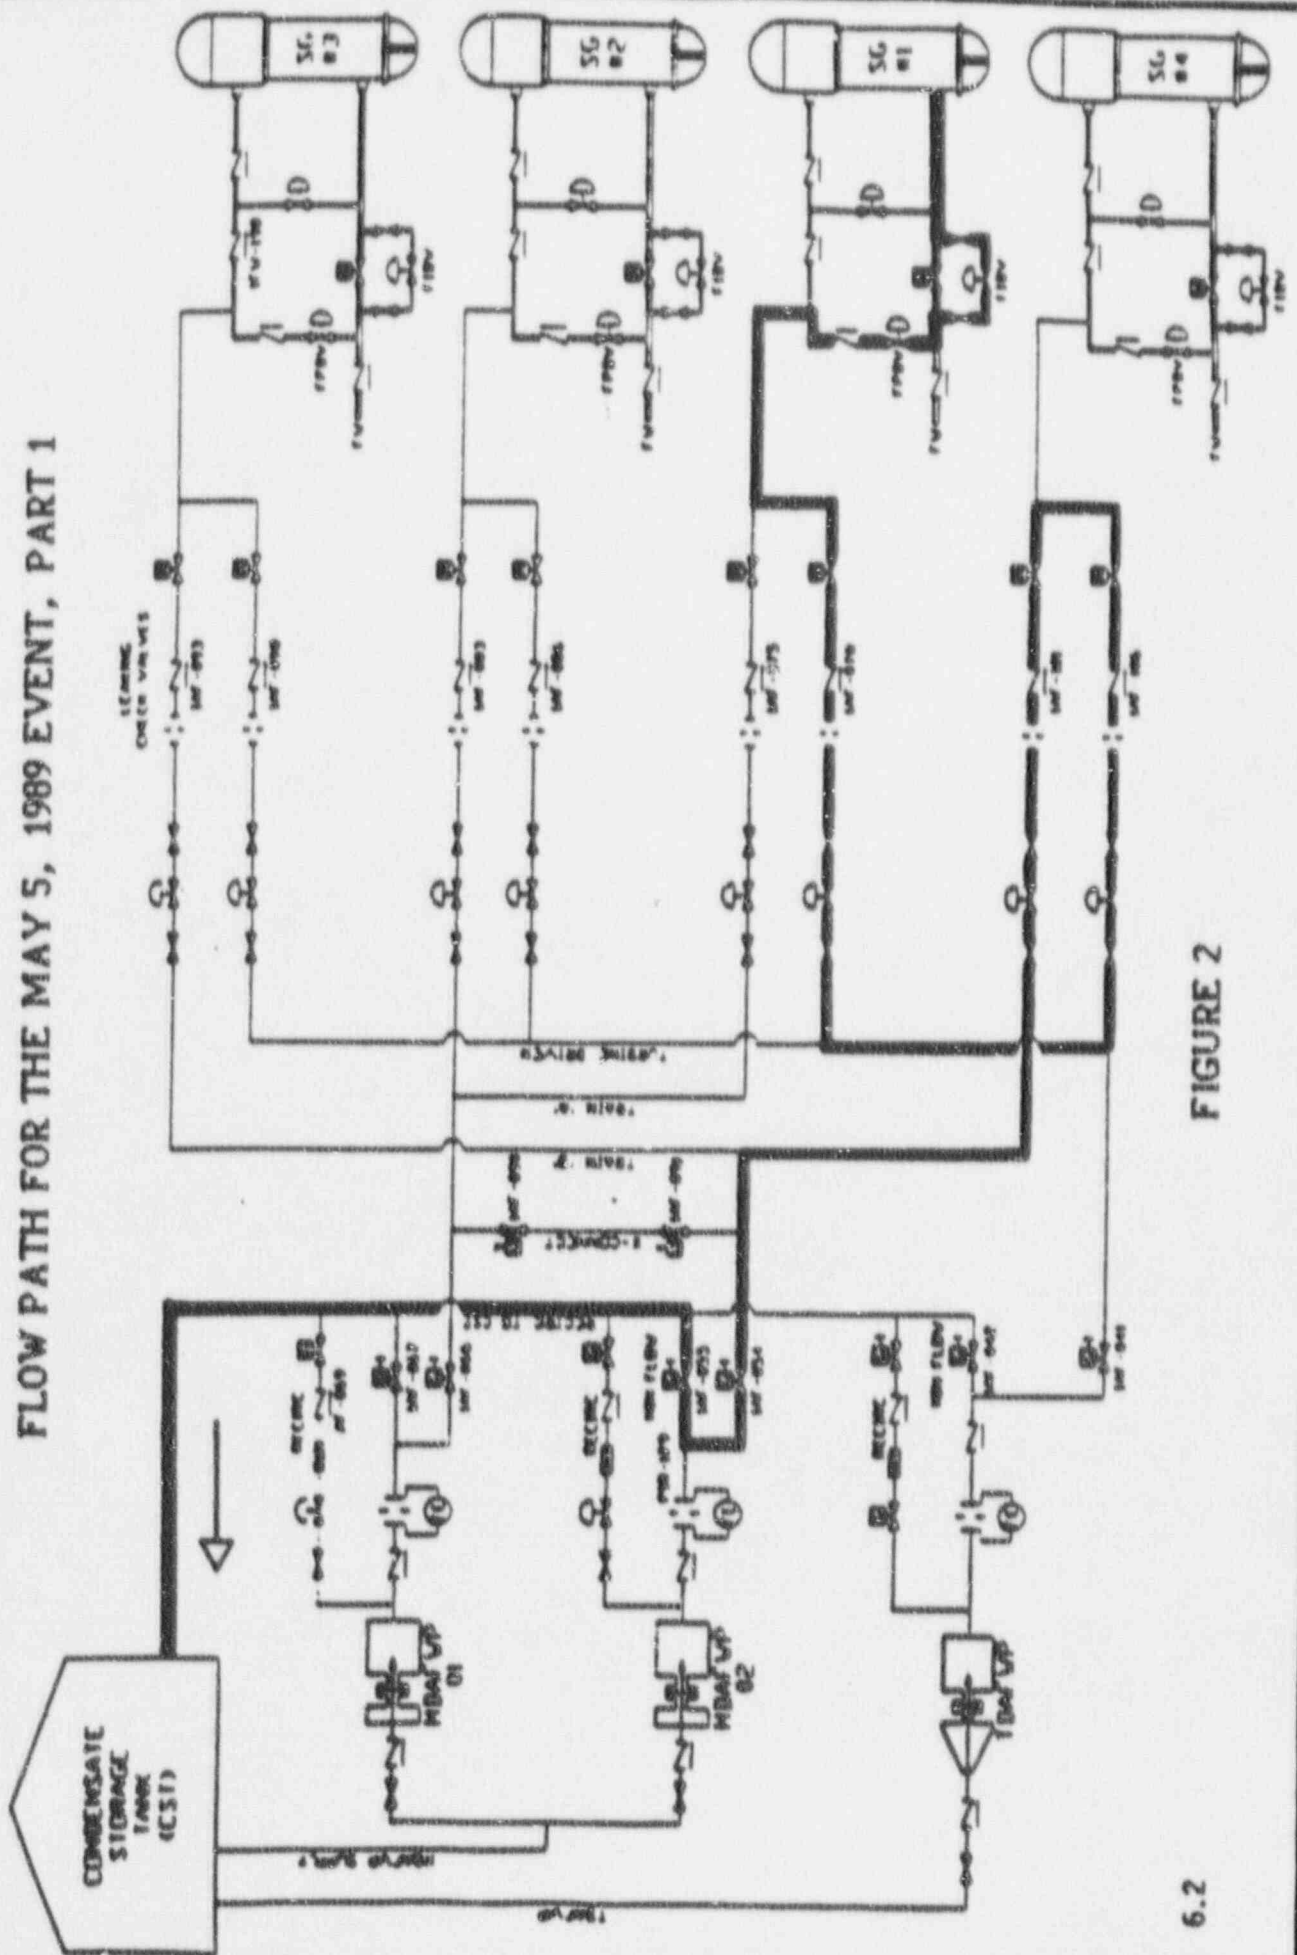
FIGURE 2

FLOW PATH FOR THE MAY 5, 1989 EVENT, PART 1

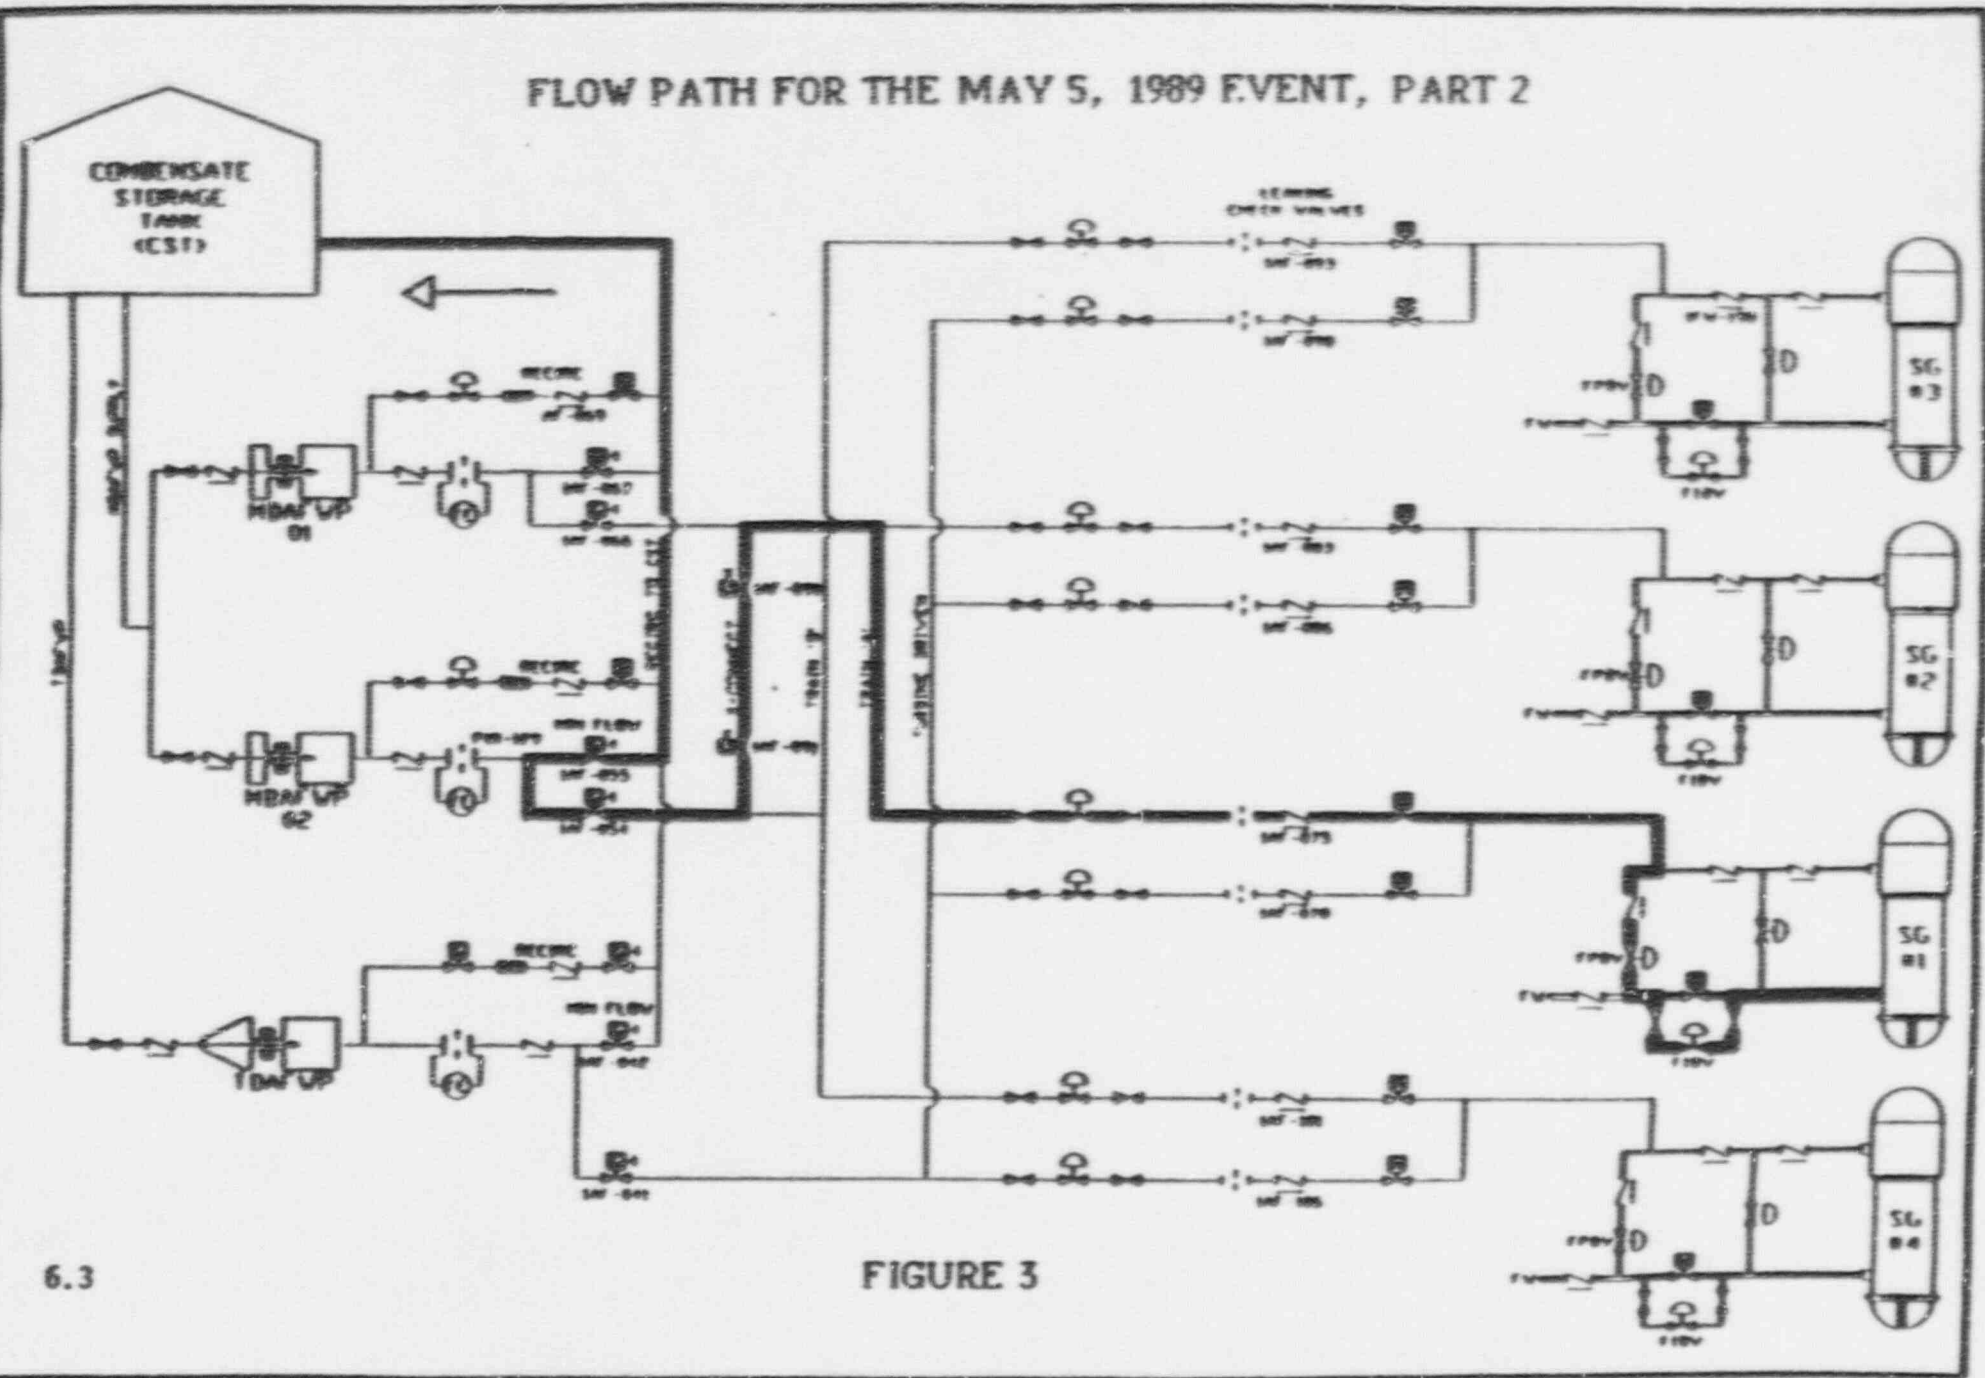
FIGURE 3

FLOW PATH FOR THE MAY 5, 1989 EVENT, PART 2

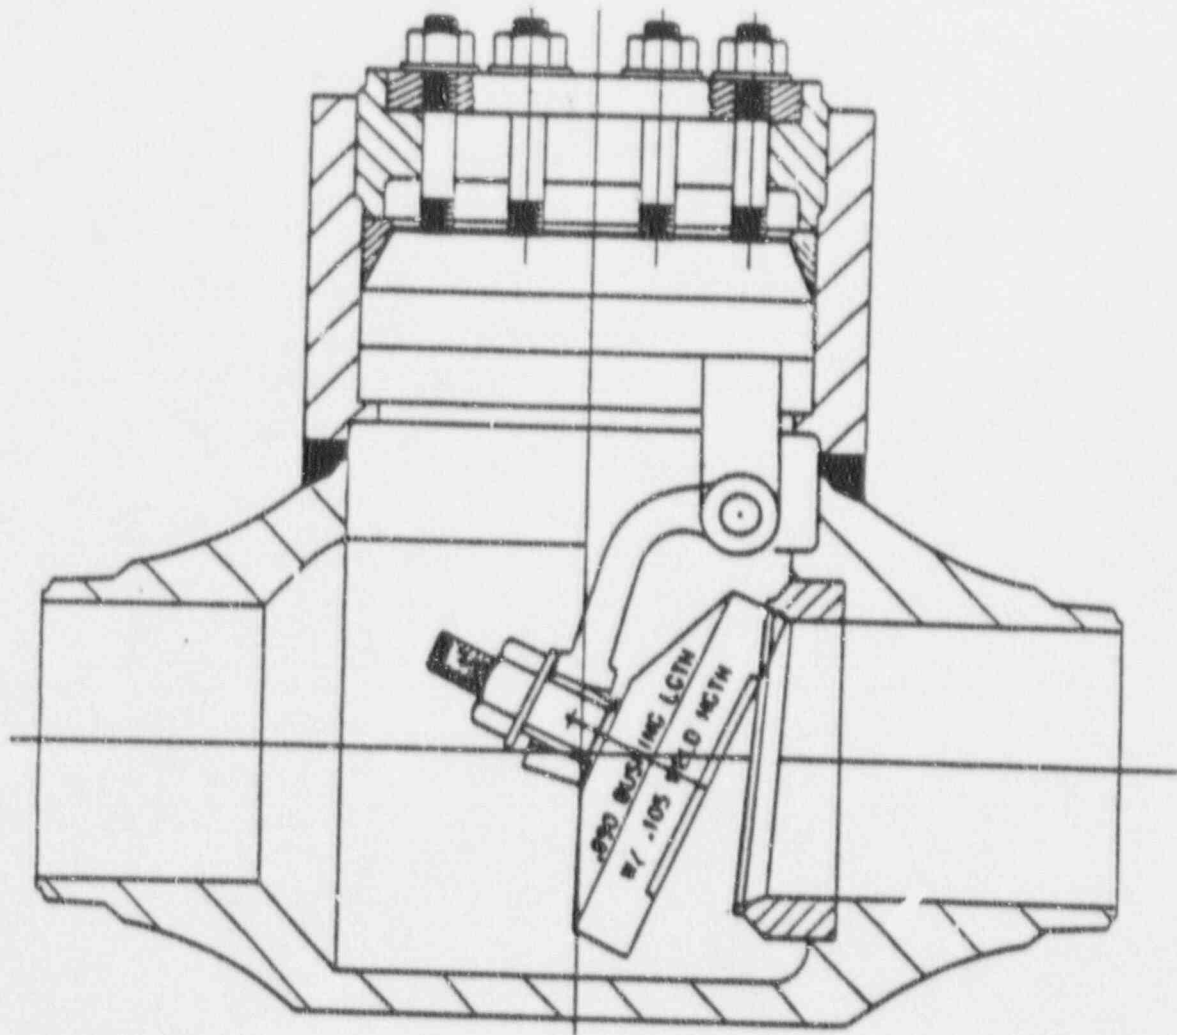
FIGURE 6

CAD Model of Valve 1AF-106 (As Found Condition)

4.7° SEAT ANGLE
EXISTING
DESIGN LAYOUT W/ WELD BEAD

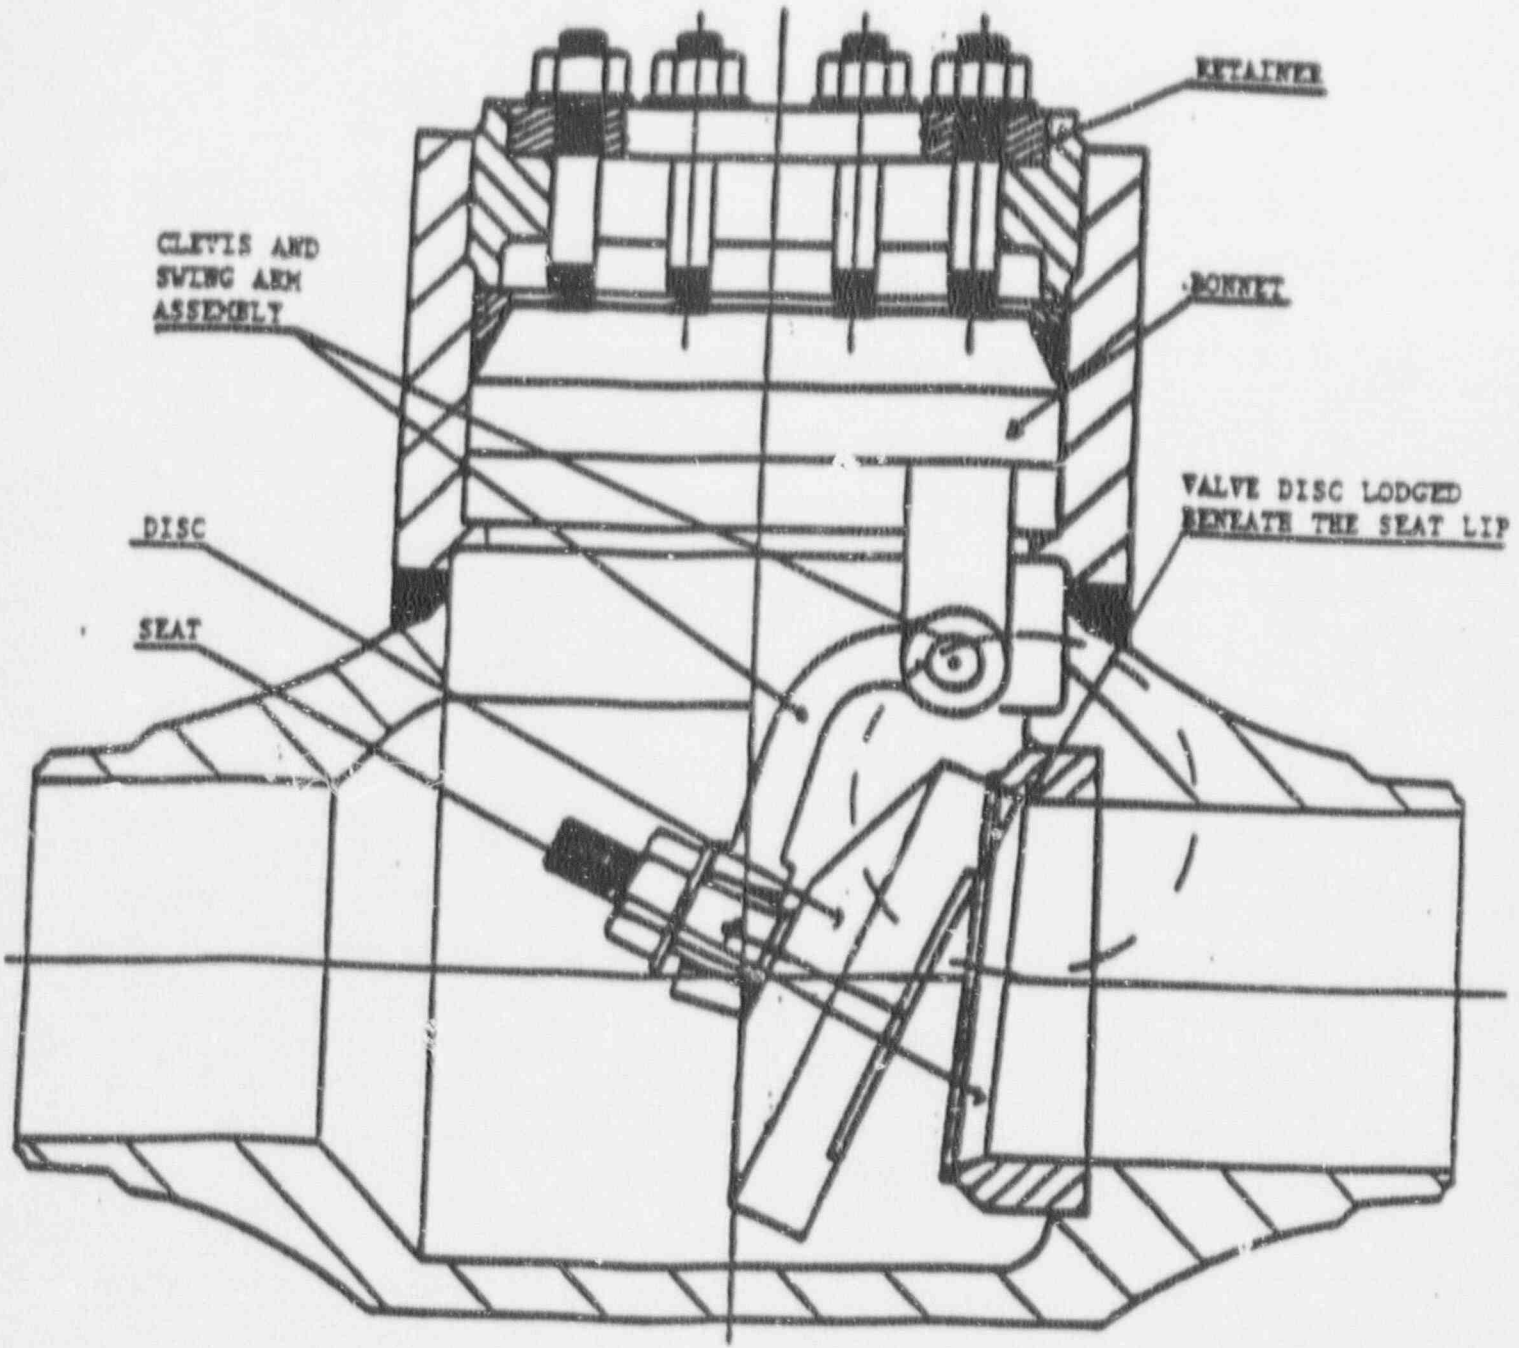
FIGURE 1

APRIL 23, 1989 EVENT

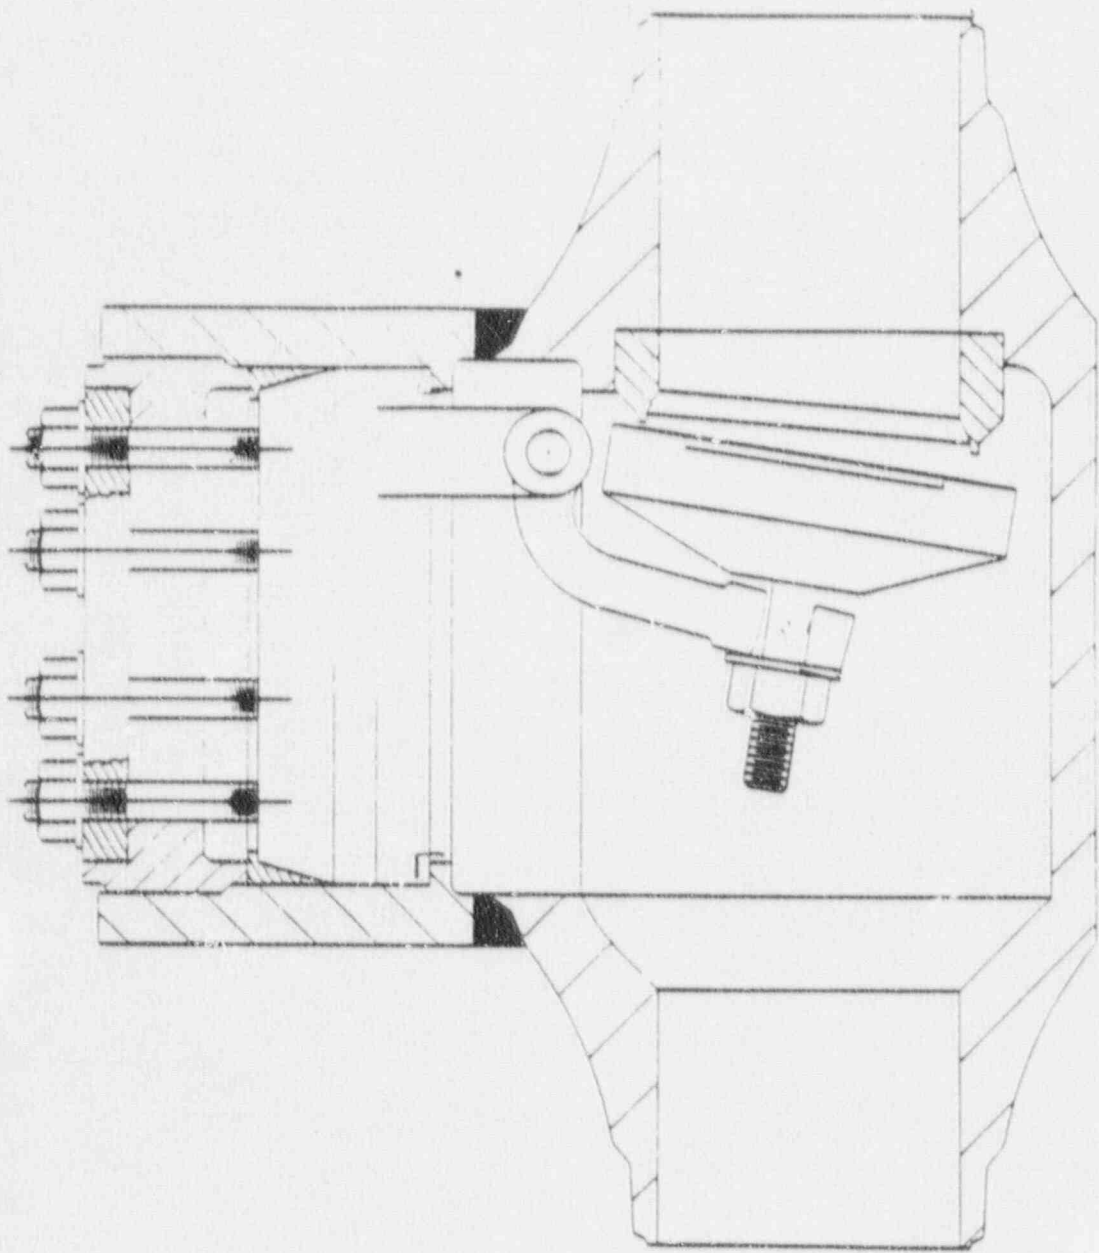
FEEDWATER PREHEATER BYPASS VALVES
CORRECTIVE ACTION

- 0 THE MANUAL ISOLATION VALVES WERE CLOSED AFTER THE WATER HAMMER INTERLOCK WAS CLEARED AND FLOW THROUGH MAIN FEEDWATER ISOLATION VALVE ESTABLISHED.
