WCAP-12791

Kewaunee Steam Generator

Mid-Cycle Report

December, 1990

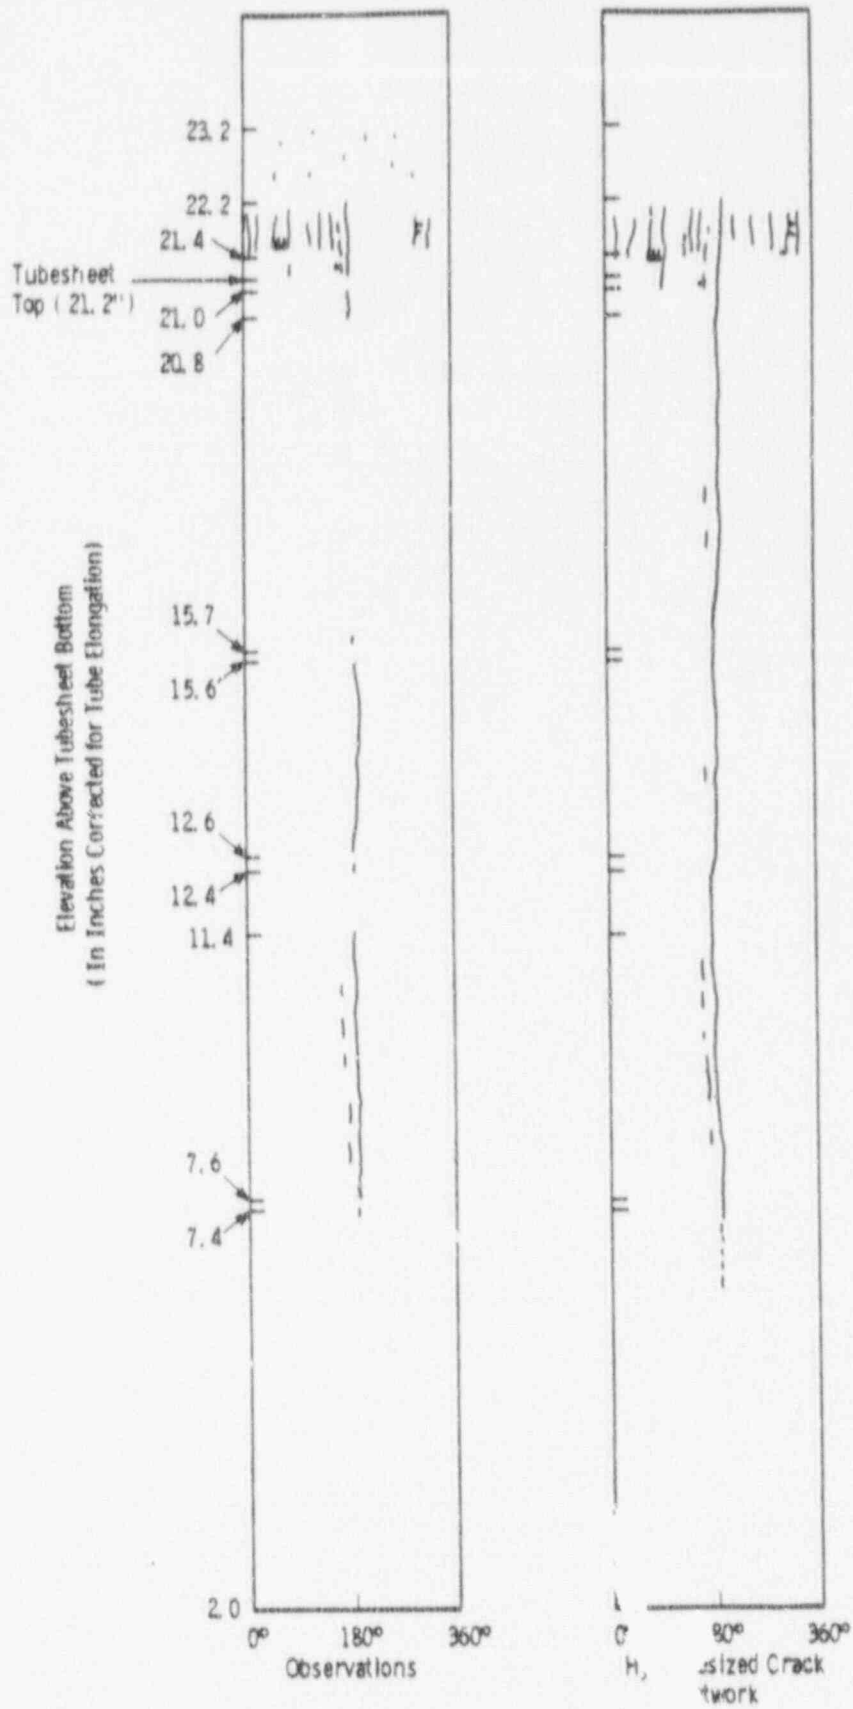
Figure 2-1. Crack Network Observed on Tube -C81.

The hot leg tube segments, Tube R4C81 and Tube R11C9, were pulled from Steam Generator B of the Kewaunee Plant for destructive examination. Figures 2-1 and 2-2 show sketches of the crack network found on the two tubes. Tube R4C81 was found to have multiple axial stress corrosion cracking (SCC) at and above the tubesheet top location as well as less extensive (fewer and more shallow) circumferential SCC. The SCC had a strong propensity towards developing a three dimensional intergranular attack (IGA). In general, the corrosion at the top of the tubesheet occurred uniformly around the circumference with most of the corrosion confined from the tubesheet top to 1.0 inches above the top. Cracking greater than 40% through wall was confined to within 0.6 inches of the tubesheet top. All of these macrocracks, with one exception discussed in the next paragraph, were short (less than 1.0 inch long). The axial macrocracks were composed of numerous shorter (less than 0.1 inches long) axial microcracks which grew together by intergranular corrosion. The maximum depth of the axial cracking in this location was 76% through wall. The largest region with circumferential involvement was 0.24 inches long and up to 75% deep. It was actually a series of close axial cracks which grew together with their "IGA skirts" to form the circumferential opening. The circumferential opening had an IGA morphology. The deepest circumferential crack found by metallography was only 20% through wall. Less extensive and much more shallow axial SCC was observed up to 2.0 inches above the tubesheet top. It was estimated that the cracking was significantly less than 10% deep in the region from 1.0 to 2.0 inches above the tubesheet top.

A long axial intergranular SCC was also found in the tubesheet crevice region of R4C81 near 180°. (The 180° is the azimuthal location of the SCC with reference to axes defined in the report on the tube examination.) It extended to and above the tubesheet top where it was deepest. Unlike the other axial stress corrosion cracks at the tubesheet top in this tube, this crack was very long. It existed below an elevation of 7.4 inches above the tubesheet bottom and extended to 1.0 inch above the tubesheet top. It may

The destructive examination results for Tube R4C81 above the tubesheet (Figure 2-1) show multiple axial crack networks around the circumference of the tube. The extent of cracking around the tube is somewhat more extensive than typically found at TSPs. This effect leads to higher voltage levels than for TSP indications. The bobbin coil voltage is a measure of volumetric levels of degradation and has been shown in laboratory sensitivity tests to increase with crack length, number of cracks around the tube and the loss of ligaments between cracks. Application of the voltage correlation data for ODSCC at TSPs is thus expected to be conservative for this Kewaunee application due to the higher voltages resulting from the increased number of axial crack networks around the tube. The height of 1.1" found for R4C81 degradation involvement at the top of the tubesheet is longer than the 0.75" height typical for ODSCC at TSPs. The principal crack network of R4C81 was 1.1" long with depths up to 68% to 0.6" and < 40% to 1.1" with a short crack up to 76% deep also found by destructive examination. Regardless of this length and depth, The crack morphology shows that this tube would not leak or burst under SLB conditions. The estimated burst pressure is about 4500 psi conservatively assuming a 68% depth over 1.1 inch. Thus this indication is

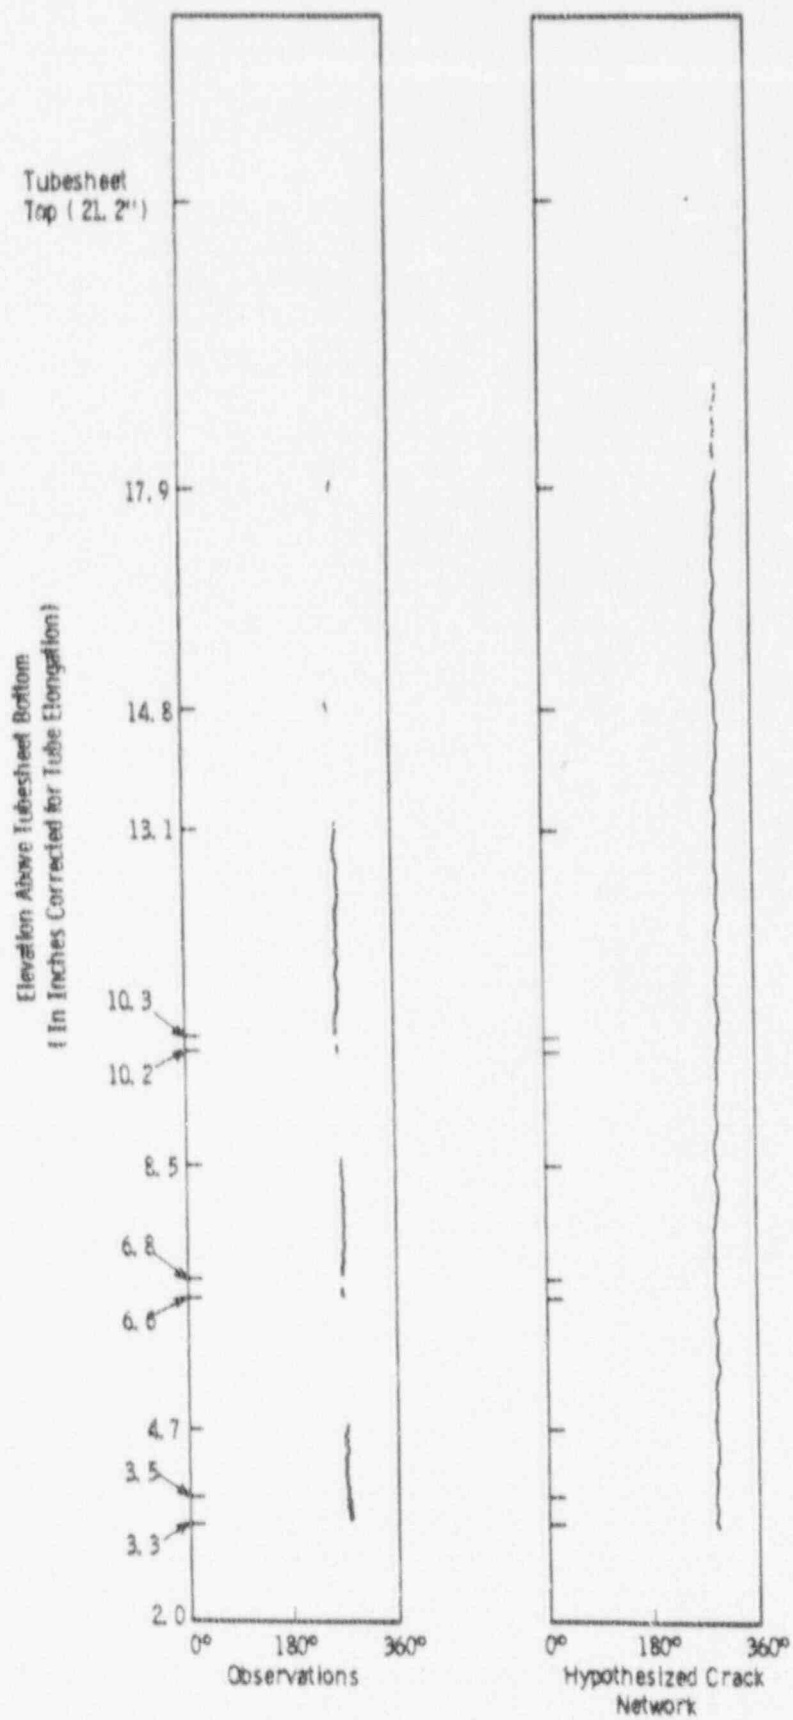
Figure 2-2. Crack Network Observed on Tube R11-C9.

Tube R11C9 had a long axial crack within the tubesheet crevice region. The crack extended from 3.3 to approximately 20 inches above the tubesheet bottom at a circumferential position of 280°. The 16.7 inch long crack was continuously deeper than 40% from 3.5 to 14 inches above the tubesheet bottom and had a maximum depth of 74%. Unlike in the long crack in Tube R4C81, it was difficult to observe separate nucleation points in the crack on Tube R11C9. It is possible that the minor (2-3% deep) OD surface IGA, found at all tube surface locations within the tubesheet crevice, acted as nucleation points for cracks that grew together by intergranular corrosion at a depth of one to two grains below the surface. In general, the axial SCC in Tube R11C9 had minor IGA characteristics. However, when the crack approached mid-wall, the crack morphology changed to IGA, suggesting that the local stress state had decreased. A drop in the local stress state would also imply that the crack growth rate decreased.

An axial scratch was observed at 280° from 3.6 to approximately 18 inches above the tubesheet bottom. Surface deposits and surface oxides on the scratch indicate that the scratch predated plant operation. The scratch was deepest and widest at the bottom elevation and gradually became less deep and wide with increasing elevation. The crack ran along the right side of the axial scratch near bottom elevations and along a ridge adjacent to the scratch at higher elevations. The ridge was probably part of the axial scratch where the scratch became less visible. Similar scratches were observed at other circumferential locations on this tube and also on Tube R4C81. None of these other axial scratches had corrosion associated with them. The axial scratches were not located at regular intervals around the circumference as has been identified at other plants.

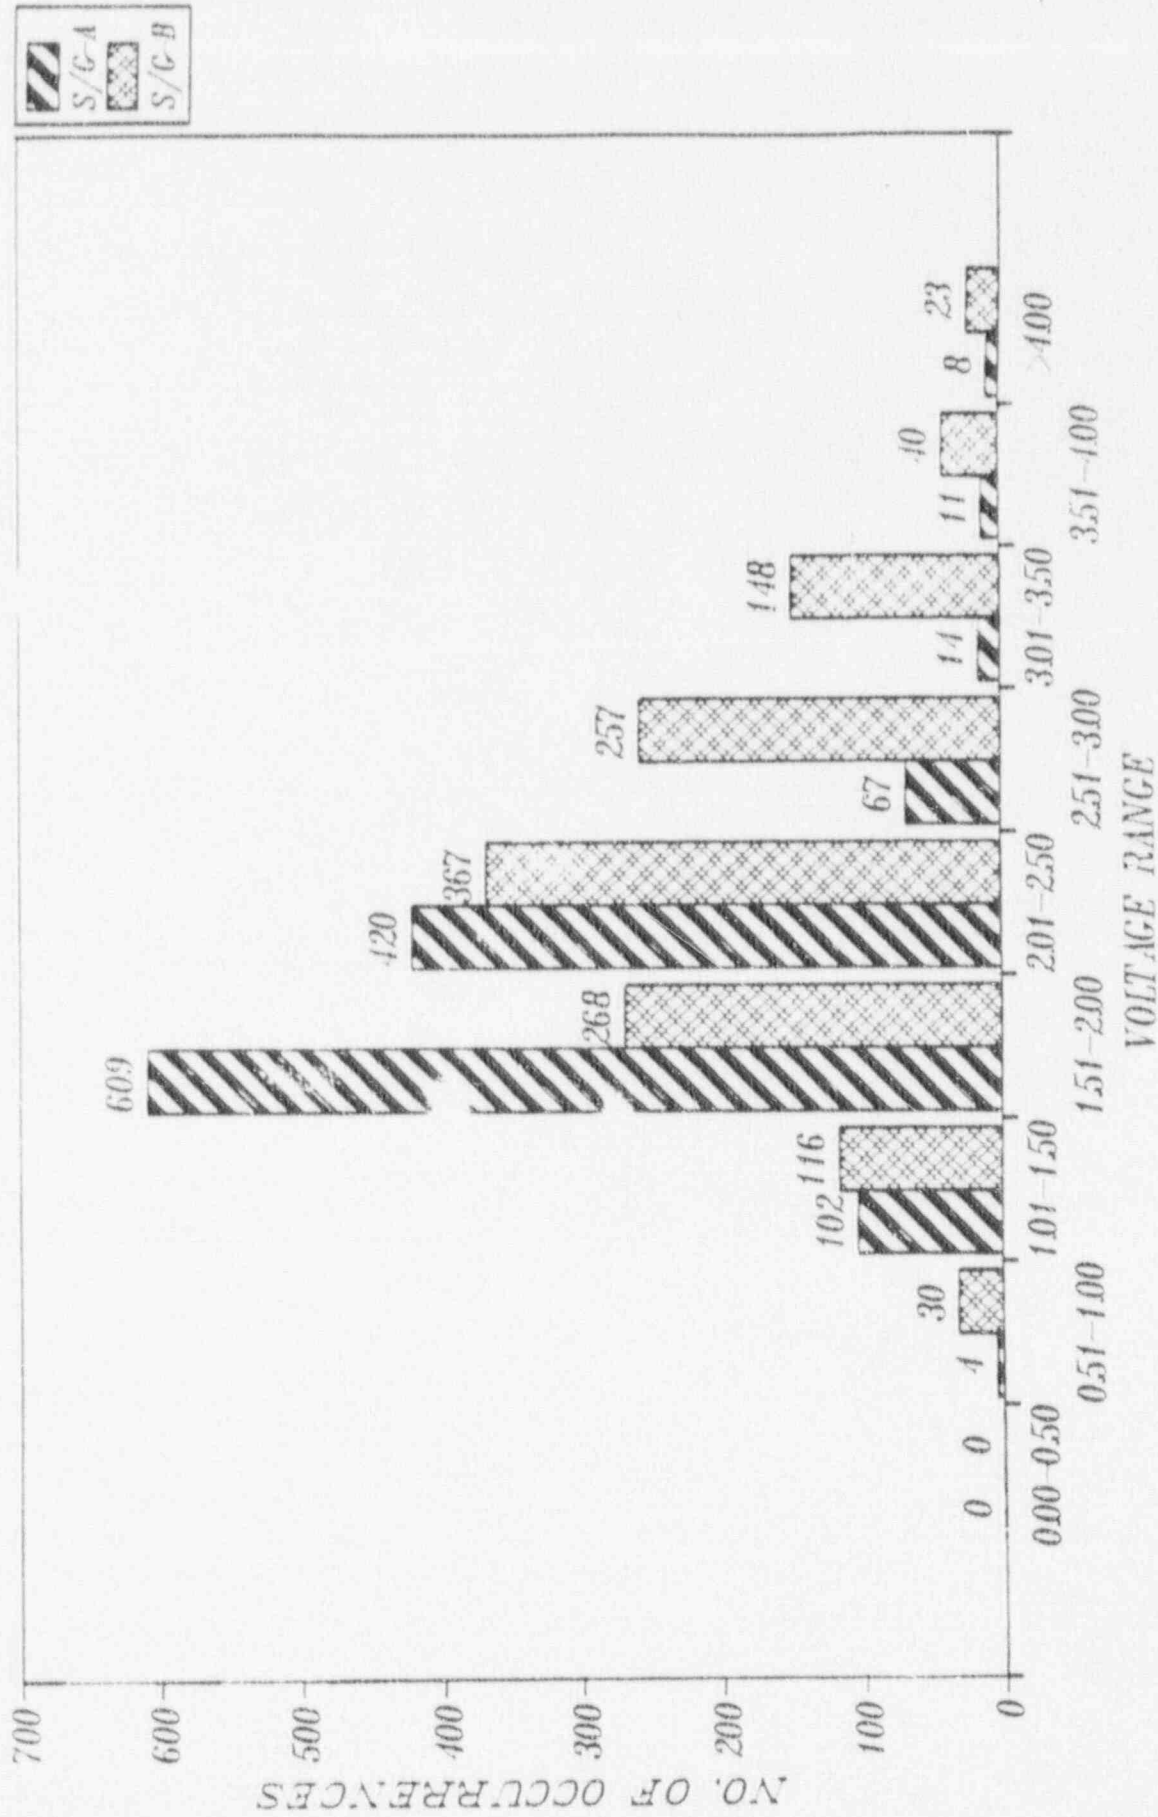
Figure 3-3 Comparison of Vent Voltages

The eddy current data for this tube was also reviewed for denting at the top of the tubesheet. A clear dent signal of ~1.8 volts was found. This dent size is typical of the most probable dent size as shown by the dent voltage distribution of Figure 3-3.

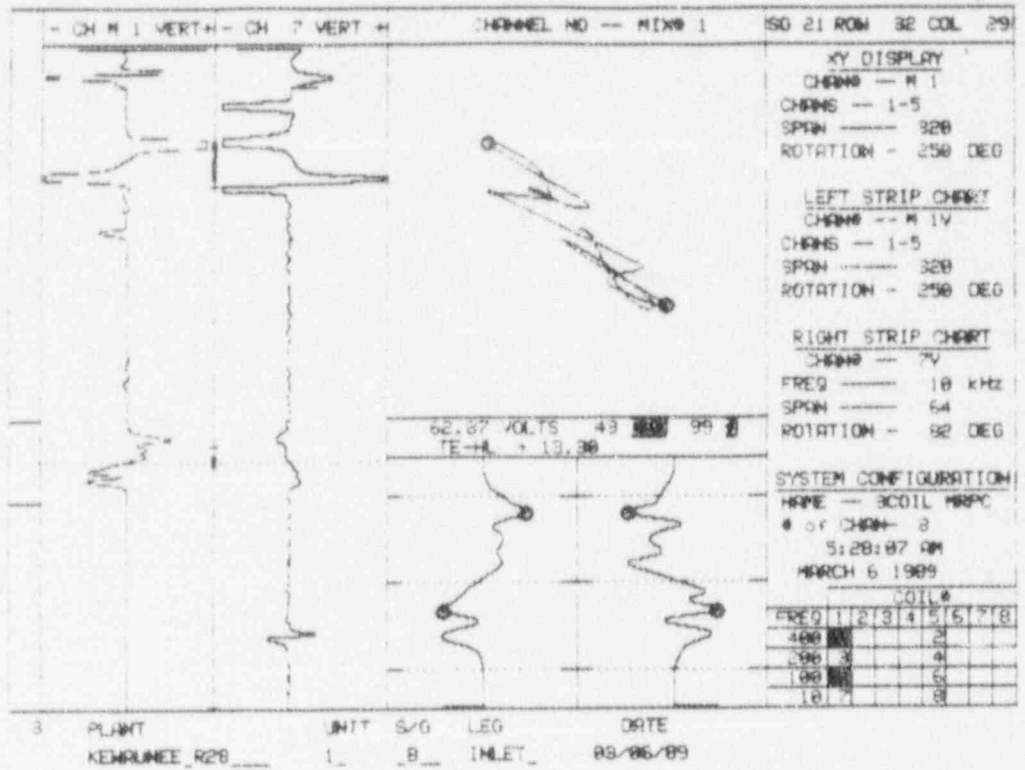
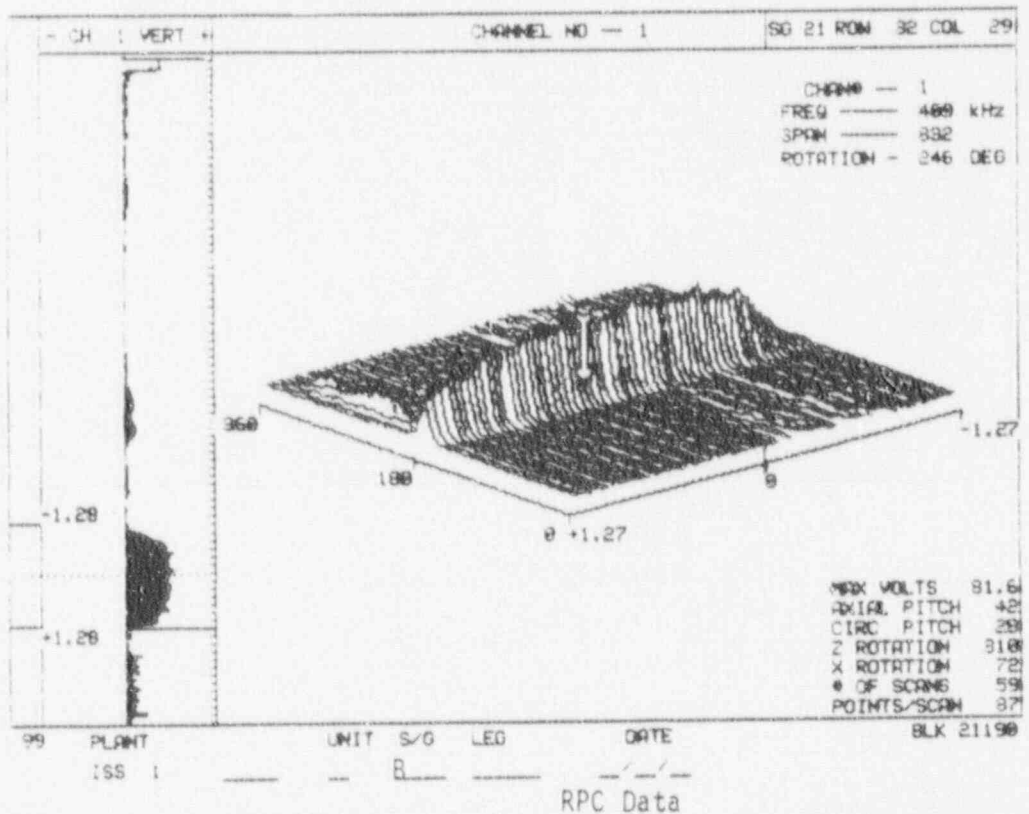
Figure 3-5 Inspection Results for Tube R32C29

Kewaunee had a primary to secondary leak rate that peaked at 0.08 gpm (118 gpd) prior to the 1989 refueling and inspection outage. The leakage was traced to tube R32C29 in Steam Generator B which had cracks within the tubesheet crevice. The bobbin coil inspection results show a deep indication between 12 and 14.5 inches above the bottom of the tube. This indication, as shown in Figure 3-5, appears to have ~100% depth. In addition, there were additional indications at other axial locations within the crevice that were 70 to 84% deep.

The RPC data at about the 12 to 14.5 inch elevation is also shown in Figure 3-5. This data indicates a probable through wall crack of about 2 inches axial length. Other axial indications were found that do not appear to be through wall.

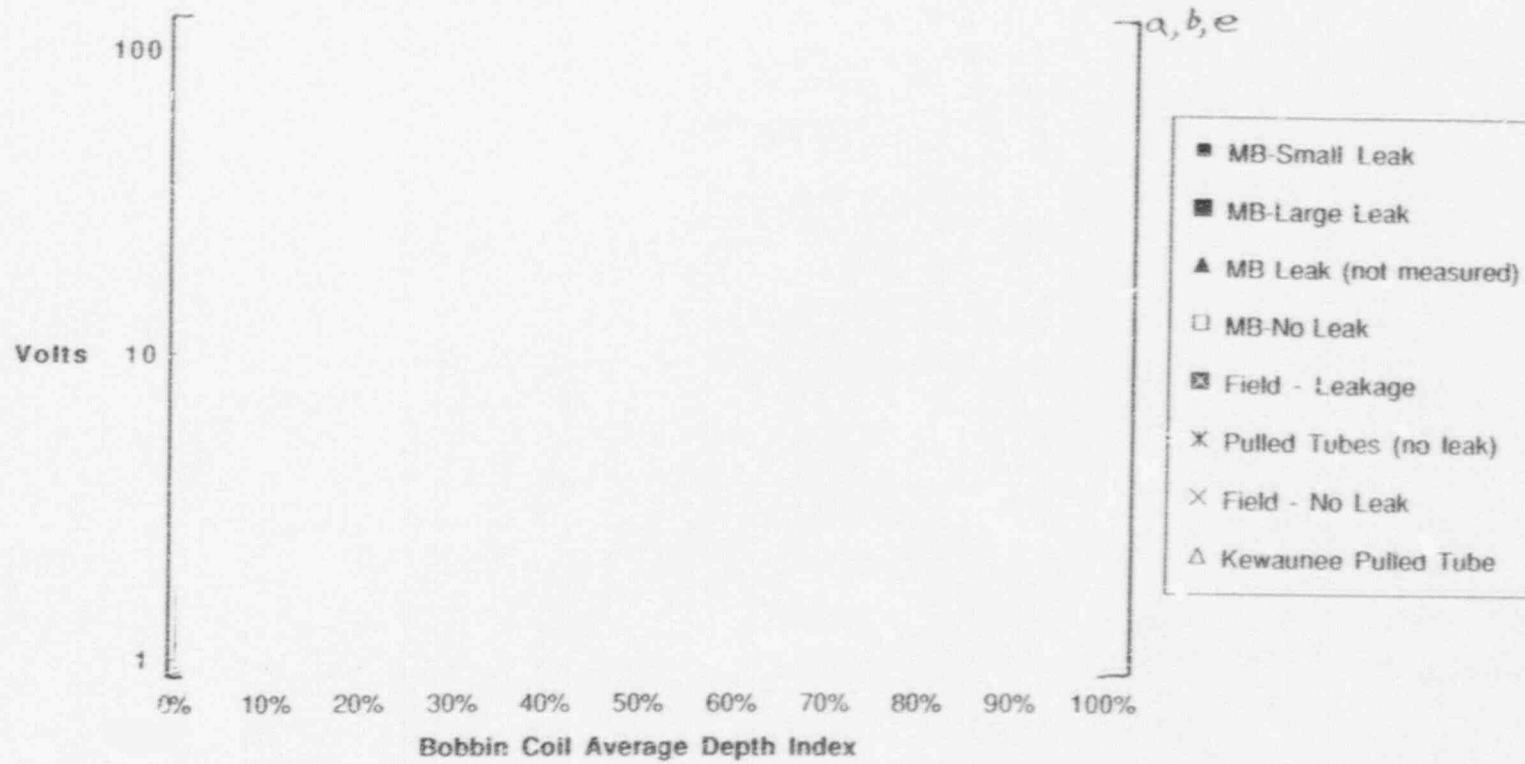
Figure 4-1
 Normal Operating ΔP Leak Rate Data Base

To develop a relation between average voltage and leakage potential, data from pulled tube examinations, laboratory model boiler induced ODSCC cracks, field leakage experience and field data with no identified leakage have been collected. These data are shown in Figure 4-1. Included in the figure is the data point for Kewaunee pulled tube R4C81. The field eddy current data for the leaking tubes found in the field is shown in Table 4-1. The field and laboratory data of Figure 4-1 indicate that operating leakage is not expected for voltages less than about []^{b,c,e}. The laboratory, model boiler (MB) data points of Figure 4-1 were also tested for leakage at steam line break (SLB) pressure differentials of 2650 psi. The largest leak rates measured for the model boiler specimens shown in Figure 4-1 were []^{b,c,e} of normal operating and SLB pressure differentials respectively. The model boiler generated crack specimens showed steam line break to normal operating leak rate ratios that were [< 3.0 which indicates no significant plastic deformation of the cracks and that burst pressures for all the model boiler points of Figure 4-1 exceed SLB conditions.]^{b,c,e}

Therefore, the data of Figure 4-1 support about []^{b,c,e} volts as a threshold for no operating leakage and no burst for SLB conditions at a much higher voltage level.
