PDR Docket 99900225

The Foxboro Company

Reference: Foxboro Model No. N-E13DM-IHM2
or Spare Part No. N0141FN

Nuclear Notification
page 2

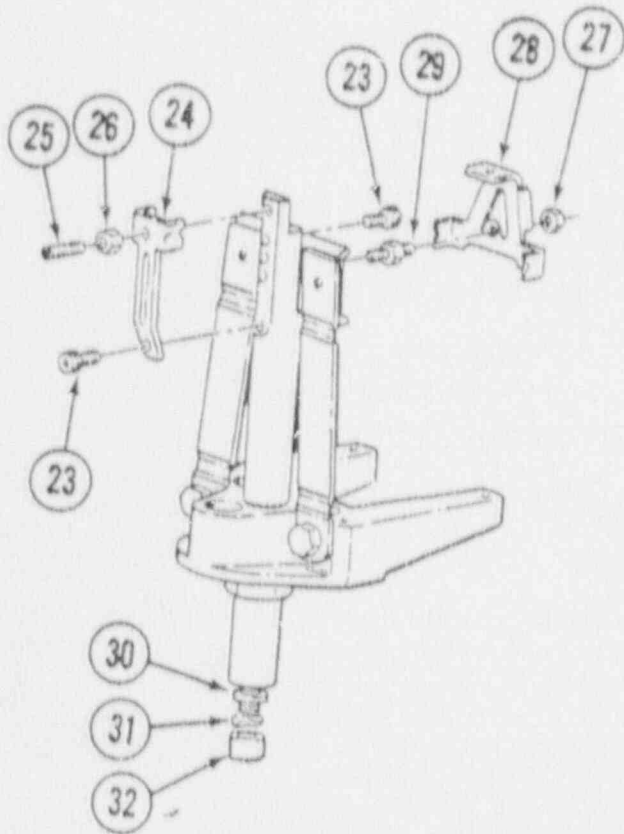
Figure No. 1

In compliance with 10CFR Part 21.21(a)(1) (ii), this letter is to notify you that we may have shipped you either a transmitter with an improperly processed part and/or the part itself. The subject part is Part No. N0141FN, a bracket, and is identified as number 24 in the attached Figure No. 1. The bracket is located in the transmitter topworks at the top of the force bar assembly and provides topworks static alignment and overrange protection. In August of 1989 the bracket material was changed to a 410SS, which requires a two step heat treating process, instead of a single step process, for proper material characteristics. The correct process change was not implemented until Jan.-Feb. 1990. Single step heat treatment of 410SS allows cracks to form near the bracket mounting hole and from which the cracks will continue to propagate, thus weakening the bracket. This discrepancy was discovered only very recently. Weakening brackets may cause one of the following to occur:

Visual inspection will not reveal the existence of cracks because of bracket painting but different bracket finishes do identify suspected or faulty processed brackets. Unfinished/unpainted brackets and brackets with a "Gray" painted finish must be replaced. Brackets with a "Silvery" finish similar to the finish on the "Forcemotor" are correctly processed and replacement is not necessary.

- 23 - Screw, Mounting
- 24 - Bracket, Pt. No. NO141FN
- 25 - Screw
- 26 - Nut, Locking

Use of applicable Foxboro Master Instructions (MI's) will be required to properly align the specific transmitter after bracket installation. It is recommended that only personnel trained in Foxboro Transmitter servicing should perform bracket replacement and transmitter re-alignment. Replacement brackets 24 include screw 25 and locking nut 26 as in Figure No. 1, attached. The mounting screw 23 can be re-used for bracket replacement.
