BRUNSWICK STEAM ELECTRIC PLANT, UNIT NO. 2
DOCKET NO. 50-324/LICENSE NO. DPR-62
ASME CODE RELIEF REQUEST - SERVICE WATER

Diesel Generator
Service Water
Relief Request

SYSTEM: Service Water (Supply Line to Diesel Generator No. 4)

Component: The 8" X 6" reducer on line 2-SW-234-6-157 just downstream on inlet supply valves 1(2)-SW-V213.

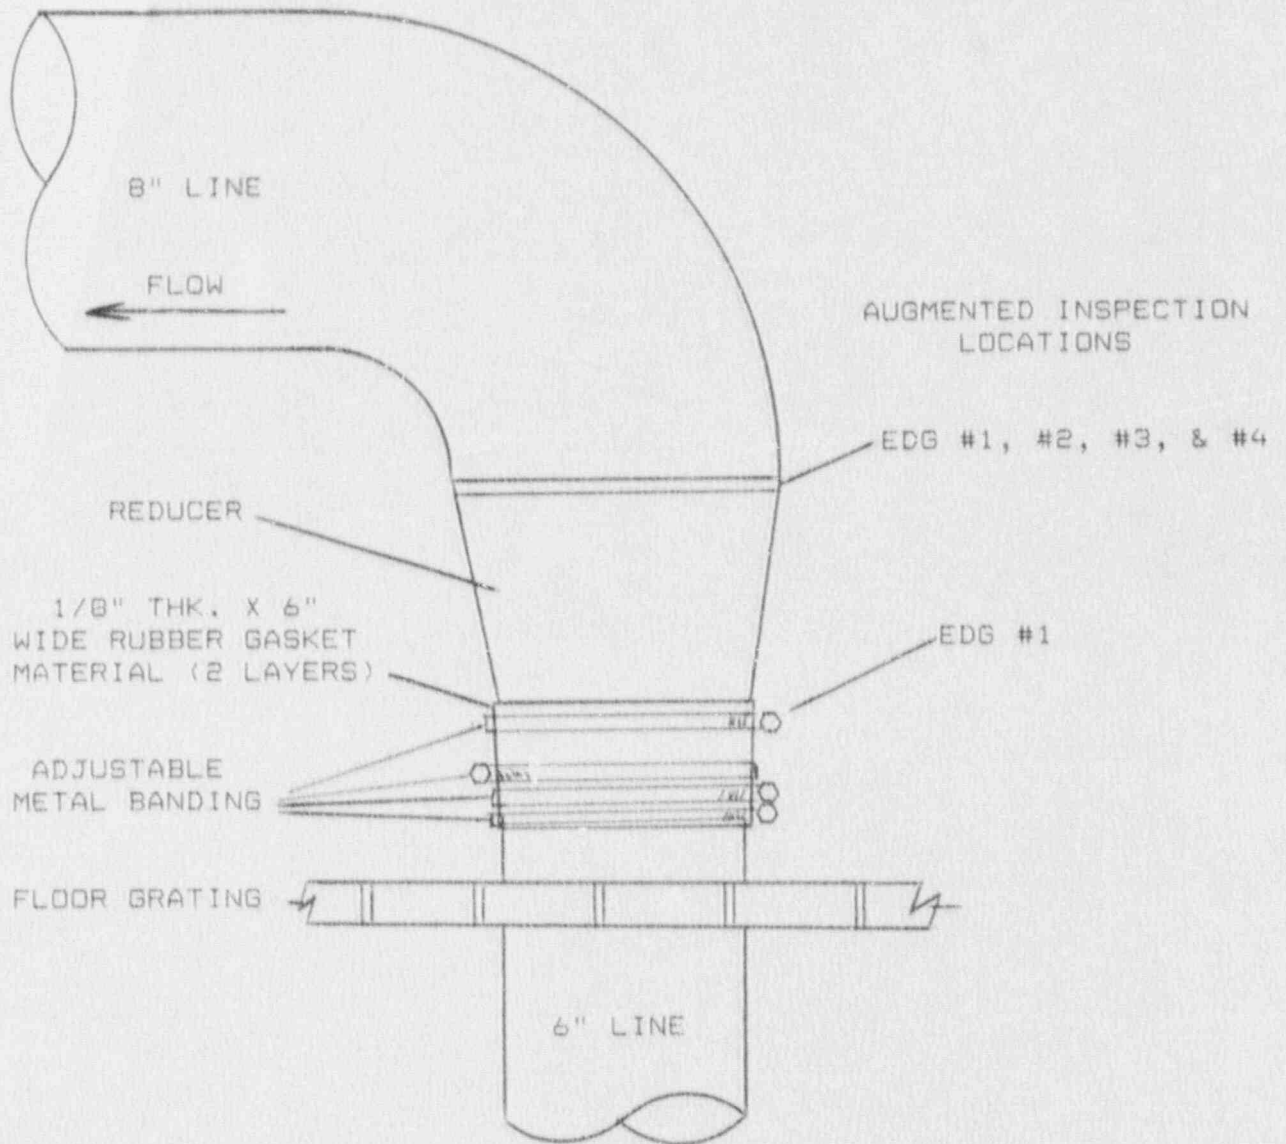
ATTACHMENT 1
RELIEF REQUEST NO.

RELIEF REQUIRED: This request is being written to allow a temporary non-code repair of a through-wall leak on the referenced line. The through-wall leak was identified on the Service Water Supply Line (2-SW-234-6-157) to Diesel Generator No. 4 Jacket Water Cooler. The leak was discovered on December 13, 1990, at which time a Maintenance Work Request for the temporary repair of the through-wall leak was initiated and Tracking LCO T1-09-2456 generated in accordance with BSEP Procedure OI-4. The leak is located on the reducer referenced above in the "Component" section at the bottom weld no. FW-B80B as identified on FP 9527-22356, Drawing No. 2-SW-IS040. The through-wall leak is characterized as a hole approximately .25" diameter. Based on past experience, it is believed that the through-wall failure was caused by corrosion in an area exposed to the salt water through a flaw in the cement lining. A temporary repair consisting of rubber gasket material secured by mechanical clamps has been installed to prevent further leakage. The soft rubber patch represents a non-code temporary repair to be justified by this relief request. Refer to Attachment 1 for a diagram of that repair.

1. Document the character of the flaw cited - An Ultrasonic (UT) Non-Destructive Examination (NDE) was conducted on December 13, 1990. The actual through wall leak is characterized as a .25" hole with localized wall thinning adjacent to it along a section approximately 4 1/2" included as an attachment to this relief request (See Attachment 2).

- SKETCH OF EMERGENCY DIESEL GENERATOR NO. 4 JACKET WATER COOLER INLET PIPING SHOWING 8" X 6" REDUCER AFFECTED BY REFERENCED THROUGH WALL LEAK (NOTE SOFT RUBBER PATCH).
- THIS SKETCH ALSO SHOWS THE LOCATIONS OF 7 SUPPLEMENTAL UTs PERFORMED IN ORDER TO INSURE COMPLIANCE WITH GENERIC LETTER 90-05.

9. Schedule implementation of permanent code repair - A permanent repair shall be implemented by the end of the next scheduled Unit 2 outage, now scheduled for April 1991. The repair will be made before that time if the 3 month UT/RT finds that it is necessary. The permanent code repair will consist of replacing the 8" X 6" reducer and the spool piece directly beneath it.

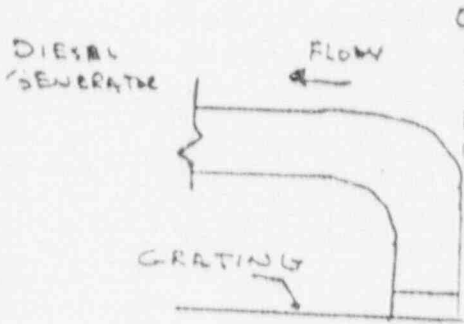
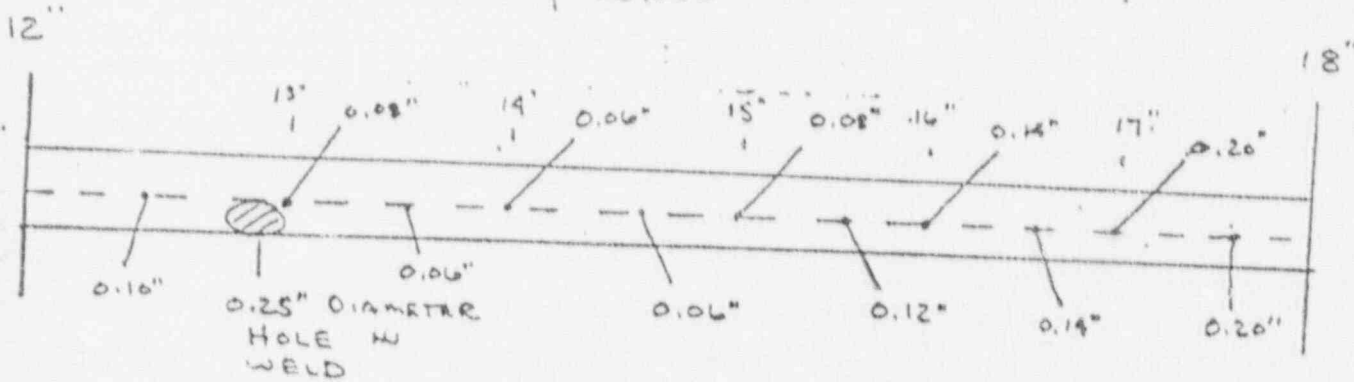
NDE DRAWING ATTACHMENT

DRAWING NA 2-14-90 SYSTEM SERVICE WATER LINE 2-SW-294-6-157 WELD/ITEM NUMBER FW-8005
