SUBJECT: Calvert Cliffs Nuclear Power Plant
Unit Nos. 1 and 2; Docket Nos. 50-317 and 50-318;
License No. DPR 53 and DPR 69
Licensee Event Report 90-027, Revision 00

LICENSEE EVENT REPORT (LER)

FACILITY NAME (1): Calvert Cliffs, Unit 1

TITLE (4): Undersized Fuses Could Have Prevented Safety-Related Equipment From Performing Its Intended Safety Function Caused By A Calculational Error

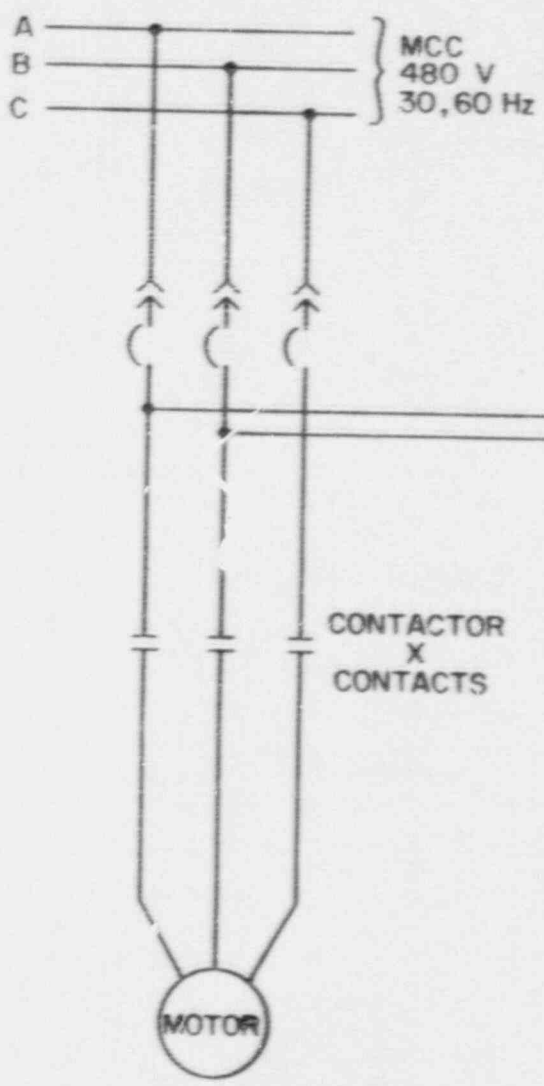
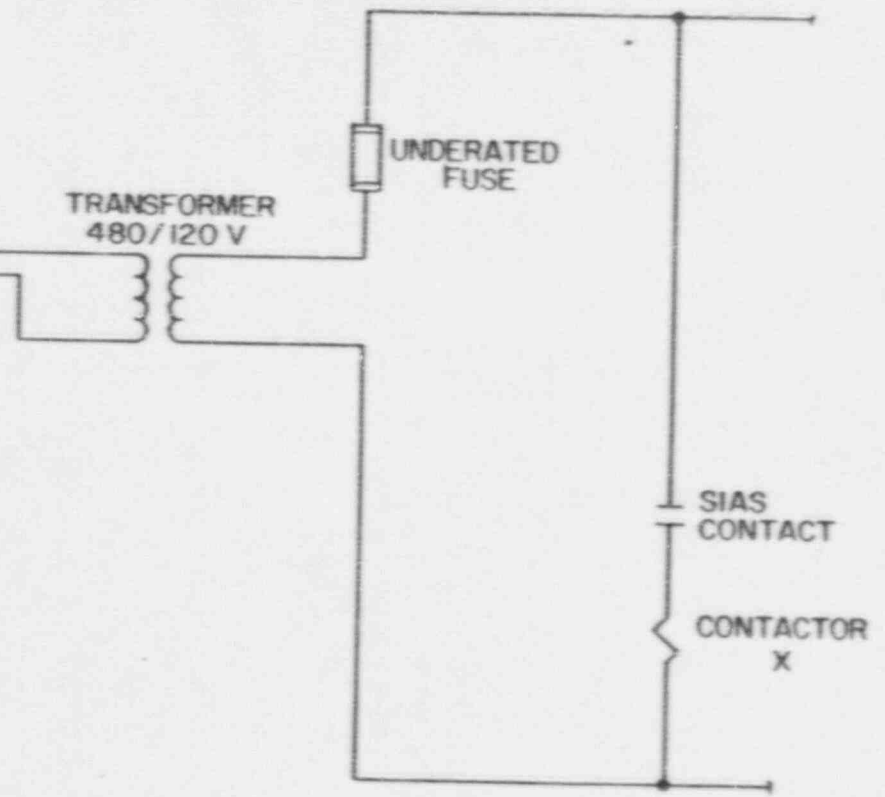
FIGURE 1
SIMPLIFIED SCHEMATIC DIAGRAM OF TYPICAL
ESFAS VALVE MOTOR CONTROL CIRCUIT

In the event of a SIAS, many motors in the plant are required to reposition valves or remain in normal operation with their control circuitry energized. A SIAS signal energizes various SIAS relays which close contact(s) in the control circuitry of these motors. This allows energization of the appropriate contactors which allows 480-volt current to flow from the MCC to the motors so that the valves and equipment perform their post-SIAS required functions of Figure 1.

If a SIAS signal is received at the same time as a degraded voltage condition, the SIAS contacts in the motor control circuit will close causing the motor contactor to energize. If the voltage at the motor contactor coils is too low to allow the contactor contacts to pick-up, a high in-rush current will result from low open-gap coil impedance. The high current will continue until the degraded voltage relays time-out (approximately 6-seconds) and the 4160-volt busses are disconnected from the offsite power supply.

Review of the calculations to determine the appropriate fuse rating for the motor control circuits discovered that a calculational error resulted in many of the fuses being undersized. In this condition the fuse would blow due to the high in-rush current during degraded voltage conditions prior to the disconnect of the offsite power supply (degraded voltage relays timing out). Blown fuses in the motor control circuitry would prevent the motors from performing their post-SIAS safety-related functions. Most of the motors with undersized fuses operate valves (35 of 38 for Unit 1 and 35 of 37 for Unit 2). Two of the motors operate the SR Air Compressors for each Unit and one of the motors for Unit 1 operates a boric acid pump.

- All of the undersized fuses for both Units have been replaced with correctly rated fuses.
- Drawings are being updated to ensure that correct fuses will be used as replacements.
- DES has verified that fusing for all Unit 1 ESFAS and all EDG loads are now correct.
