FACILITY: Maine Yankee Atomic Power Plant

SUBJECT: MEETING WITH MAINE YANKEE ATOMIC POWER COMPANY ON THERMAL SHIELD POSITION PINS.

ATTENDANCE AT
MEETING WITH MAINE YANKEE ON
THERMAL SHIELD POSITION PINS
OCTOBER 27, 1982

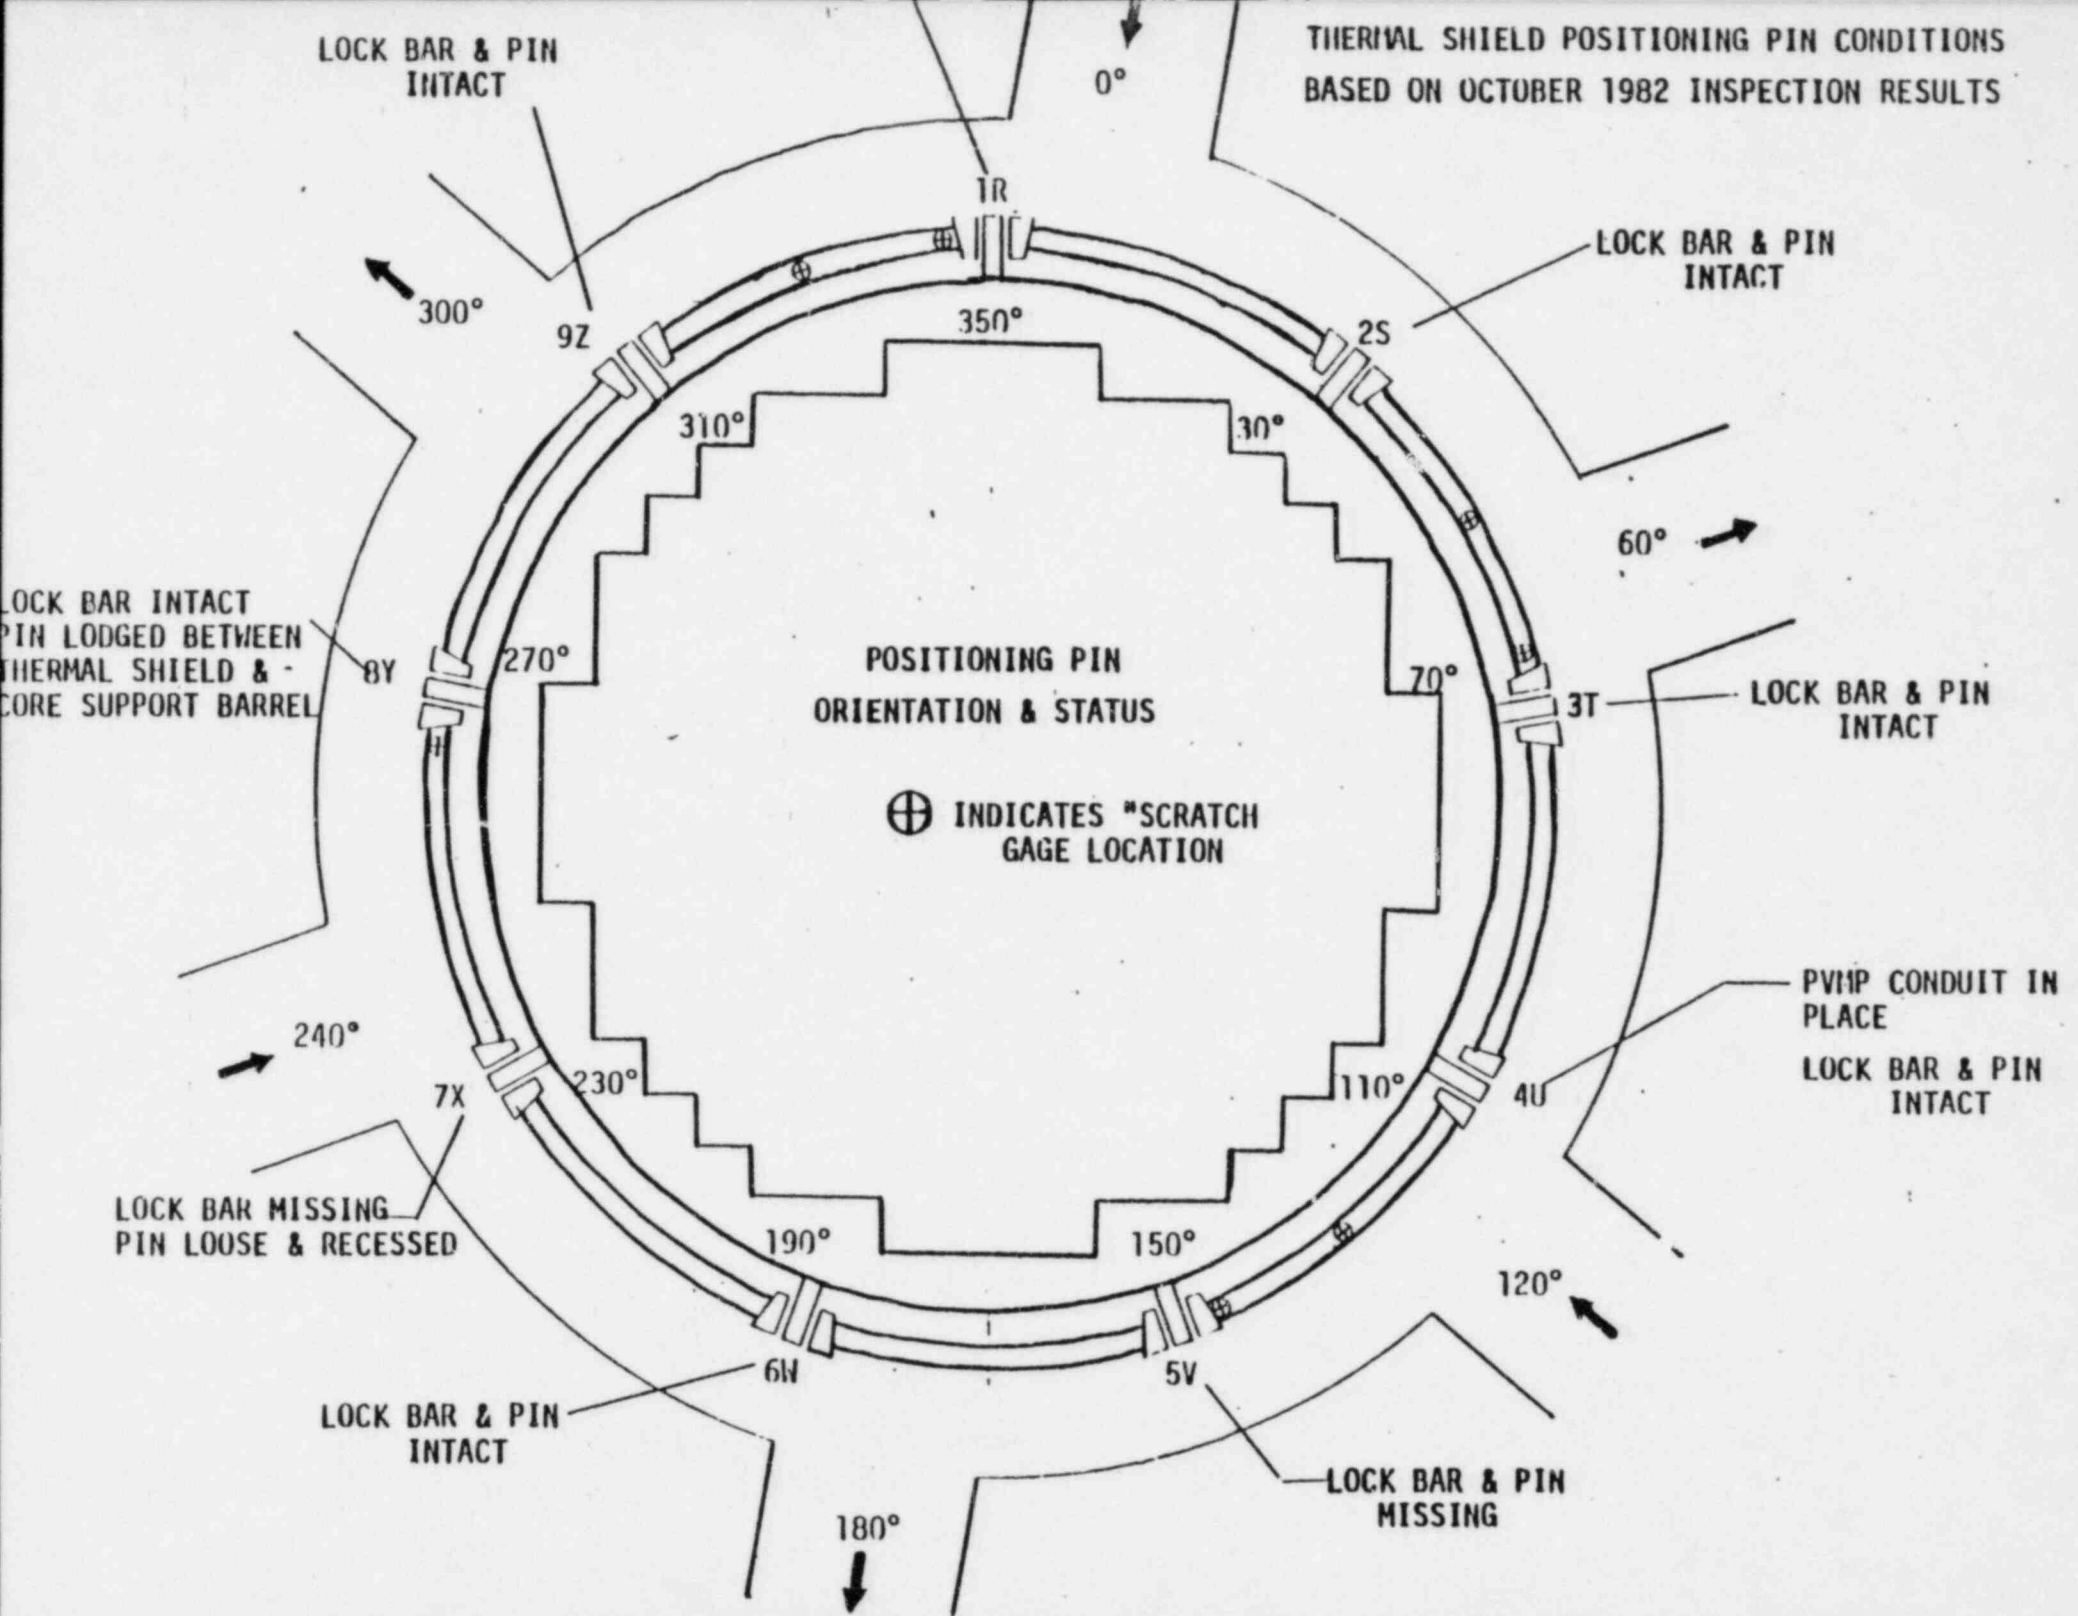
THIERMAL SHIELD POSITIONING PIN CONDITIONS
BASED ON OCTOBER 1982 INSPECTION RESULTS

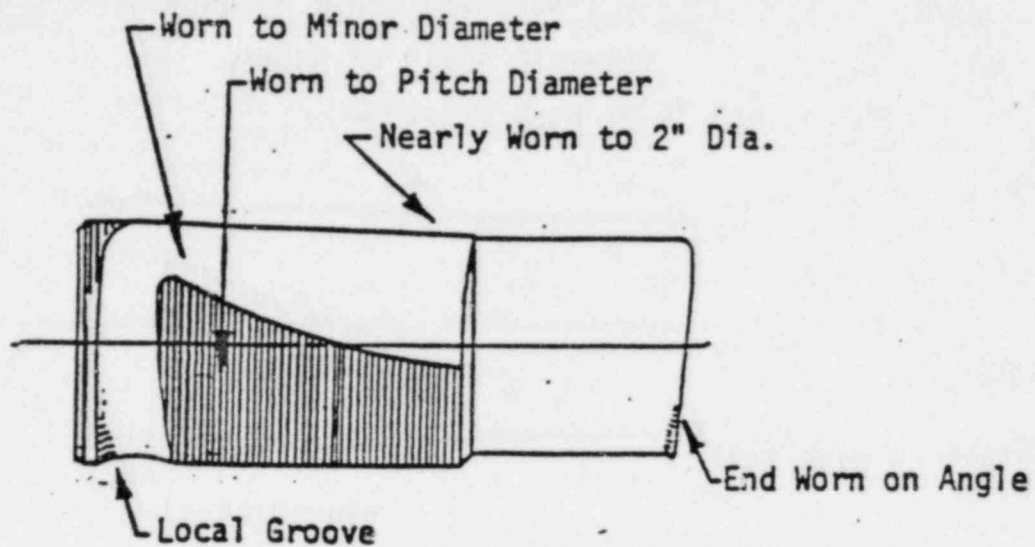
150° 5 V	PIN AND LOCKBAR MISSING. PIN AT THE BOTTOM OF REACTOR VESSEL OUTSIDE FLOW SKIRT.

PIN 5 LOCATED AT 150° , RETRIEVED FROM BOTTOM OF REACTOR VESSEL

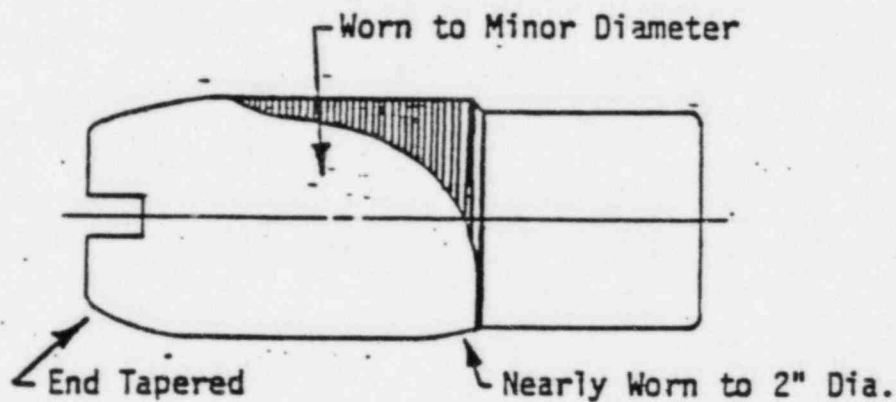
230° 7 X	PIN MISSING. LOCKBAR DETACHED. PIN CAUGHT IN HOLE, PROTRUDING INTO T.S. /C.S.B. ANNULUS.

PIN 7 LOCATED AT 230° , PROTRUDES FROM ITS INSTALLATION HOLE IN THE THERMAL SHIELD INTO THE THERMAL SHIELD/CORE SUPPORT BARREL ANNULUS

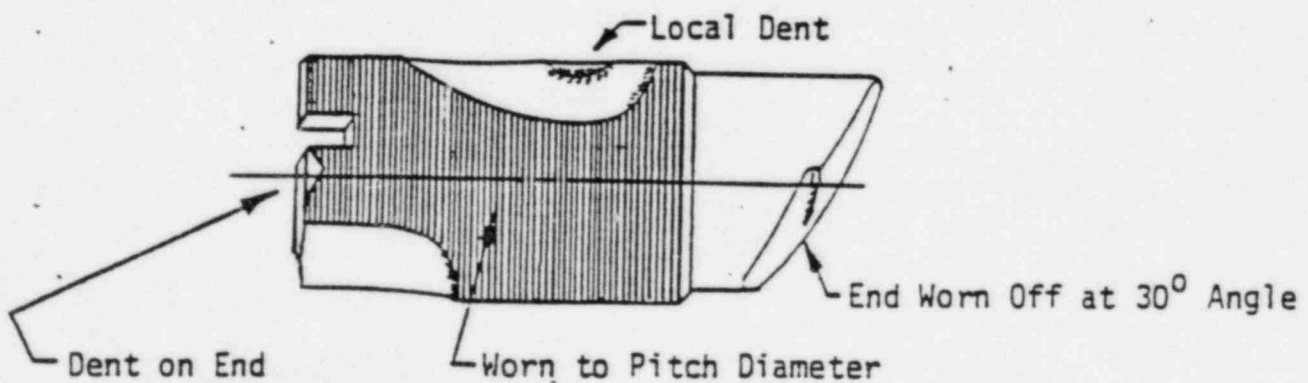
270° 8 Y	PIN MISSING. LOCKBAR IN PLACE. PIN LODGED BETWEEN THERMAL SHIELD AND CORE SUPPORT BARREL.

PIN 8 LOCATED AT 270° , LODGED HORIZONTALLY IN THERMAL SHIELD/CORE SUPPORT BARREL ANNULUS BELOW ITS INSTALLATION HOLE

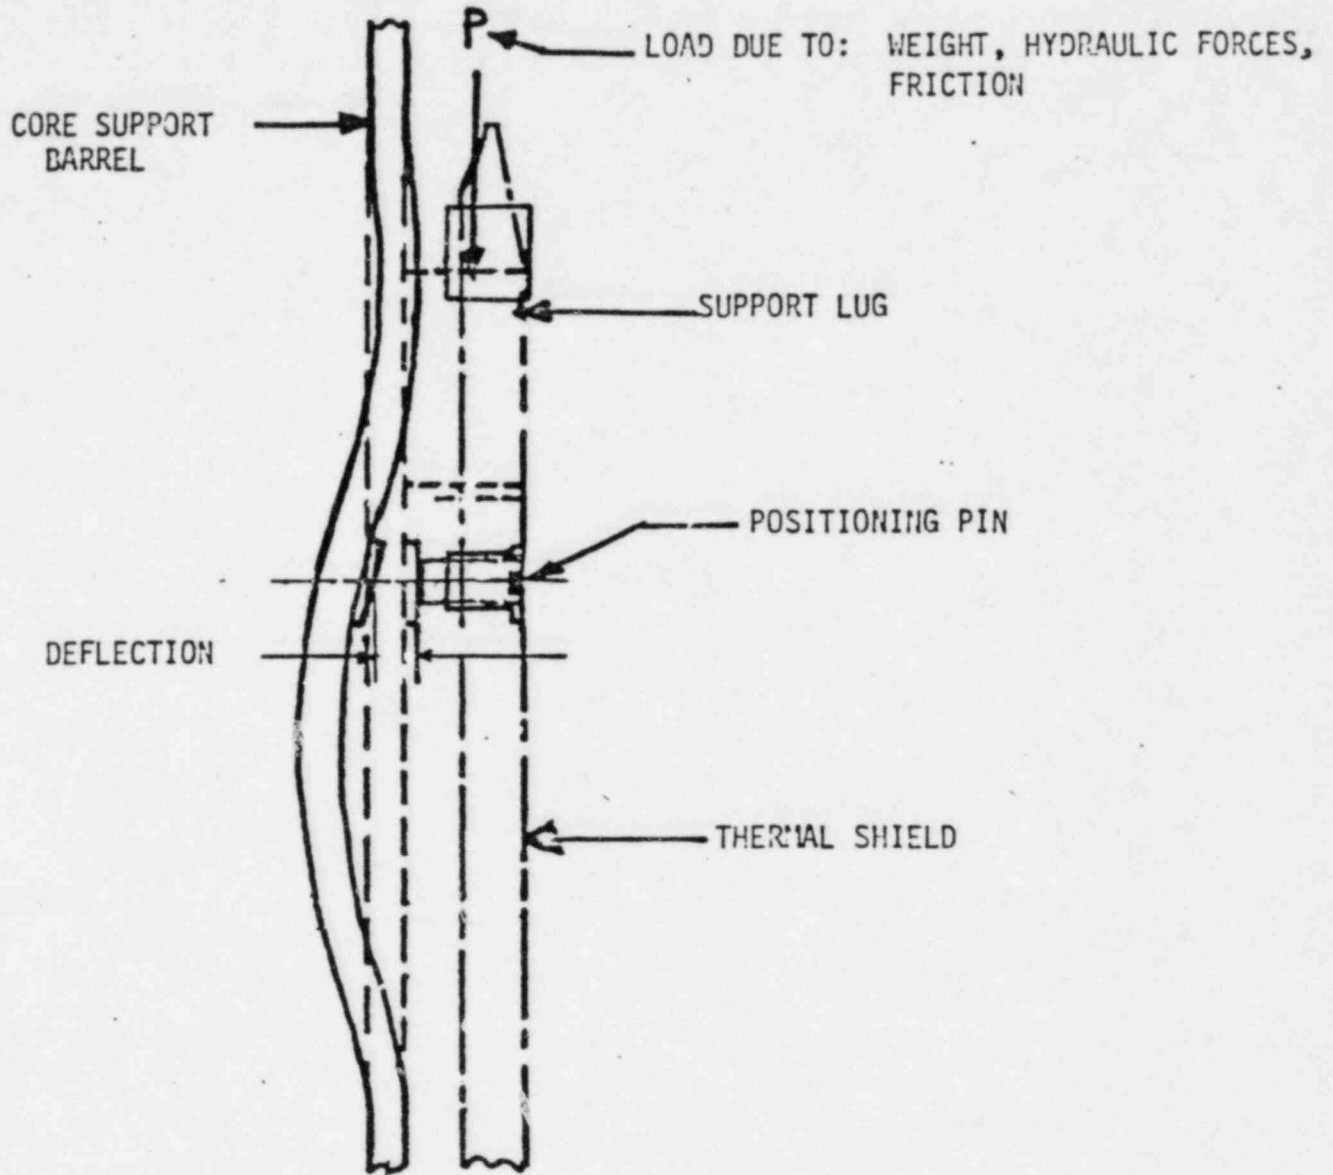
POSTULATED SHELL DEFORMATION DUE TO VERTICAL LOAD ON LUG
