LIMERICK GENERATING STATION

SUBJECT: Licensee Event Report
Limerick Generating Station - Unit 1

Reference:	Docket No. 50-352
Report Number:	1-90-034
Revision Number:	00
Event Date:	December 9, 1990
Report Date:	January 8, 1991
Facility:	Limerick Generating Station P.O. Box A, Sanatoga, PA 19464

TITLE (4) Technical Specification required shutdown due to inoperability of the 'B' loop of the Residual Heat Removal Service Water system.

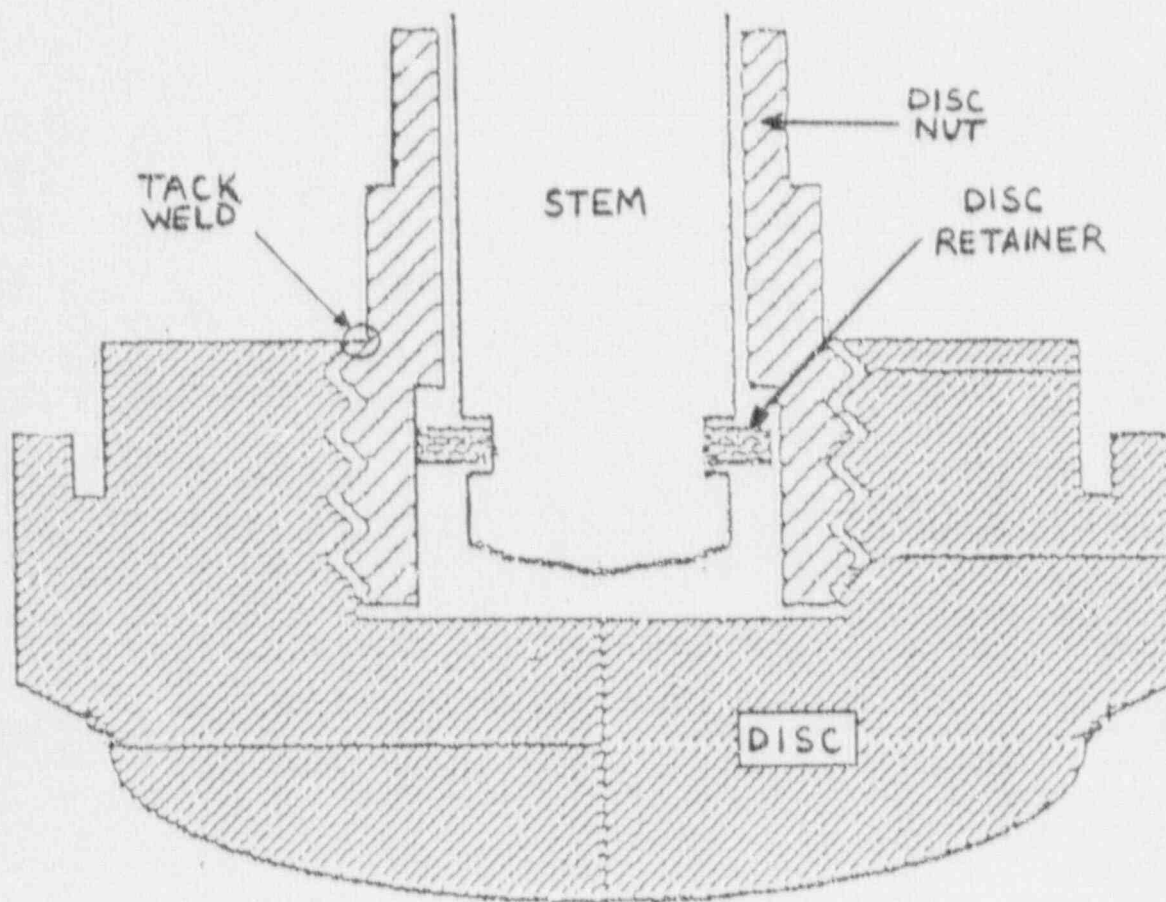
DIAGRAM 1

The cause of this event was an unexpected equipment failure of the 'B' RHR system outlet valve from the 'B' RHR system heat exchanger; a 20 inch Anchor Darling Globe Stop Valve with bolted bonnet (See Diagram 1). Upon investigation, we determined that process water entering the threaded area between the valve disc and disc nut eroded the threads causing them to weaken. The threads eroded away and, when the valve was opened, the tack weld broke, separating the disc and disc nut, causing the stem to dislodge from the disc nut and the disc retainer to fall out. This resulted in an inability to open or close the valve, therefore the RHR system loop 'B' was declared inoperable.

Following repair of HV-51-1F068B, the threaded area between the disc and disc nut was seal welded to prevent water from entering. The routine preventive maintenance program for this valve would not have discovered this problem internal to the valve. We, in cooperation with the vendor/supplier (Anchor Darling), are currently investigating options to increase the reliability, and thereby ensure operability, of these valves. The effectiveness of the repair (seal weld) performed on HV-51-1F068B will be evaluated and, if appropriate, similar actions will be taken for HV-51-1F068A and the two corresponding Unit 2 valves. There are no other similar valves on either unit.
