**Florida  
Power**

CORPORATION  
Crystal River Unit 3  
Docket No. 50-302

Subject: Eddy Current Testing Summary Report

## EDDY CURRENT TESTING SUMMARY REPORT

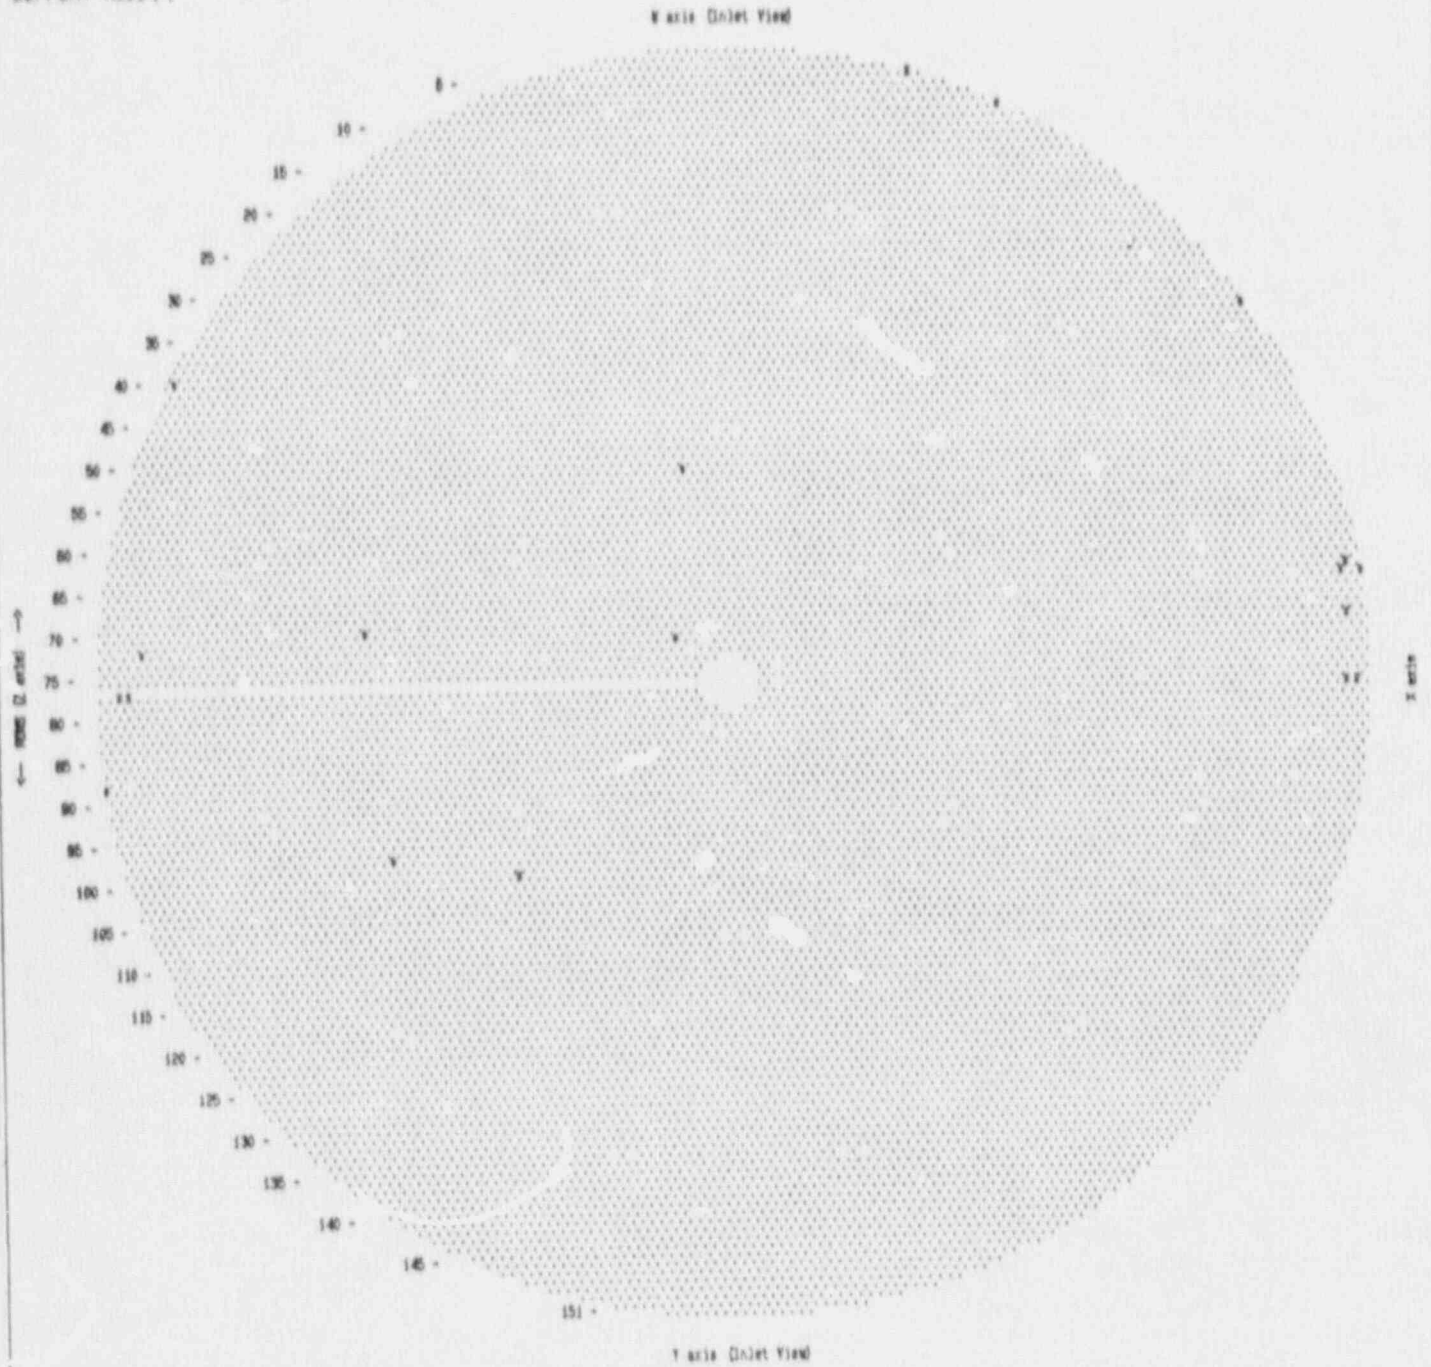
FIGURE 1A

Figures 1A, 2A, 1B and 2B, reveal no groups or clusters of tubes which had been removed from service. A pattern would be evident if control of a critical operational or chemical parameter had been lost. Therefore, based on the data presented it can be concluded that the steam generators at Crystal River 3 are in good health, both operationally and chemically.

# TUBE PLUG STATUS - POST 4/90 OUTAGE

GENERATOR: A

o = PLUGGED PRIOR TO 4/90 OUTAGE (10)

x = PLUGGED DURING 4/90 OUTAGE (10)

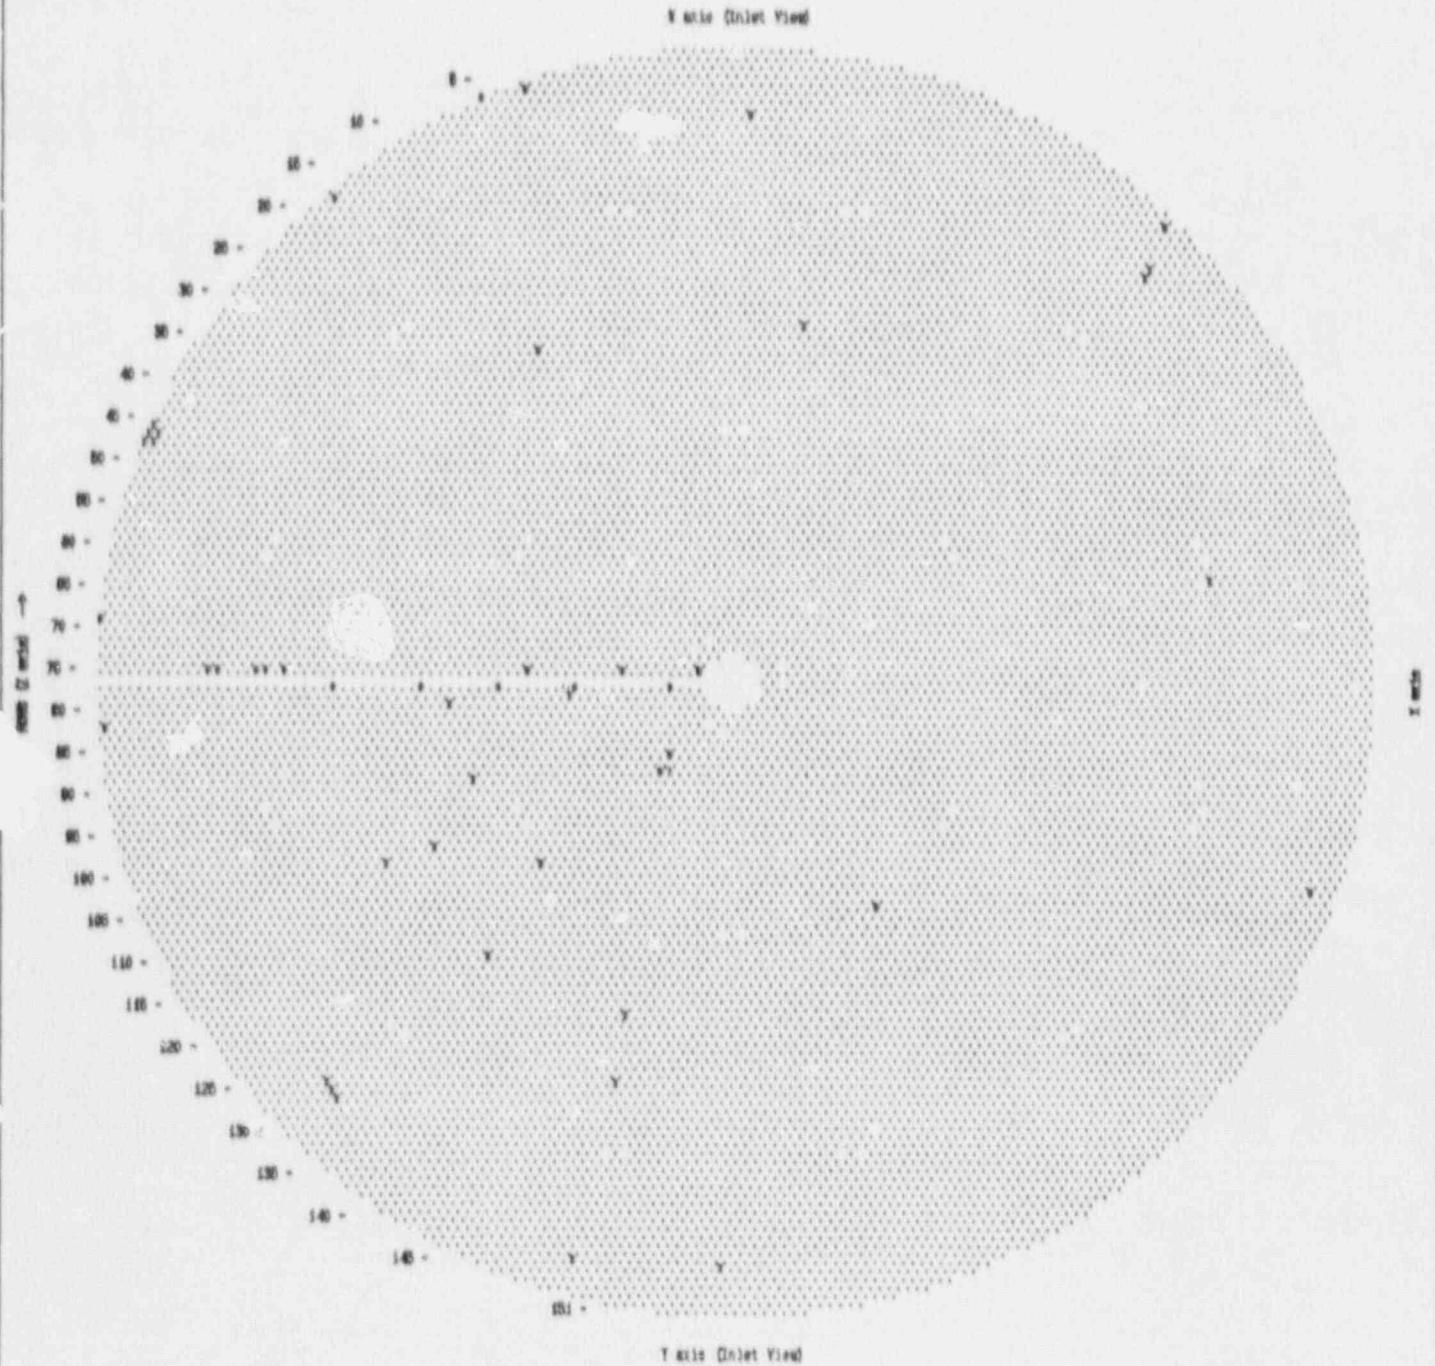
FIGURE 1B

# TUBE PLUG STATUS - POST 4/90 OUTAGE

GENERATOR: B

0 = PLUGGED PRIOR TO 4/90 OUTAGE (26)

1 = PLUGGED DURING 4/90 OUTAGE (23)

2 = PLUG UTS ONLY & ITS PREVIOUS PLUG (1)

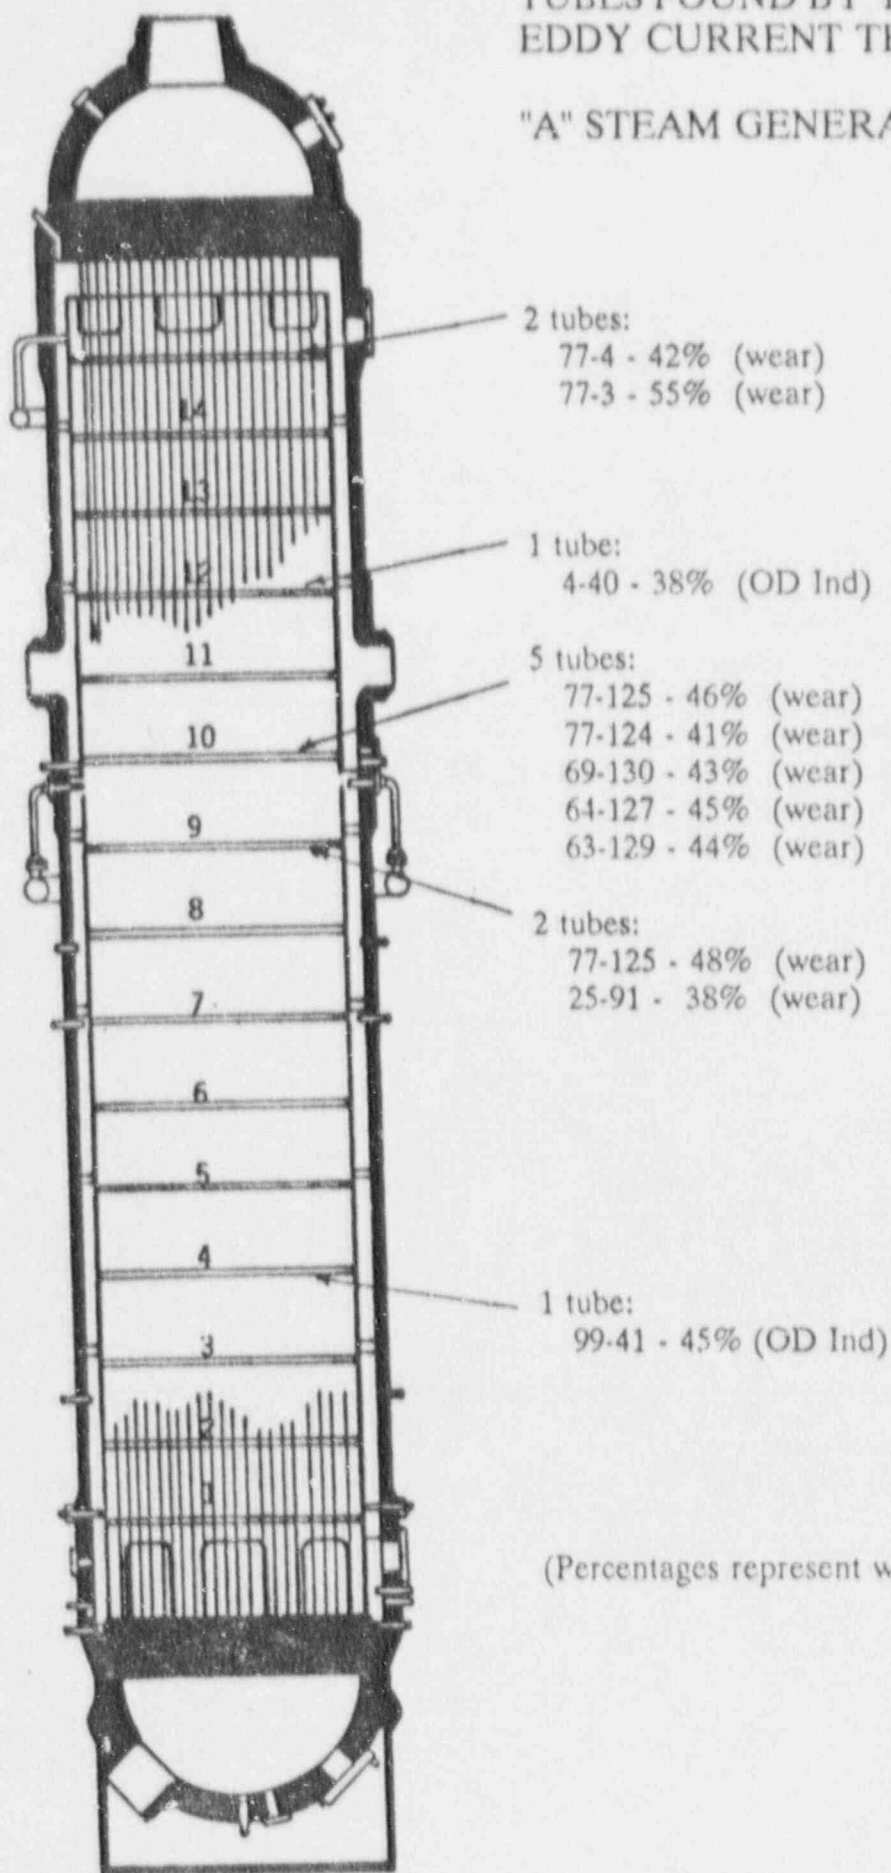
FIGURE 2A

<u>Tube</u>	<u>Defect Type</u>	<u>% Wall Loss</u>	<u>Remarks</u>
77-125	Wear	48%	Not previously inspected
69-130	Wear	43%	Not previously inspected
4-40	OD	38%	Not previously inspected
77-4	Wear	42%	Special interest
77-124	Wear	41%	Special interest
25-91	Wear	38%	Special interest
64-127	Wear	45%	Special interest
63-129	Wear	44%	Special interest
77-3	Wear	55%	Special interest
99-41	OD	45%	Special interest

The inspection of the "A" Steam Generator resulted in plugging ten (10) tubes. Three (3) of the tubes plugged were tubes that had not been inspected before. Seven (7) of the tubes had been identified as special interest tubes. Special interest tubes are defined as tubes containing from 1% to 40% wall loss; tubes three rows either side of the open lane; and, tubes containing indications that were below the threshold of clear signals. These tubes are tracked in the "special interest list", and reinspected for defect growth each time ECT is performed. The defects on these seven (7) tubes had grown to a size where it became necessary to remove them from service.

LOCATION OF DEFECTIVE  
TUBES FOUND BY REFUEL 7  
EDDY CURRENT TESTING

"A" STEAM GENERATOR

(Percentages represent wall loss)

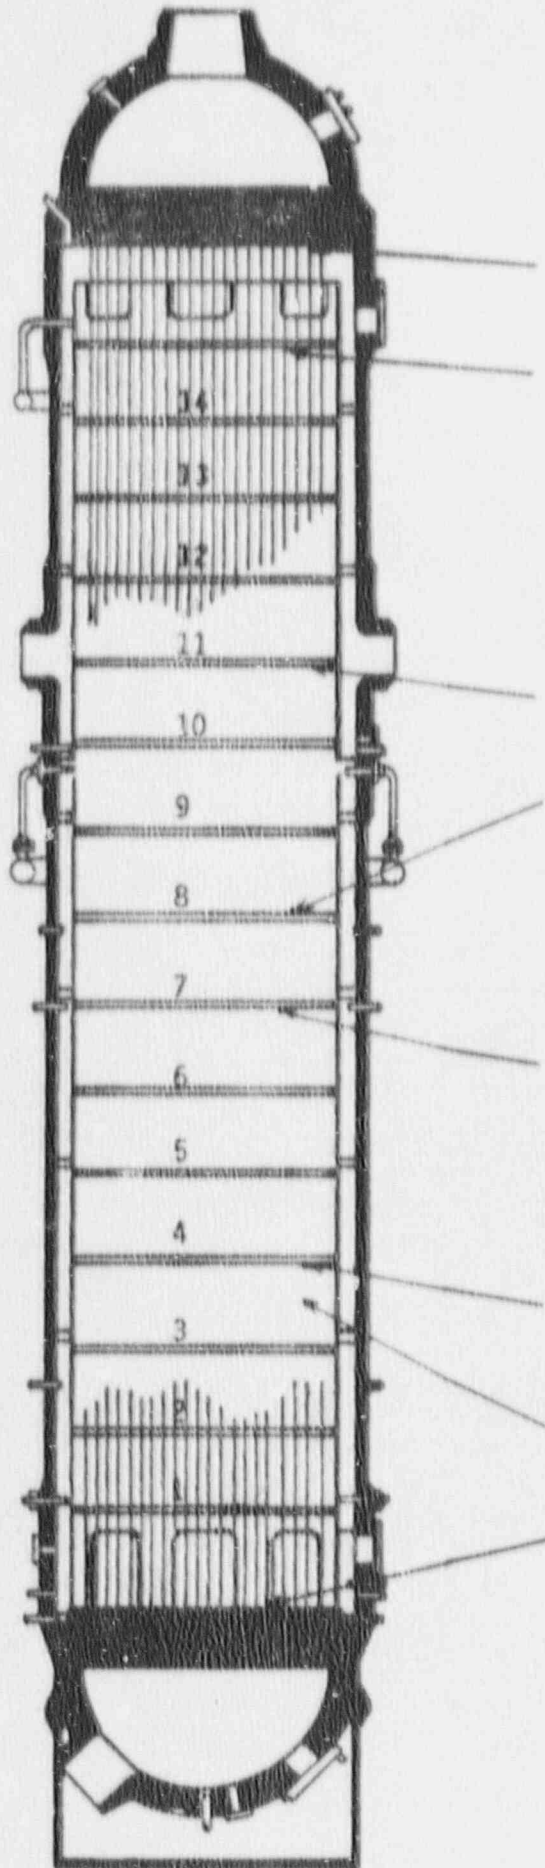
Figure 2B

<u>Tube</u>	<u>Defect Type</u>	<u>% Wall Loss</u>	<u>Remarks</u>
125-9	Wear	42%	Not previously inspected
146-25	Wear	64%	Not previously inspected
27-93	Wear	70%	Not previously inspected
88-39	OD	47%	Not previously inspected
34-61	OD	61%	Not previously inspected
126-9	OD	66%	Not previously inspected
124-9	OD	38%	Special interest
28-93	OD	40%	Special interest
64-114	OD	38%	Special interest
78-49	OD	40%	Special interest
79-37	OD	55%	Special interest
124-39	OD	56%	Special interest
145-11	OD	61%	Special interest
87-59	No defect		Conservatively plugged to correct previous error
47-1	Administrative		Obstructed tube
46-1	Administrative		Surround obstructed tube
47-2	Administrative		Surround obstructed tube
48-1	Administrative		Surround obstructed tube
48-2	Administrative		Surround obstructed tube
96-33	Administrative		Burnish marks
98-28	Administrative		Burnish marks
98-44	Administrative		Burnish marks
109-34	Administrative		Burnish marks

The examination of the "B" steam generator resulted in plugging 24 tubes. Six (6) tubes that had never previously been inspected were plugged. Seven (7) tubes plugged had been identified as special interest tubes. Special interest tubes are defined as tubes containing from 1% to 40% wall loss; tubes three rows either side of the open lane; and, tubes containing indications that were below the threshold of clear signals. These tubes are tracked in the "special interest list", and reinspected for defect growth each time ECT is performed. The defects on these seven (7) tubes had grown to a size where it became necessary to remove them from service.

Five (5) additional tubes were plugged due to locating an obstruction approximately 39 inches from the top of one tube. This obstruction was lodged in a tube where high steam flow conditions exist (between the 15th tube support plate and the upper tube sheet). If that obstruction had developed into a through-wall defect causing the tube to sever, the severed tube could have damaged the surrounding tubes. Normal practice is to stabilize and plug a tube with defects in this sensitive cross flow area, but due to the obstruction, the tube could not be stabilized. Therefore, the four (4) surrounding tubes which contained no indications, were stabilized and plugged to capture the one tube containing the obstruction.

LOCATION OF DEFECTIVE  
TUBES FOUND BY REFUEL 7  
EDDY CURRENT TESTING

"B" STEAM GENERATOR

- 2 tubes:
  - 34-61 - 61% (OD Ind)
  - 78-49 - 40% (OD Ind)
- 1 tube obstructed  
(5 tubes plugged)
- 1 tube:
  - 79-37 - 55% (OD Ind)
- 5 tubes:
  - 27-93 - 67% (wear)
  - 28-93 - 40% (OD Ind)
  - 126-9 - 66% (OD Ind)
  - 125-9 - 42% (wear)
  - 146-25 - 64% (wear)
- 3 tubes:
  - 27-93 - 70% (wear)
  - 88-39 - 47% (OD Ind)
  - 124-39 - 56% (OD Ind)
  - 145-11 - 61% (OD Ind)
- 1 tube:
  - 64-114 - 38% (OD Ind)
- 1 tube:
  - 124-9 - 38% (OD Ind)
- 5 tubes:
  - 96-33 - 65% (Burnish mark)
  - 98-28 - 66% (Burnish mark)
  - 98-44 - 43% (Burnish mark)
  - 109-34 - 53% (Burnish mark)
  - 116-46 - 54% (Burnish mark)
