U.S. NUCLEAR REGULATORY COMMISSION

Report No. 50-461/90025(DRP)

Facility Name: Clinton Power Station

Inspection Conducted: November 20 through December 14, 1990

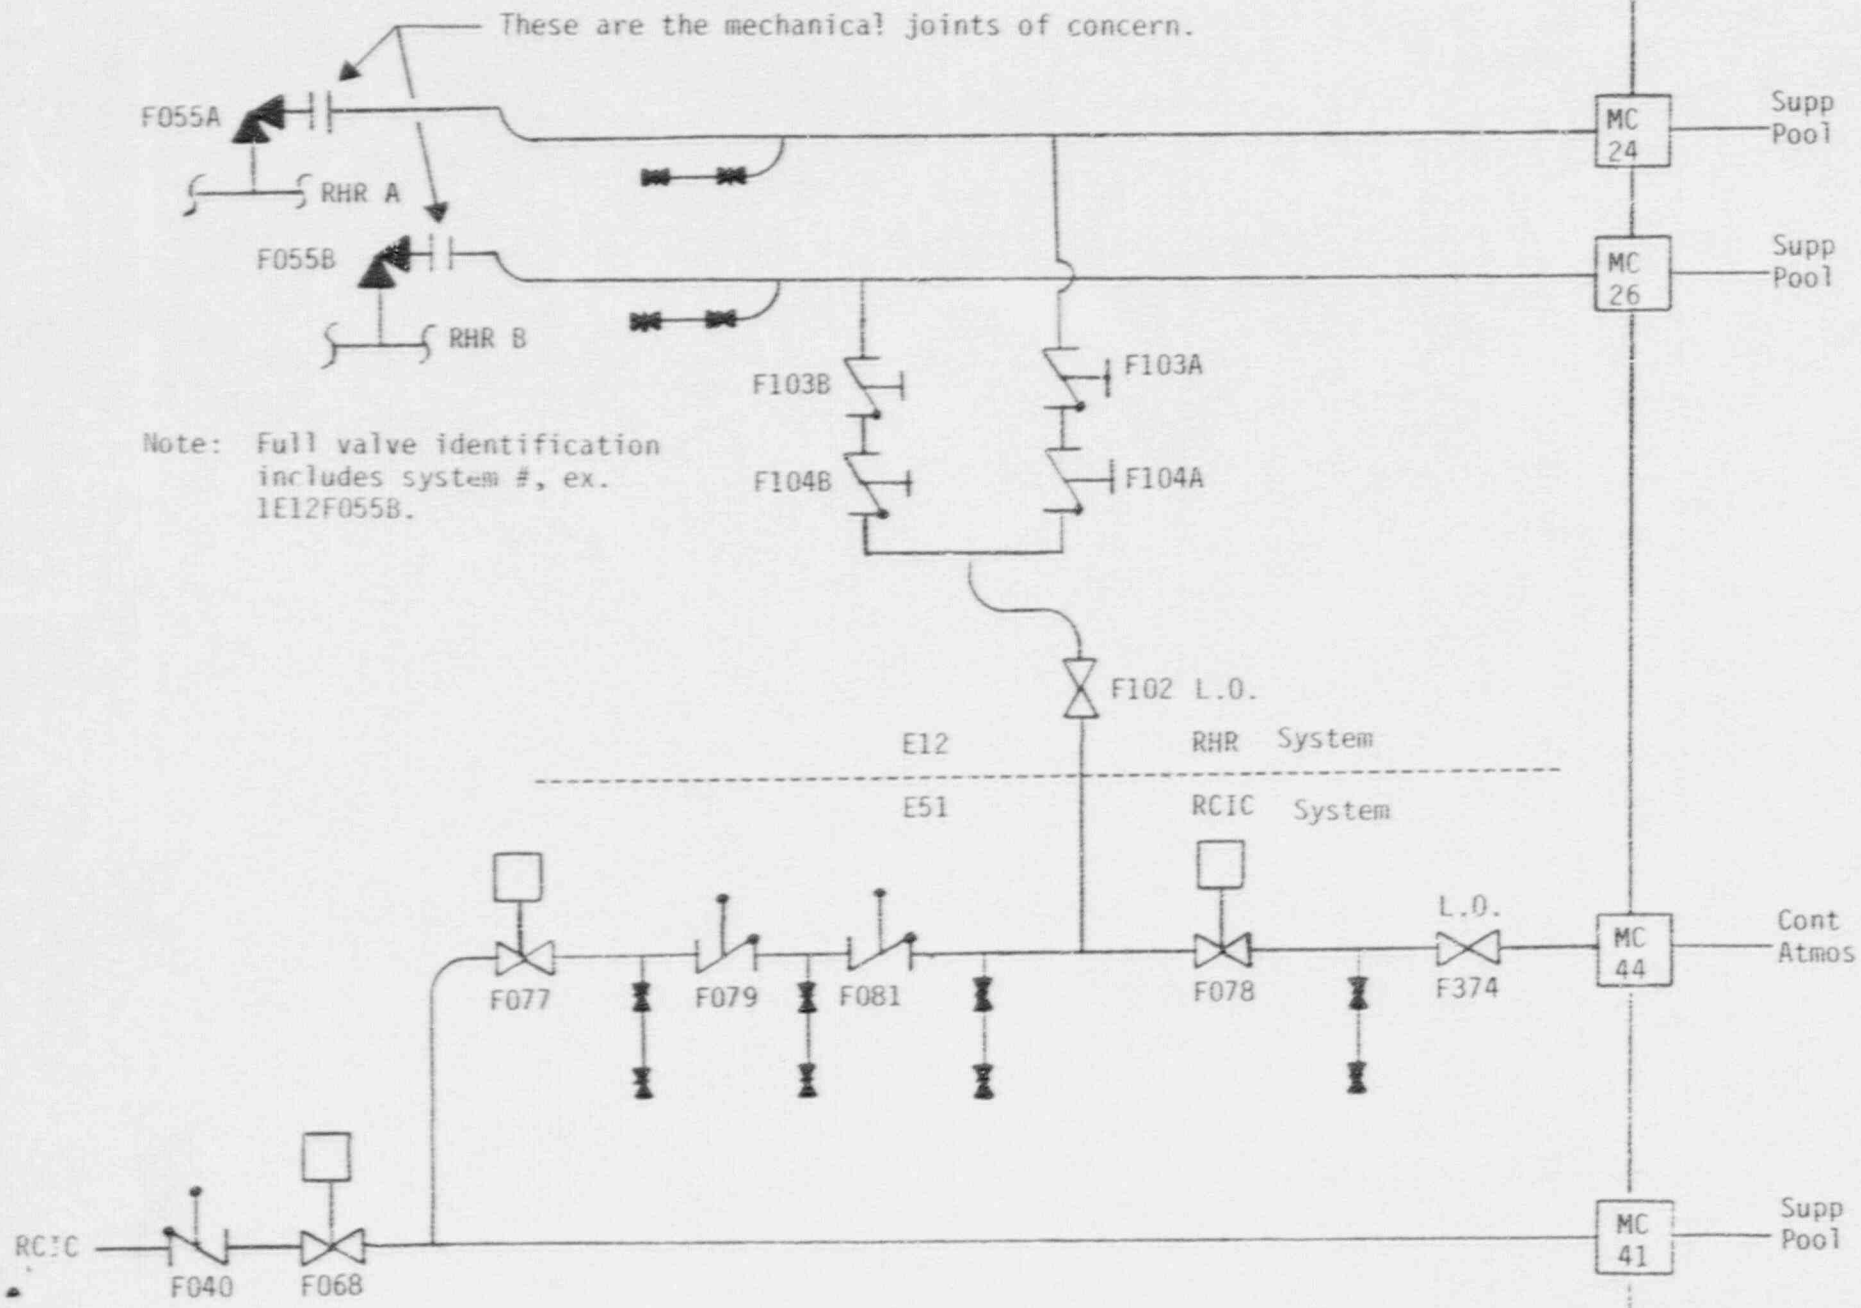
Figure 1 - Simplified Arrangement Drawing of RCIC and RHR Containment Penetrations

During a review of maintenance activities, the inspectors identified a concern related to the design of primary containment, with regard to valves 1E12F055A and 1E12F055B (see figure 1).

These valves are safety valves which are designed to protect the RHR system from overpressure conditions. They have a setpoint of 500 psig and discharge into the suppression pool (inside containment). The valves are physically located in the RHR HX rooms and are installed with flanged mechanical joints, as opposed to welded joints. The inspectors concern relates to the flanged joints on the discharge of the valves and not to the valves themselves. The inspector postulated that these flanged joints could be exposed to containment atmosphere via valve 1E12F102 if valve 1E51F078 was to fail open. If that was correct then the joints should be designed in accordance with the requirements of 10 CFR Part 50, Appendix A, General Design Criteria 54, in that the reactor containment shall be designed to permit periodic testing at containment design pressure of the leaktightness of penetration which have resilient seals. This question will be followed as an unresolved item (461/90025-04(DRP)). Additionally, the inspector questioned if the flanged joints had been tested in accordance with the requirements of 10 CFR Part 50, Appendix J, Paragraph III.B for testing of Type "B" containment penetrations. This question will be followed as an unresolved item (461/90025-05(DRP)).
