*File  
Decontamination*

Pacific Northwest Laboratories  
P.O. Box 999  
Richland, Washington U.S.A. 99352  
Telephone (509)  
Telex 15-2874

September 14, 1979

Mr. Jim Renshaw  
Director of Decontamination  
General Public Utilities  
P.O. Box 480  
Middletown, PA 17051

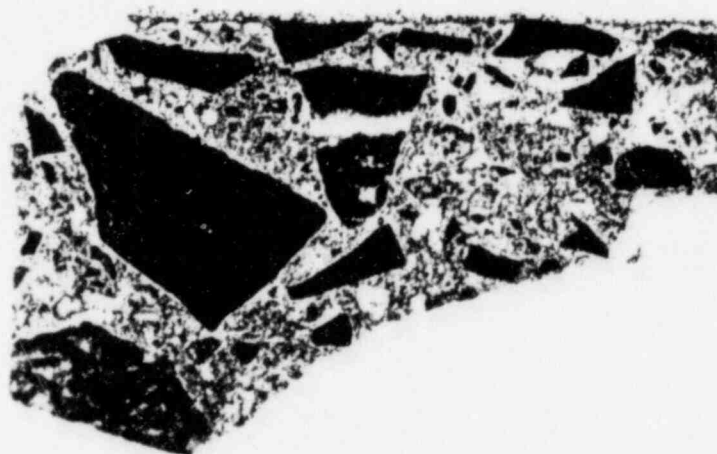
(Figure 1)

Figure 1 An autoradiographic exposure and optical photograph of the same area of the "Elevator" core sample at 2.2x. The painted surface of the core sample read 10,000 cpm before mounting and was reduced to 2,000 cpm after sectioning and mounting. Exposure time for all autoradiographic exposures was 124 hrs.

Elevator Core Sample (281') With Paint

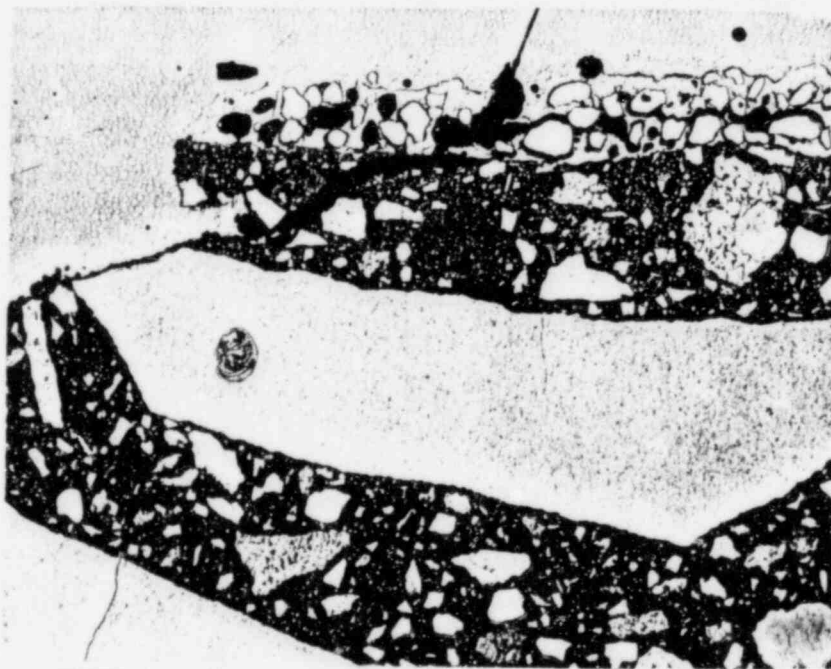
(Figure 2)

Figure 2 The same autoradiograph used in Figure 1 was enlarged to match a 12x magnification optical photograph of the same area. At this magnification it is easy to identify the mounting material, paint layers, and cement. The holes in the paint layer are the result of the paint filler "pulling out".

- ↖ Mounting Material
- ↖ Paint Layer
- ↖ Cement

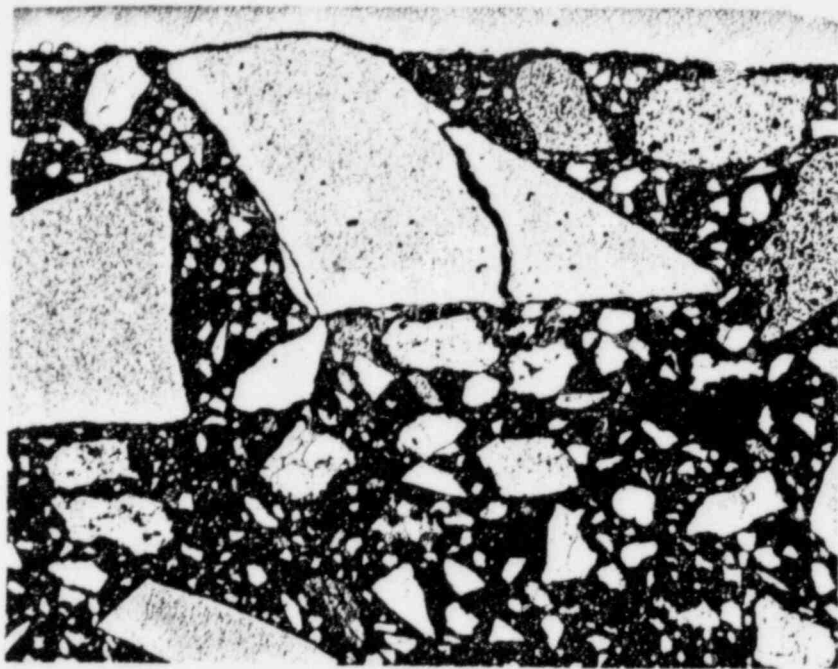
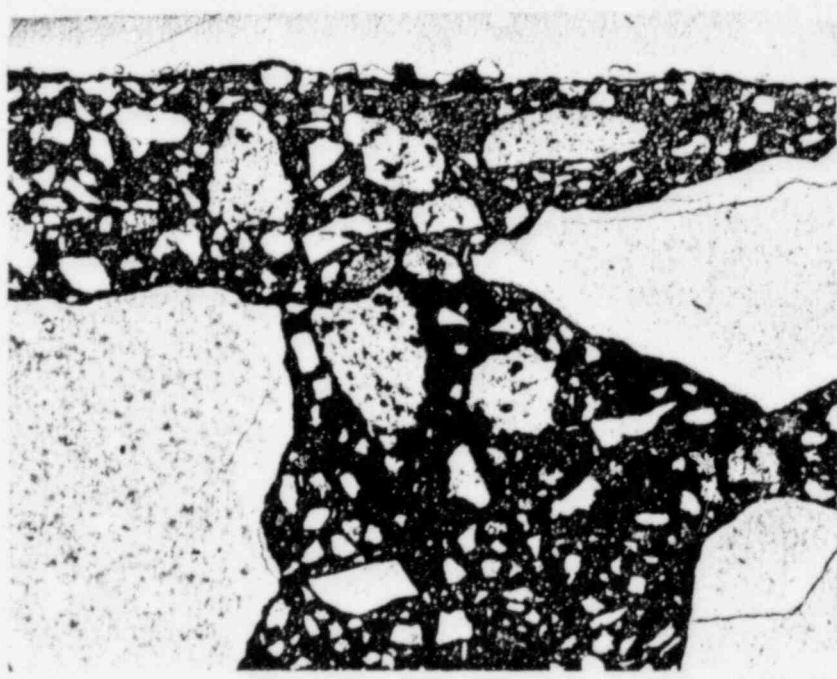
(Figure 3)

Figure 3 Two 12x optical photographs, each showing a different area of the "elevator" core sample after the paint layer was removed. The autoradiographic exposure did not reveal any contaminated areas.

No Contamination  
in this Area After  
Paint Strip

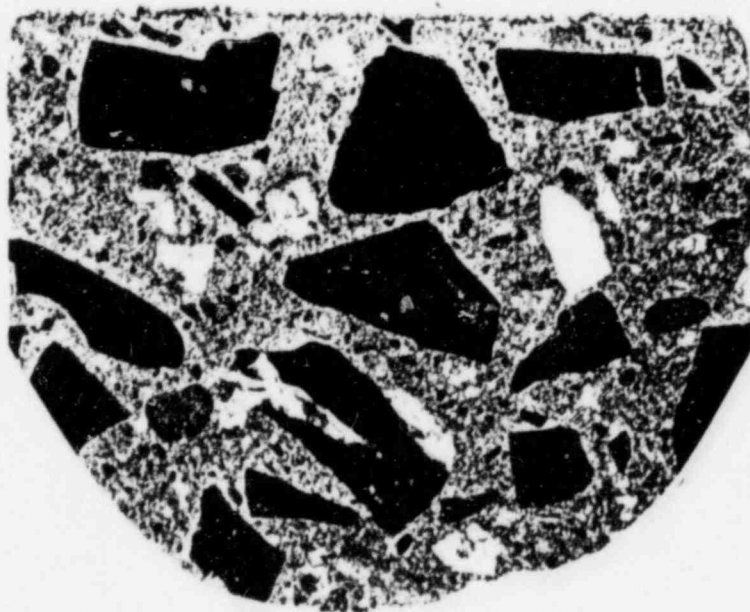
(Figure 4)

Figure 4 An autoradiographic exposure and optical photograph of the same area of the "DHV" core sample enlarged to 2.2x. The painted surface of the core sample read 600 cpm before mounting and was reduced to 300 cpm after sectioning, mounting, and polishing. Notice that this sample seems to have hot spots connected by very low levels of contamination in the general paint layer.

"DHV" Core Sample (281') As Ground

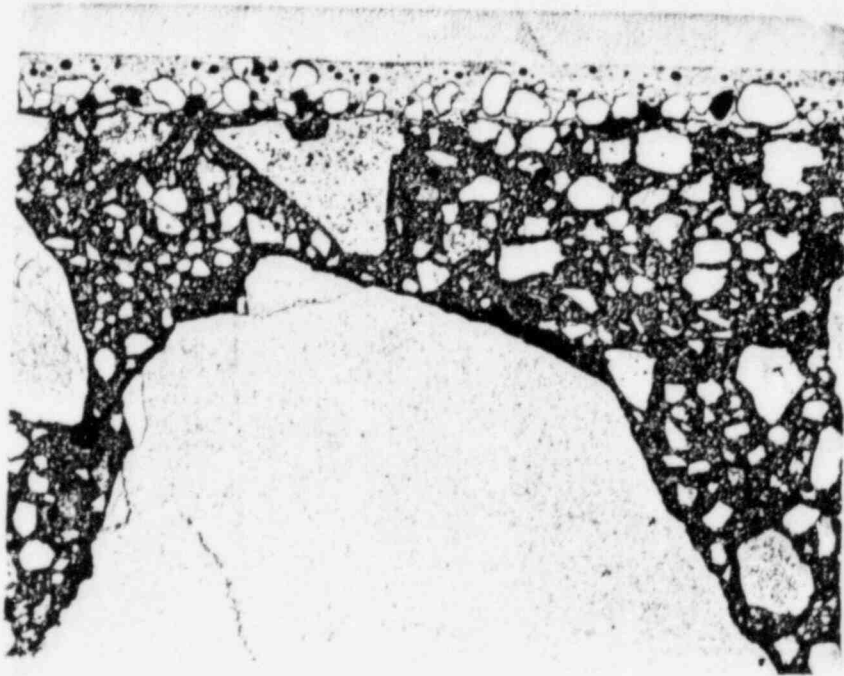
(Figure 5)

Figure 5 The same autoradiographic exposure used in Figure 4 enlarged to match a 12x magnification optical photograph. It is difficult to see where the radioactive material is retained in the paint layer, but the autographic exposure clearly reveals that it is there.

"DHV" Core Sample (281') As Ground

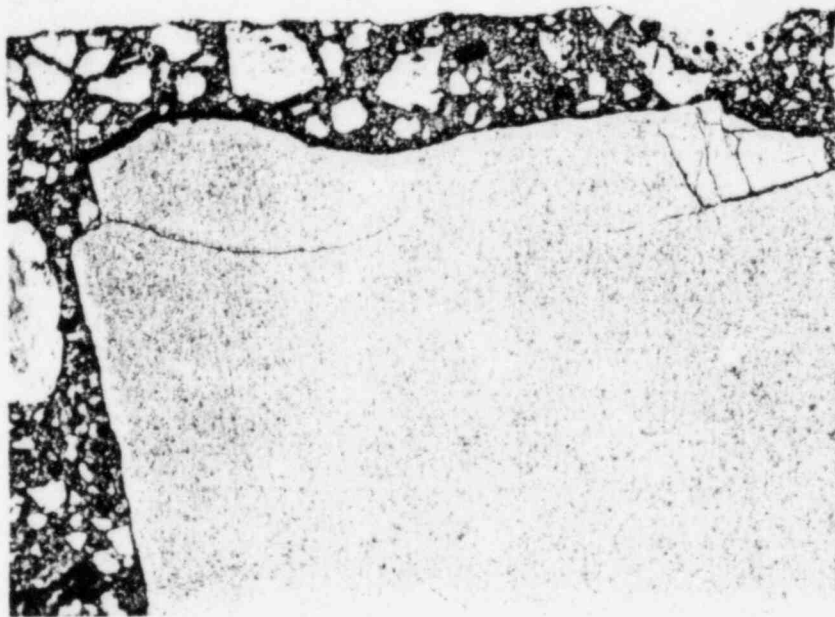
(Figure 6)

Figure 6 An autoradiographic exposure and optical photograph of the same area of the "DHV" core sample, taken at 12x after paint removal. Notice the small depressions which still retained some paint and contamination.

Contamination in  
Pocket Area

Paint Layer in  
Pocket

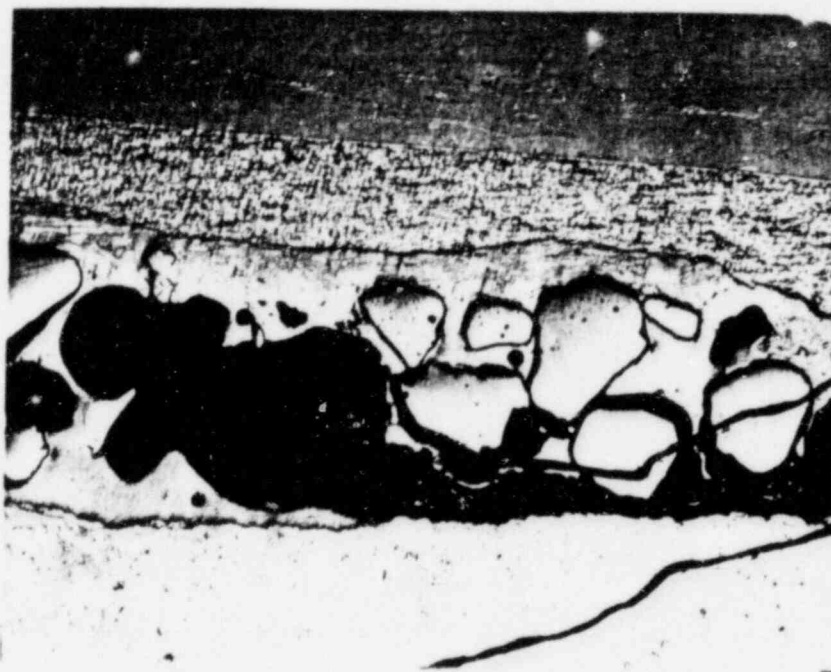
(Figure 7)

Figure 7 The 50x optical photograph reveals the structure of paint. Notice that there appears to be a top layer without filler, a middle layer with long narrow filler, and a bottom layer next to the cement which has larger particles. I believe that the holes are paint filler that has been "pulled out" during preparation.

Voids caused  
by paint filler  
"pulling out"  
during polishing
