SUBJECT: Calvert Cliffs Nuclear Power Plant
Unit Nos. 1 and 2; Docket Nos. 50-317 and 50-318;
License Nos. DPR 53 and DPR 69
Licensee Event Report 90-030, Revision 00

TITLE (4) Fatigue Cracking in the Safety Injection Tank Nitrogen Vent Line Welds Due to Design Engineering Personnel Error

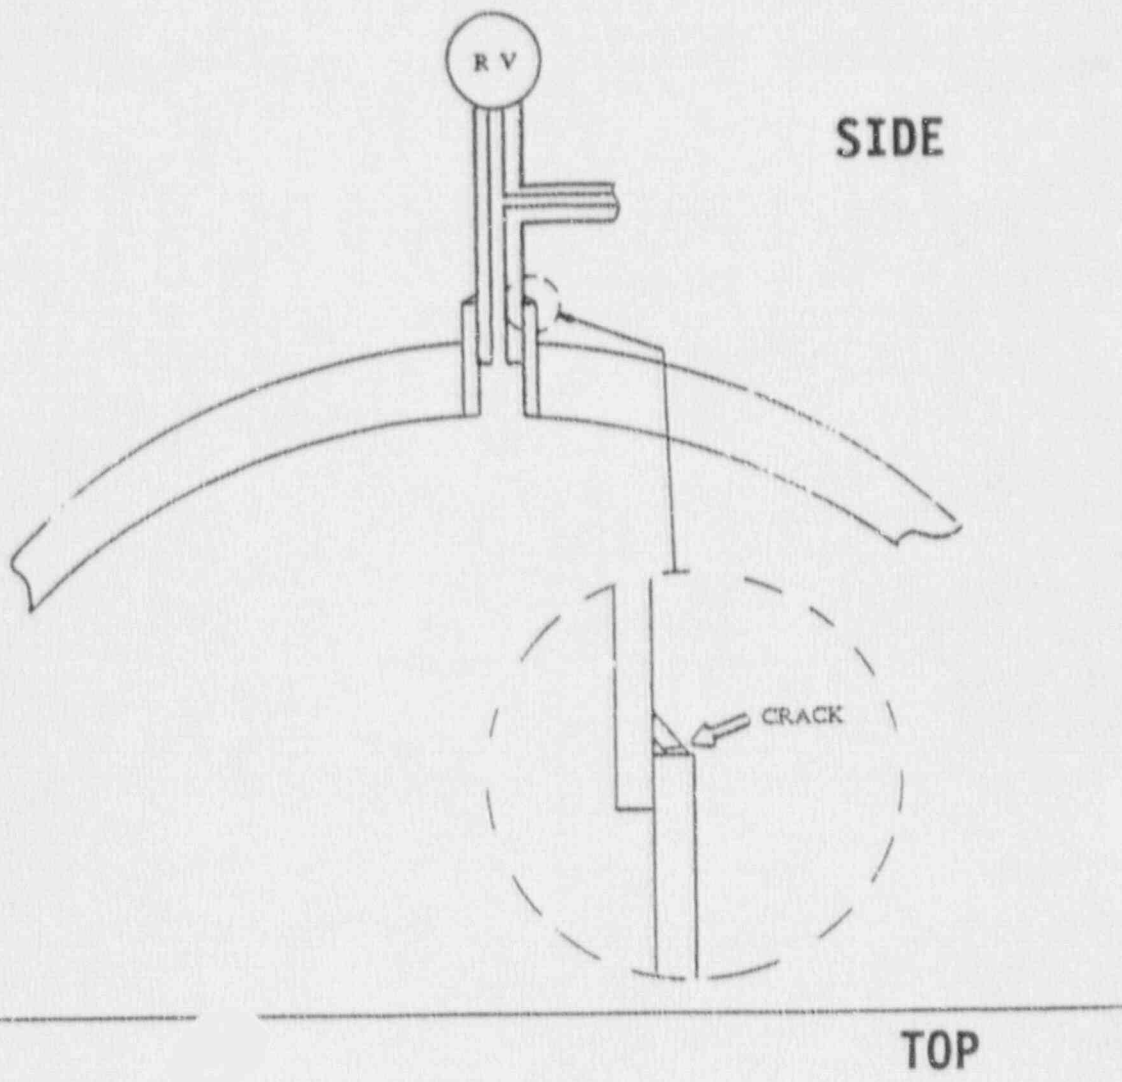
FIGURE 1: SAFETY INJECTION TANK

On December 1, 1990 we shutdown Unit 1 to repair leaks in the Safety Injection Tank (SIT) Nitrogen Supply System. On December 4, 1990, with the Unit in MODE 5 at 170 degrees and 180 psia, we inspected the nitrogen vent lines on top of tanks 11B and 12B and found cracks in the structural weld at the coupling-to-vent line junction (see Figure 1). We found no similar cracks in the other Unit 1 SITs (11A and 12A) or the Unit 2 SITs.

Unit 1 was restarted on October 5, 1990 following a maintenance outage. On October 29, 1990 operators noted nitrogen leakage accumulating in the containment atmosphere. Unit 1 was not immediately shutdown since the operators were able to supply enough nitrogen to maintain SIT pressure, thereby meeting the SIT Technical Specification requirement. The leakage gradually increased and Unit 1 was shutdown on December 1, 1990 and the cracks were discovered on December 4, 1990. The cracks were circumferential, running approximately 150 degrees around the weld on tank 11B and 120 degrees around the weld on tank 12B. We determined the cracks to have been caused by high cycle fatigue. The cantilevered configuration of the relief line caused the valve to vibrate in one direction. The increase in weight on top of the vent line due to the new, heavier valves caused an increase in the moment applied to the weld when the valve vibrated. This increase in moment greatly decreased the number of fatigue cycles the weld could withstand.

The root cause of this condition was the failure of design engineers to detect the cantilever condition during the replacement of the relief valves. This modification was reviewed by two qualified design engineers and received input from two others. Each of these engineers failed to recognize the lack of sufficient support for the valve in the direction perpendicular to the nitrogen relief line.

LOADING DIRECTIONS TO
PROPAGATE OBSERVED
CRACKS

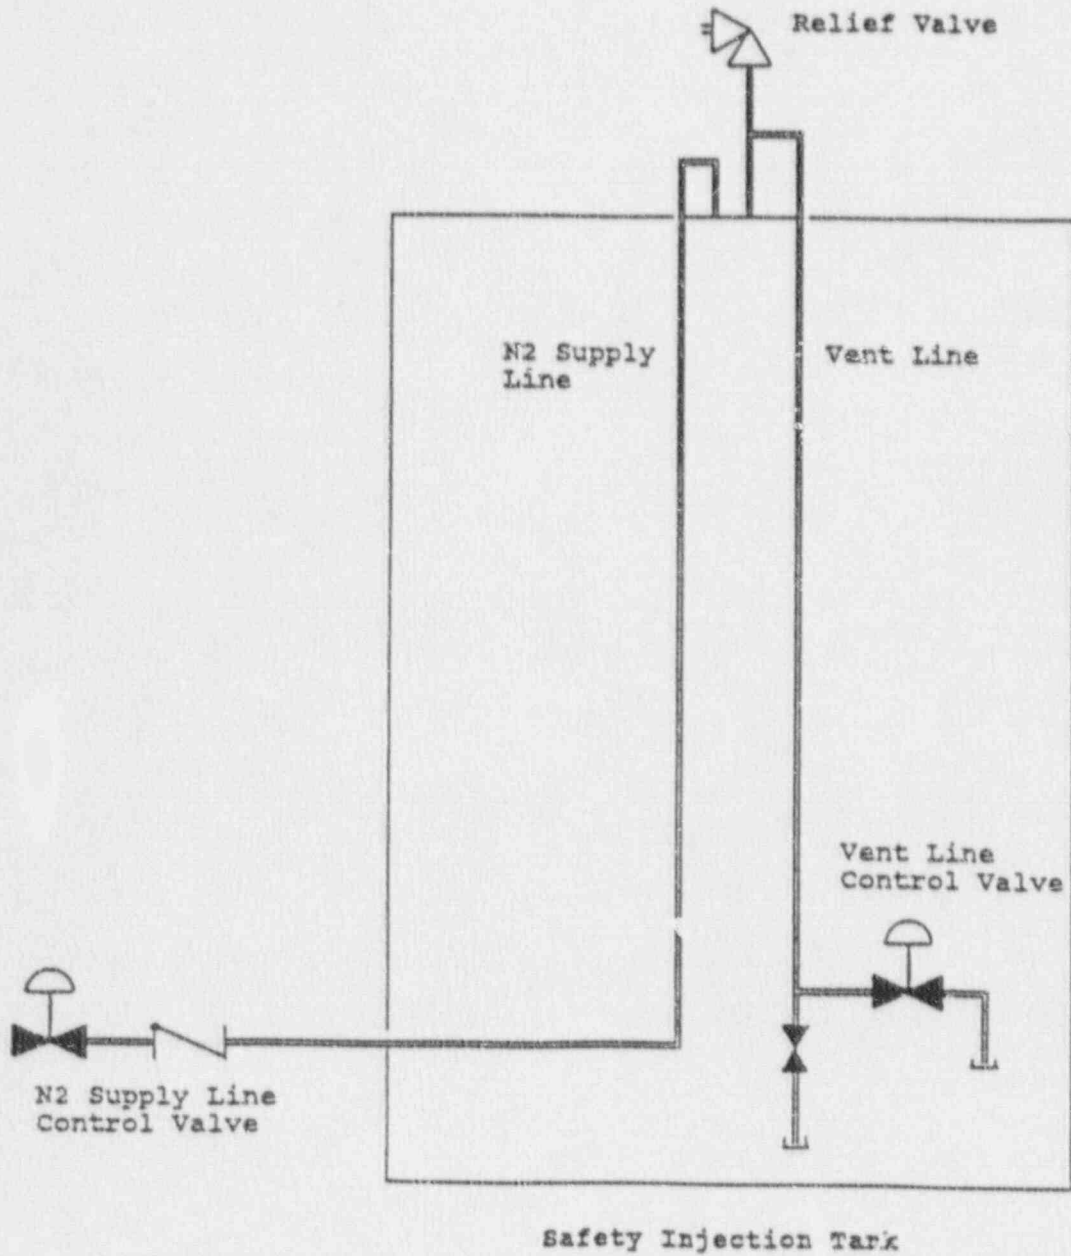
FIGURE 2: INITIAL CONFIGURATION

Each Calvert Cliffs Unit has four SITs, each of which contains borated water under a nitrogen blanket. The nitrogen blanket is pressurized to 200 to 250 psi per Technical Specifications to force the water into the Reactor Coolant System in the event of a large break Loss of Coolant Accident (LOCA). A relief valve was located on top of each tank to prevent overpressurization of the tank (see Figure 2).

In February of 1990, the relief valves on the SITs were replaced with higher capacity valves weighing 42 lbs. The original valves weighed 19 lbs.
