SUBJECT: Calvert Cliffs Nuclear Power Plant  
Unit Nos. 1 and 2; Docket Nos. 50-317 and 50-318;  
License Nos. DPR 53 and DPR 69  
Licensee Event Report 90-030, Revision 00

LICENSEE EVENT REPORT (LER)

TITLE (4) Fatigue Cracking in the Safety Injection Tank Nitrogen Vent Line Welds Due to Design Engineering Personnel Error

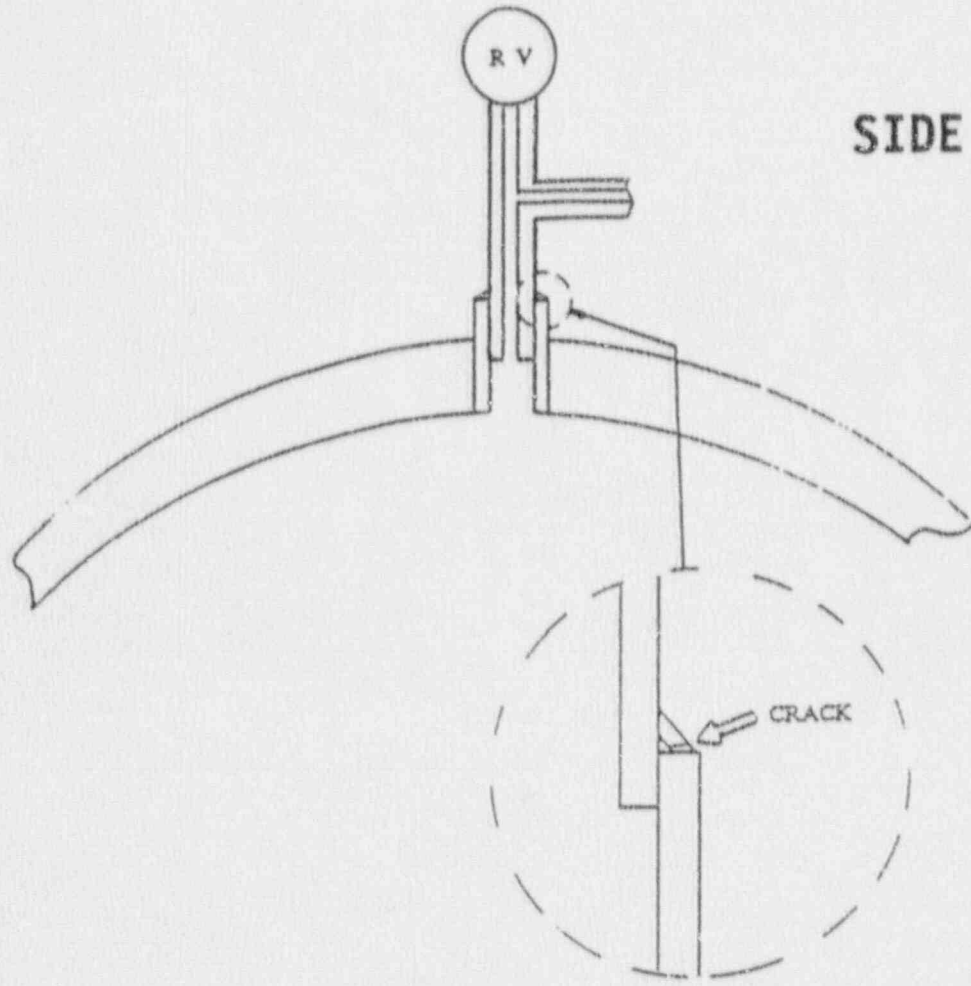
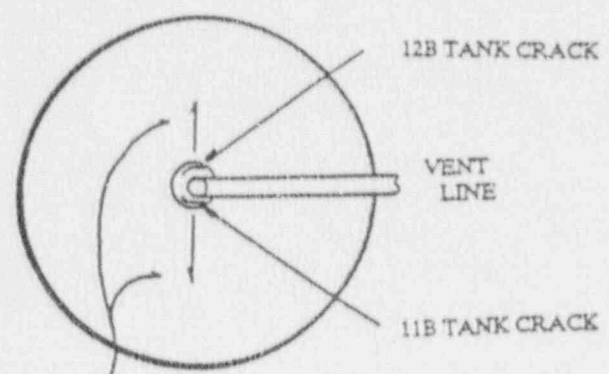
FIGURE 1: SAFETY INJECTION TANK

The root cause of this event was personnel error in that design engineers failed to recognize a cantilever condition during replacement of the SIT relief valves.

On December 1, 1990 we shutdown Unit 1 to repair leaks in the Safety Injection Tank (SIT) Nitrogen Supply System. On December 4, 1990, with the Unit in MODE 5 at 170 degrees and 180 psia, we inspected the nitrogen vent lines on top of tanks 11B and 12B and found cracks in the structural weld at the coupling-to-vent line junction (see Figure 1). We found no similar cracks in the other Unit 1 SITs (11A and 12A) or the Unit 2 SITs.

The root cause of this condition was the failure of design engineers to detect the cantilever condition during the replacement of the relief valves. This modification was reviewed by two qualified design engineers and received input from two others. Each of these engineers failed to recognize the lack of sufficient support for the valve in the direction perpendicular to the nitrogen relief line.

LOADING DIRECTIONS TO PROPAGATE OBSERVED CRACKS

1. The relief valves on all four tanks for both units were relocated to the nitrogen supply line at the base of the tanks and adequately supported to prevent recurrence of this event (see Figure 3).

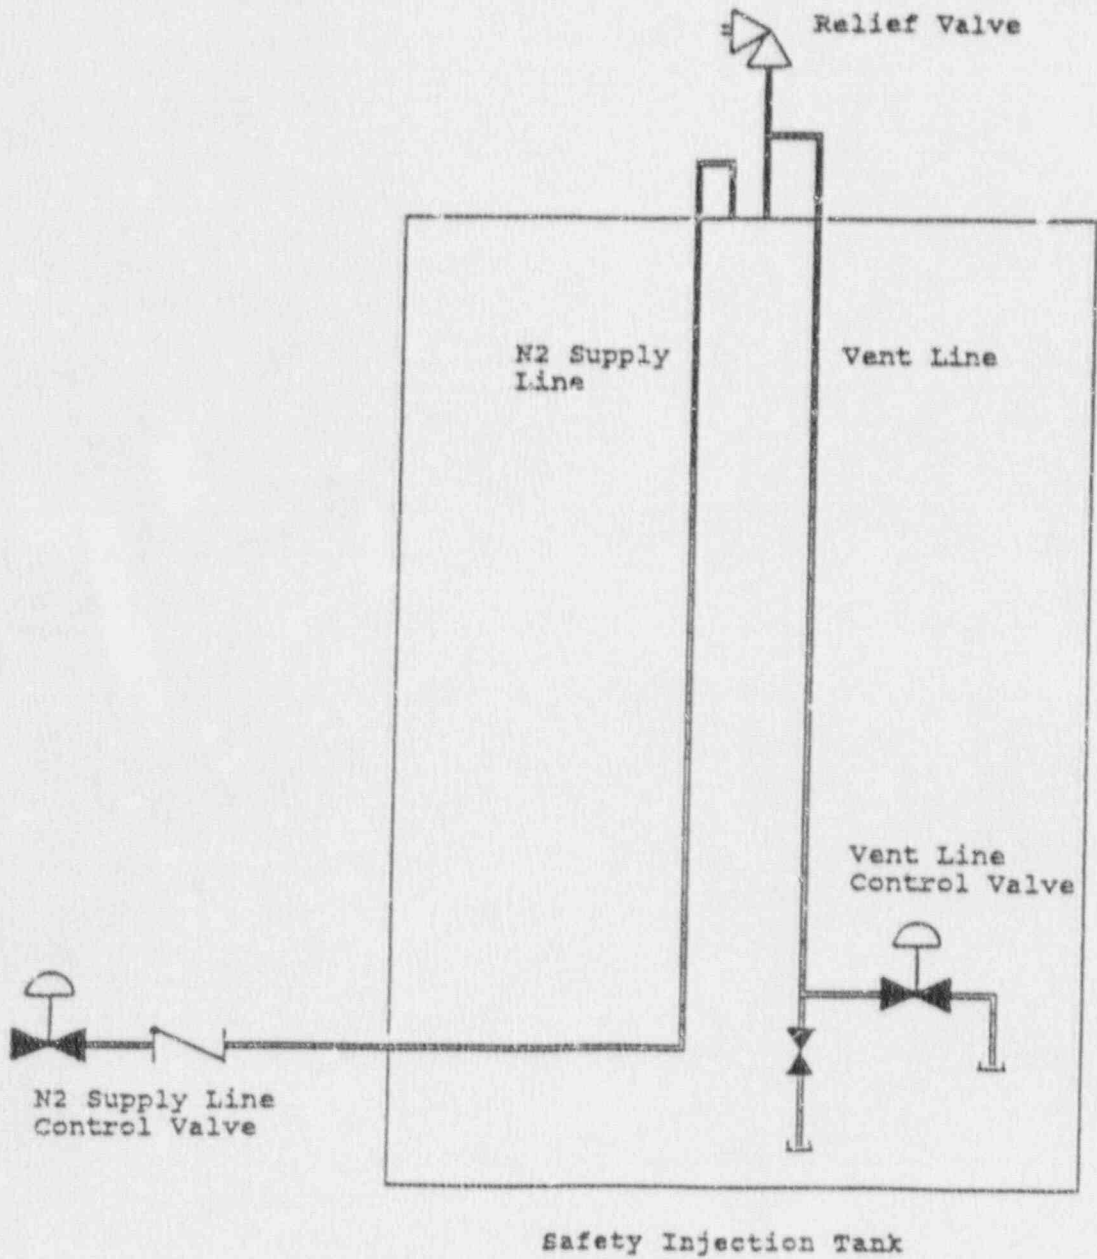
FIGURE 2: INITIAL CONFIGURATION

Each Calvert Cliffs Unit has four SITs, each of which contains borated water under a nitrogen blanket. The nitrogen blanket is pressurized to 200 to 250 psi per Technical Specifications to force the water into the Reactor Coolant System in the event of a large break Loss of Coolant Accident (LOCA). A relief valve was located on top of each tank to prevent overpressurization of the tank (see Figure 2).

In February of 1990, the relief valves on the SITs were replaced with higher capacity valves weighing 42 lbs. The original valves weighed 19 lbs.
