SUBJECT: TRANSMITTAL OF PRESENTATION MATERIALS FOR CRGR
MEETING #24

UNITED STATES
NUCLEAR REGULATORY COMMISSION
OFFICE OF INSPECTION AND ENFORCEMENT
WASHINGTON, D. C. 20555

IE BULLETIN NO. 82- : OVEREXPOSURES IN PWR REACTOR CAVITIES

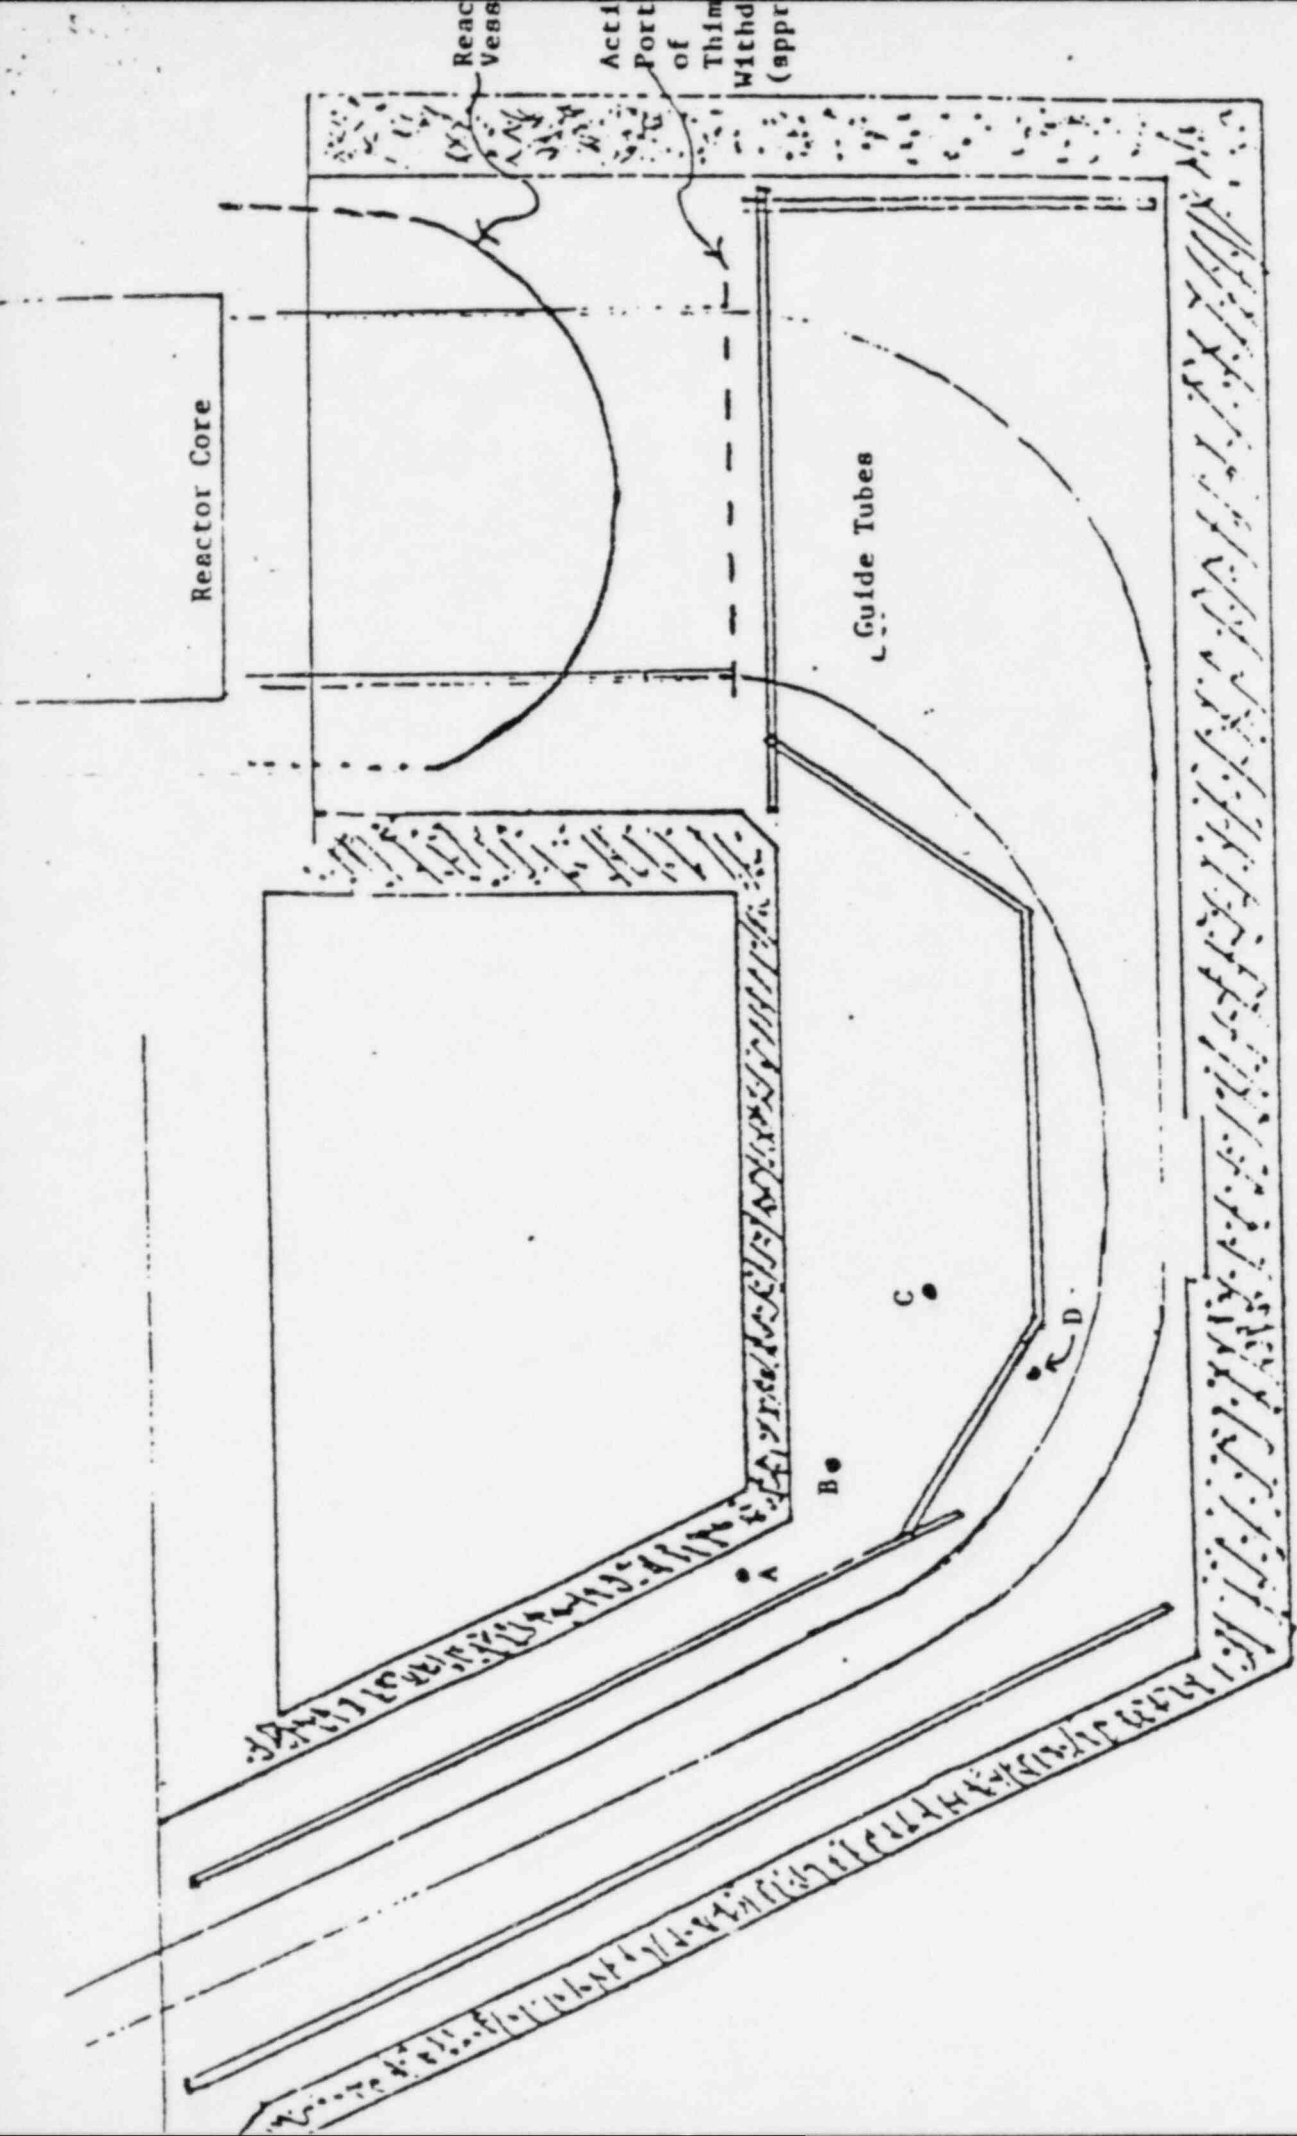
Measured Exposure Rates

A =	200 mrem
B =	35000 mrem
C =	50000 mrem
D =	85000 mrem
