# Maine Yankee

Subject: Maine Yankee Licensee Event Report 91-001-00 - Plant Shutdown Due to  
Failure of Manual Containment Integrity Valve

LICENSEE EVENT REPORT (LER)

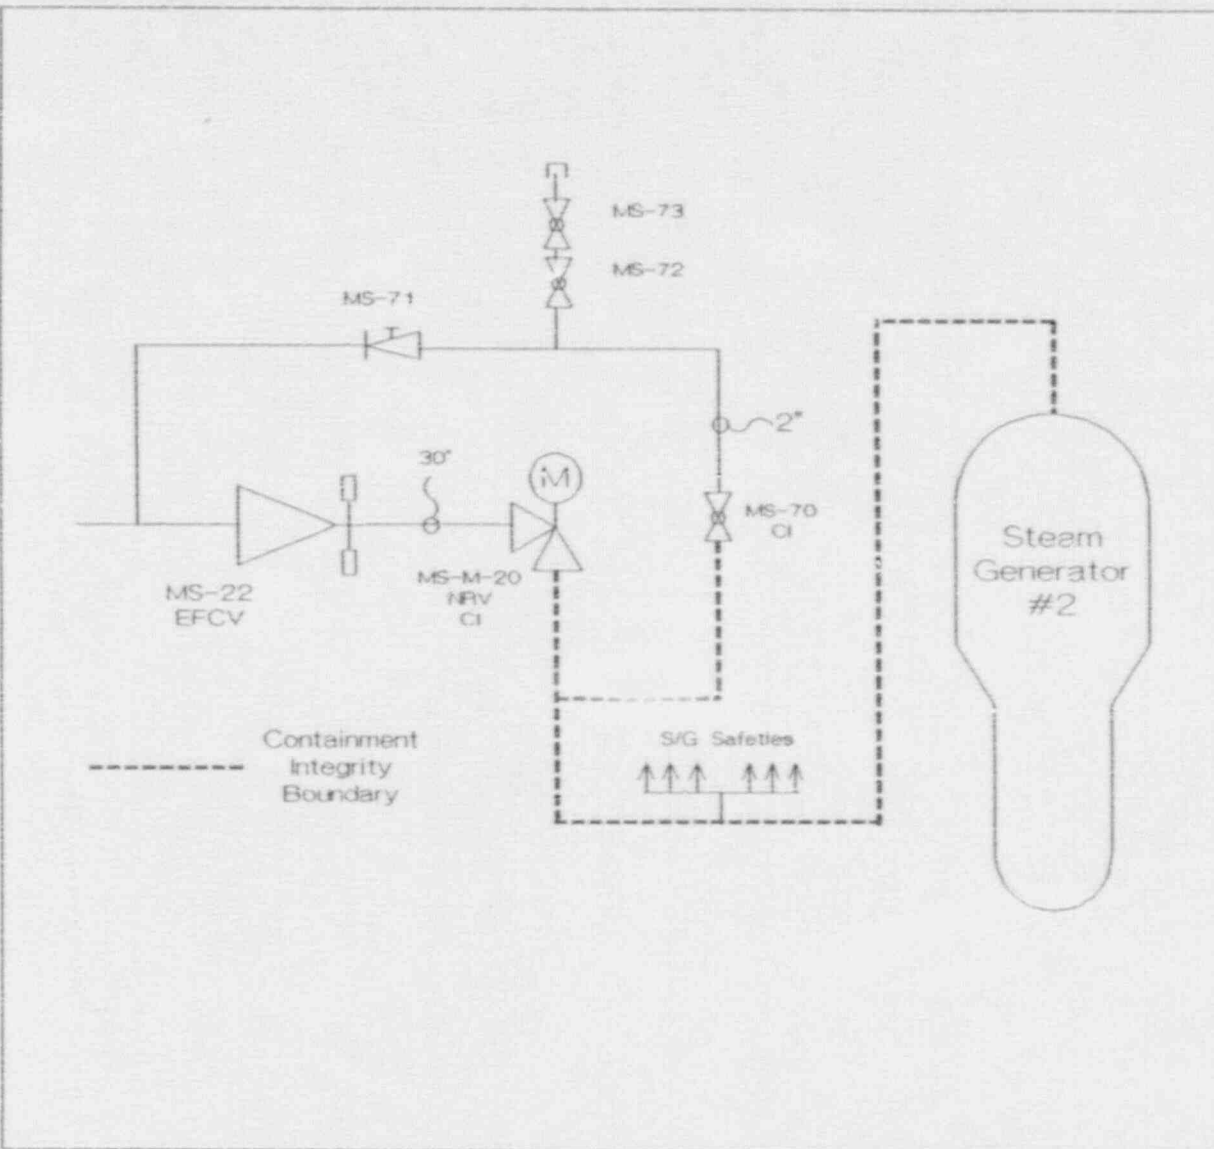
On January 8, 1991, Maine Yankee performed a plant shutdown from 19% reactor power, as required by Technical Specifications due to the failure of a containment integrity isolation valve and the inability to adequately isolate the affected containment penetration. During a plant start up, the bypass lines around the main steam system (SB) non-return valves (NRV) and excess flow check valves (EFCV) were opened for steam line warmup. When attempting to shut the bypass isolation valve (MS-70) for the #2 steam line, it was discovered that MS-70 could not be shut due to damage to the valve stem and yoke bushing threads.

The valves used to isolate the bypass line consisted of a stop check valve (MS-71) downstream and in series with MS-70 and an instrumentation isolation valve (MS-72) for a tap between the two inline valves. (See attached figure.) Valves MS-71 and MS-72 were not designated as safety class and upgrading the valves was believed to be unlikely. Therefore, an on-line repair was attempted on MS-70 within the time constraints of the remedial action. The valve yoke was to be cut and the upper portion of the yoke including the yoke bushing was to be split and replaced with a new section and welded in place.

At 2045, when the existing yoke on MS-70 was cut, a portion of the valve stem and the severed yoke were ejected from the valve. The remaining portion of the valve stem and the disk remained in the valve body, backseated and blocked the stuffing box opening. A "soft patch" made of lead was clamped over the valve to secure a small steam leak that remained.

After reaching cold shutdown, MS-70 was replaced. Similar valves in the other two steam lines were inspected and their maintenance history reviewed. As a result, MS-50 in the #1 steam line was also replaced due to similar stem thread damage. In the #3 steam line, MS-90 stem and yoke bushing threads were cleaned and lubricated.
