PEACH BOTTOM ATOMIC POWER STATION

SUBJECT: Licensee Event Report  
Peach Bottom Atomic Power Station - Unit 3

This LER concerns a reactor scram following the failure of the '2' Main Transformer.

TITLE (4)  
Reactor Scram Following '3A' Main Transformer Failure

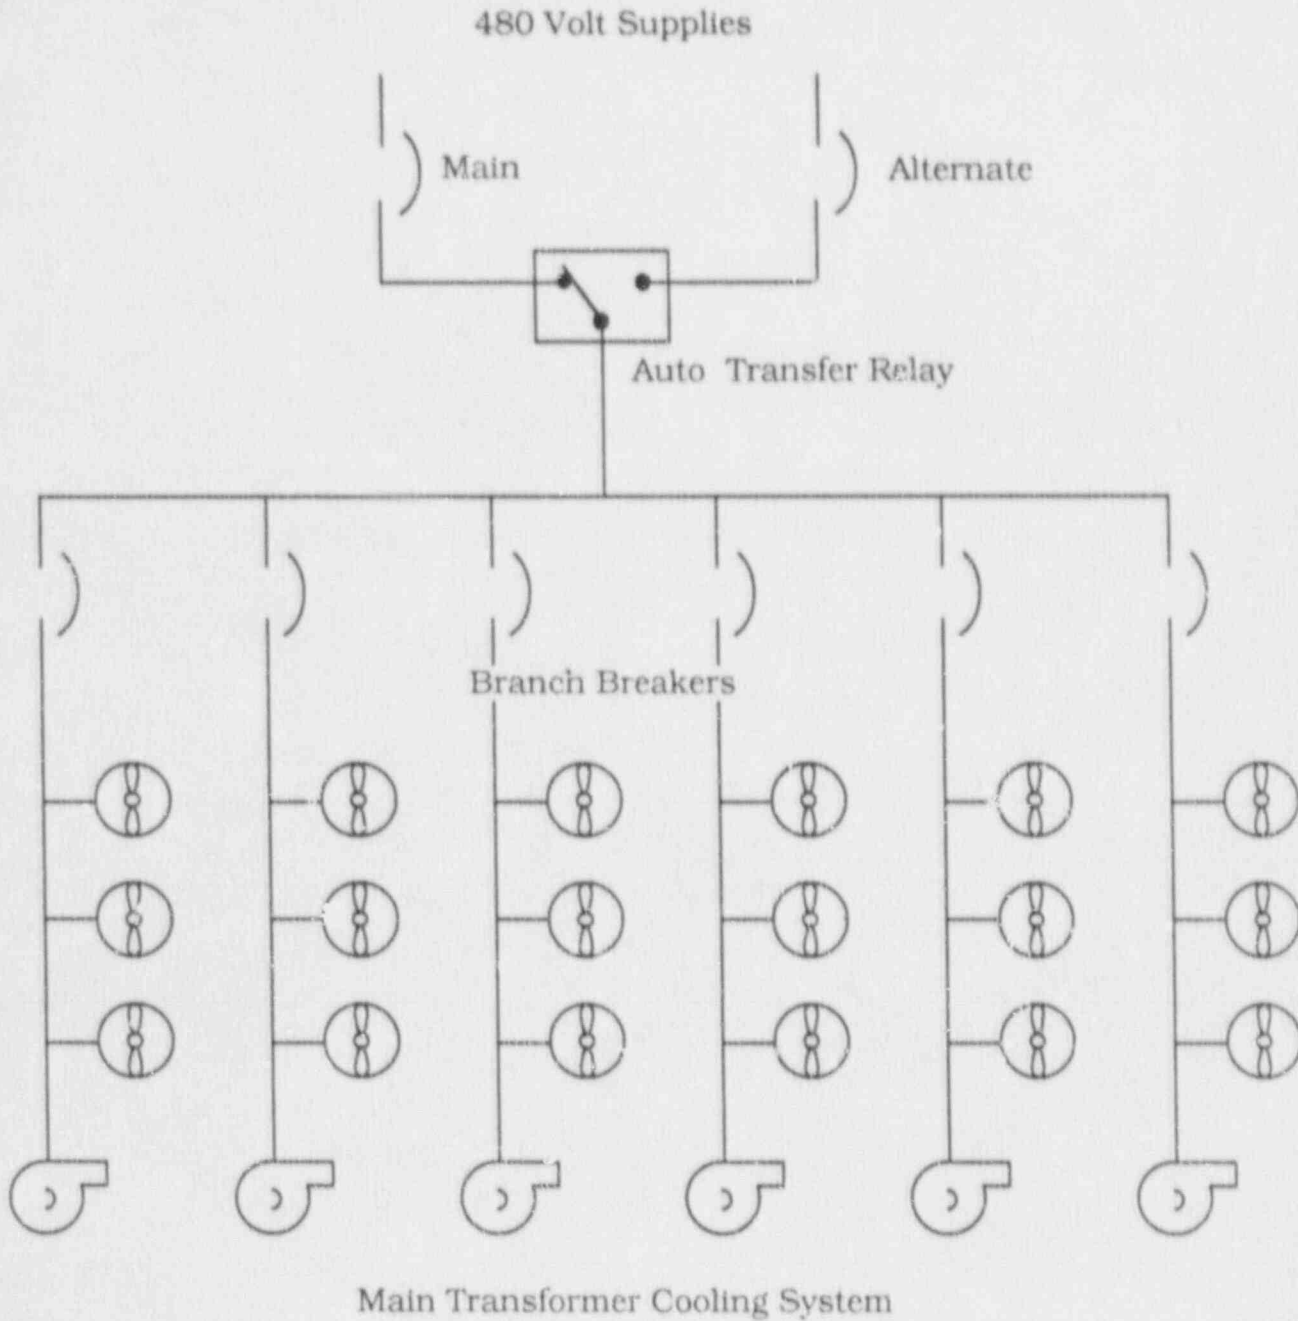
Figure 1

In response to the loss of power to the fans, the FF contacted the CO and requested that an Operator be dispatched to check the normal power feed. Each transformer's control power is supplied from a preferred 480V supply breaker (See Figure 1), which transfers to an alternate feed on an undervoltage condition. These supply breakers then feed six branch breakers which feed three fan motors and one oil circulating pump each. The shift personnel dispatched to the main supply breaker found the breaker tripped and attempted to reclose it. The breaker tripped free. A second attempt to reclose the breaker resulted in a similar trip. By then, the FF and SSV discovered that the control power failed to transfer to the the alternate feed due to a defective auto transfer undervoltage relay (EIIS:RLY).

The cause of the first event was component failure and inadequate equipment design. The transformer cooling system consists of 18 fans and 6 circulating pumps. The event was initiated when one of the fans short circuited. A branch circuit breaker should have tripped in response to the short circuit removing only three fans and one pump from service. However, during this event, the main breaker supplying all transformer fans and pumps tripped instead of the individual branch breaker causing a total loss of cooling. The main breaker tripped at the proper setting to protect the motor control center. The individual branch breakers are vendor supplied, non-adjustable and trip at a setpoint higher than the main breaker. Additionally, failure of the cooling system undervoltage auto transfer relay prevented the alternate feed breaker from automatically supplying power to the cooling system when the main breaker tripped. The failure was caused by excessive wear in the auto transfer relay. Based on the breaker trip setting coordination problems and the failed attempts to reclose the main breaker, closure of the alternate breaker would not have prevented the total loss of cooling.

The adequacy of the cooling system power supply circuit design is being evaluated. All operators received a reading assignment discussing the event and the breaker coordination problems. Also included was guidance on how to properly respond to breaker trips of this type in the future.

The auto transfer relays were checked on the other Unit 3 transformers and were found to be working properly. The auto transfer relays on the Unit 2 transformers will be checked during the current refuel outage. A routine test will be developed to perform an operability check of the auto transfer relay.
