SUBJECT: COMANCHE PEAK STEAM ELECTRIC STATION (CPSFS)  
DOCKET NO. 50-445  
OPERATION PROHIBITED BY TECHNICAL SPECIFICATIONS  
LICENSEE EVENT REPORT 90-036-01

Enclosed is Licensee Event Report 90-036-01 for Comanche Peak Steam Electric Station Unit 1, "Personnel Error Resulting in Failure to Comply With Technical Specification Action Requirements."

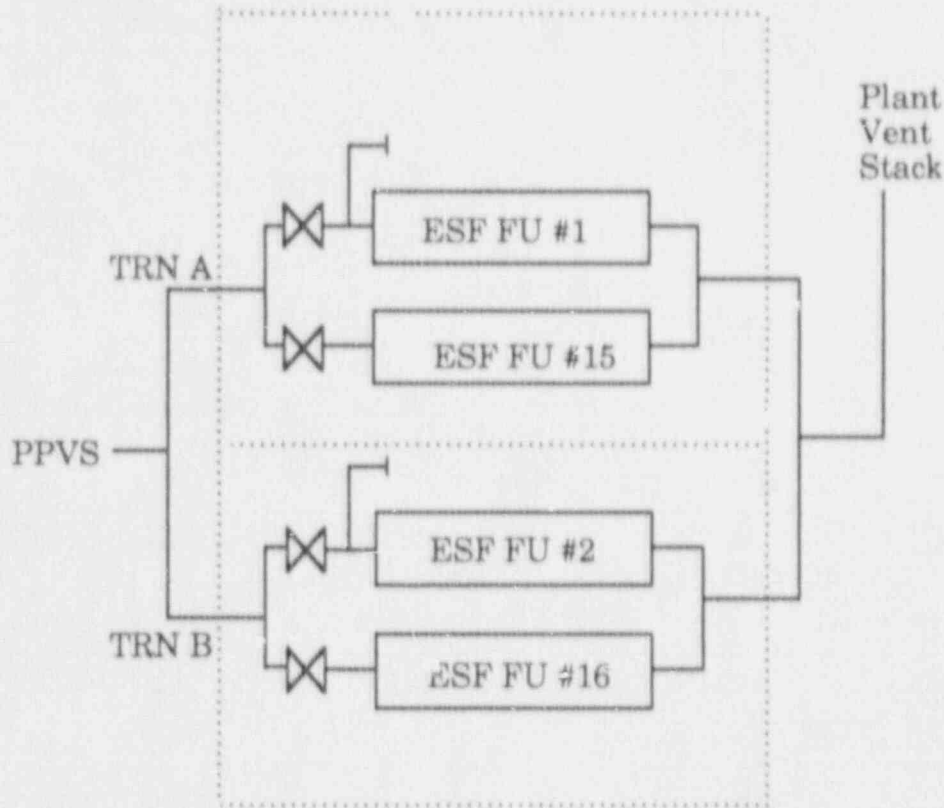
Figure 1

Filtration Units 01 and 02 were originally the only two filtration units designed as ESF units (refer to Figure 1). Filtration Units 15 and 16 were upgraded to ESF design criteria in 1988. These units are identical except for the following: filtration units 01 and 02 are provided with an exhaust register which removes air from its respective room. This register, added as part of the ESF upgrade of filtration units 15 and 16, functions to exhaust excess heat generated by the two fan motors and heaters in each ventilation equipment room while running both filtration units per train in post-accident configuration.
