Beaver Valley Power Station, Unit No. 1  
Docket No. 50-334, License No. DPR-66  
LER 91-004-00

LER 91-004-00, 10 CFR 50.73.a.2.i, "Containment Liner Test Channel Vents Found Unplugged".

TITLE (4)  
Containment Liner Test Channel Vents Found Unplugged

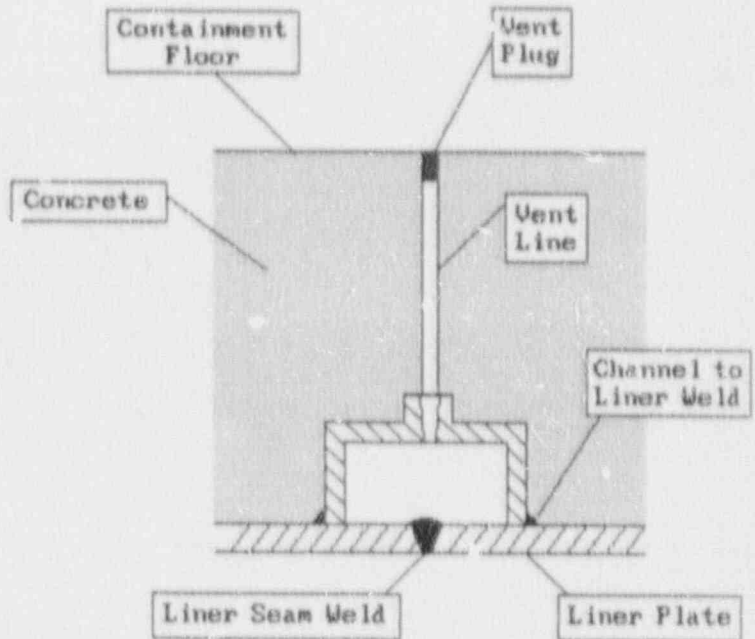
Figure 1

The concrete reactor containment building was constructed with a steel liner to ensure the structure would have minimum air leakage. The liner was made of preformed steel plates welded together. The liner test channels, also made of steel, were welded over the liner plates seam welds. (See Figure 1) The channel vents were then used to pressure test the channels to verify weld reliability. After the liner was completed, a protective coating was applied to the liner to prevent corrosion. But, as the test channels were still in place, no coating could be applied over the seam welds. The test channels were therefore sealed shut with vent plugs (allen head bolts) to ensure that corrosion would not occur on the uncoated parts of the liner. Also, after the liner was completed, reinforced concrete was poured inside the liner to a depth of approximately two feet for the containment's floor.

Simplified Test Channel
