PEACH BOTTOM ATOMIC POWER STATION

SUBJECT: Licensee Event Report  
Peach Bottom Atomic Power Station - Unit 2

Reference: Docket No. 50-277  
Report Number: 2-91-003  
Revision Number: 00  
Event Date: 01/21/91  
Report Date: 02/18/91  
Facility: Peach Bottom Atomic Power Station  
RD 1, Box 208, Delta, PA 17314

TITLE (4)  
'2B' Reactor Pressure System Bus Trip on Undervoltage due to '3B' Recirc. Pump Start

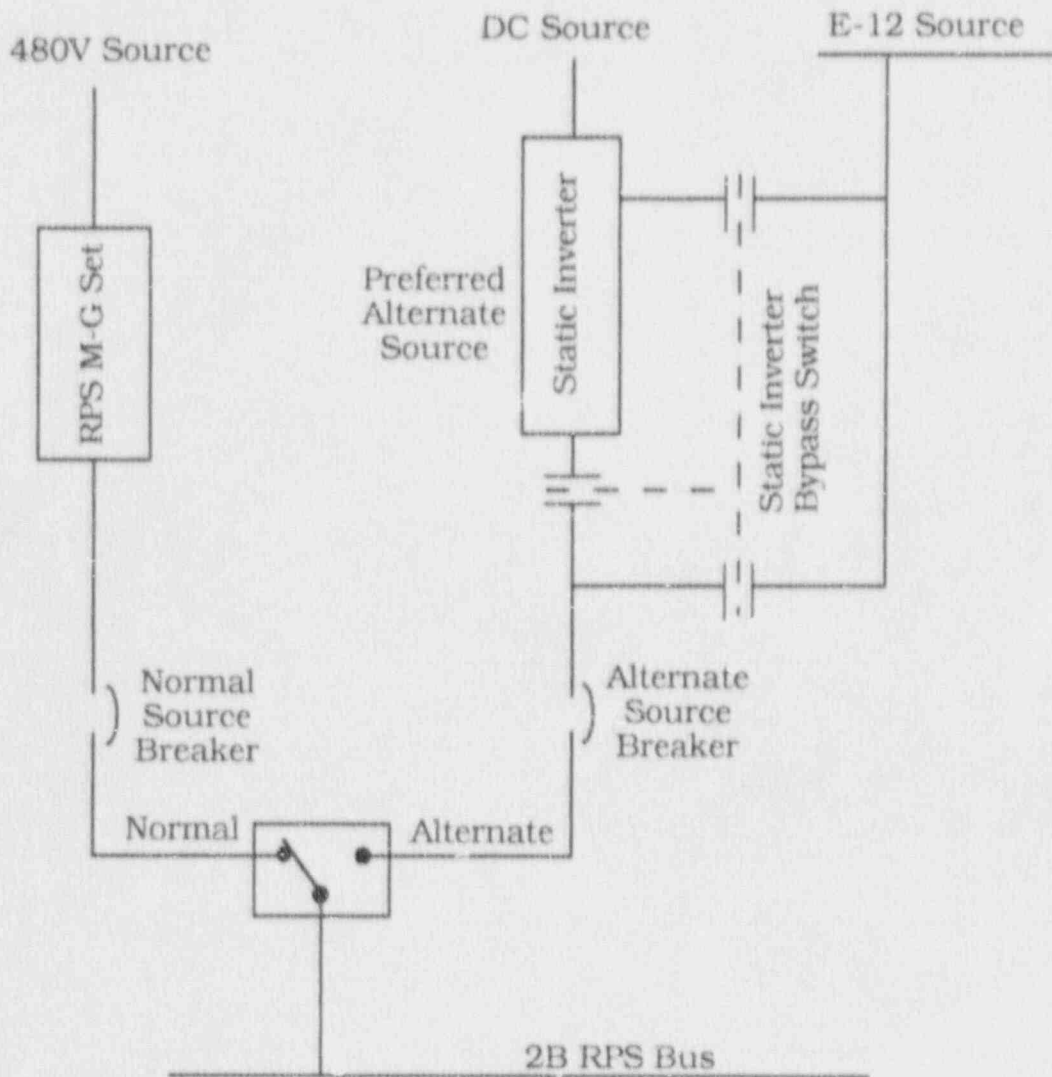
Figure 1

Unit 2 was in the Refuel mode at 0% of rated thermal reactor power with scram inserted. The Unit 2 '2B' Reactor Protection System (RPS) was being supplied from the alternate feed (See Figure 1) due to outage conditions. The Unit 2 Static Inverter was bypassed for maintenance. Unit 3 was in the startup mode.

The cause of the event was an undervoltage condition on the RPS Alternate supply. This was a result of the starting of a large motor which was being supplied by the same source as the '2B' RPS with the static inverter bypassed.

RPS Bus Normal and Alternate Supply

The procedure used for starting a recirculation motor-generator set has been revised to inform operations personnel that when starting a recirc M-G set which is powered by the same startup source as the the RPS Alternate power supply they may receive a half scram, half Group III Isolation, and a SBGT

start if RPS is being supplied from its Alternate Source with the Static Inverter bypassed. The pertinent information contained in this report will be routed to appropriate Operations personnel.
