MONTICELLO NUCLEAR GENERATING PLANT
Docket No. 50-263 License No. DPR-22

Response to IE Bulletin 82-03, Revision 1, and
Confirmatory Action Letter dated October 19, 1982
From J. Keppler Regional Administrator, Region III, USNRC

Summary Report of the
Augmented Inservice Inspection of Stainless Steel Pipe Welds
Prepared by: Phillip J. Krumpo

Summary Report
of
Weld Overlay Repairs
of
Recirculation System Piping

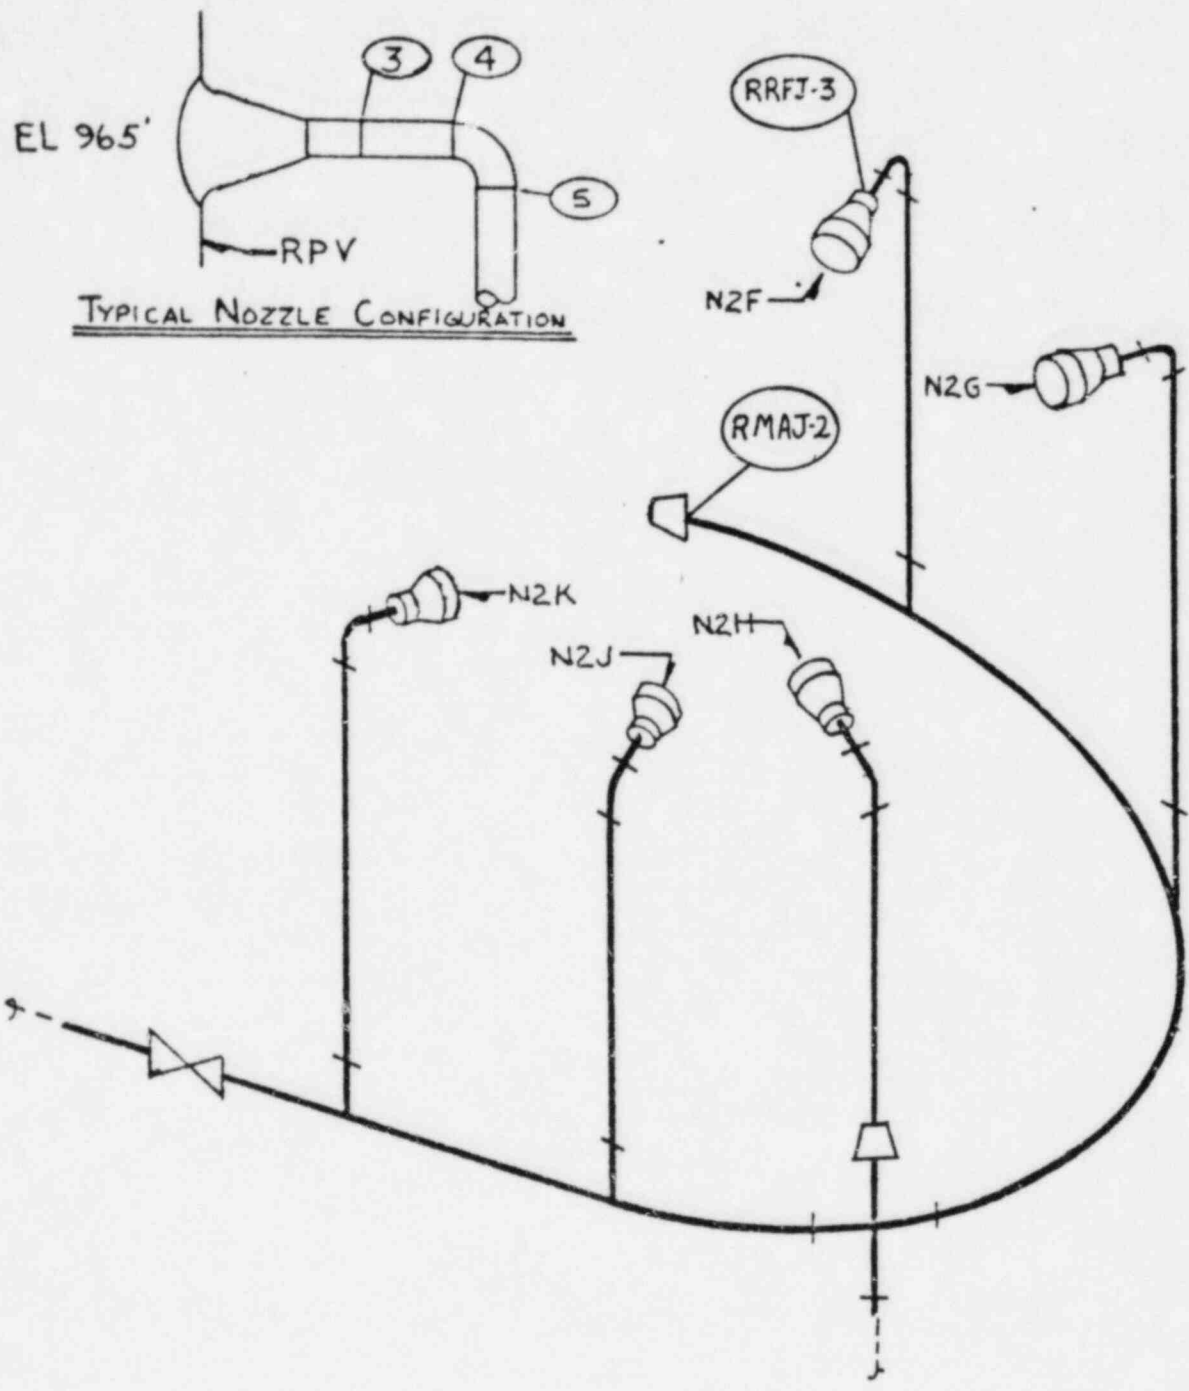
FIGURE 1A

Evaluation of the inspection results revealed five welds of the reactor recirculation system with indications that have been interpreted as being intergranular stress corrosion cracks (IGSCCs). Table I identifies the welds and describes the respective indications. Figure IA and Figure IB identifies the location of these welds.

The 22 inch diameter manifold end cap weld RMAJ-2 was inspected and identified in the first week of the outage as having linear indications in the axial direction of the end cap. After the system was drained, these ultrasonic indications were confirmed by radiography as being three (3) axial intergranular stress corrosion cracks (IGSCCs).

Later in the inspection, four (4) other welds in the 12 inch diameter recirculation riser piping were found to contain IGSCC's. Three welds (RRCJ-3, RREJ-3, and RRFJ-3) were pipe to safe end welds and the fourth weld (RRDJ-5) was pipe to elbow weld. All four welds were in separate risers; refer to Figures 1A and 1B.
