U. S. NUCLEAR REGULATORY COMMISSION

Reports No. 50-456/90026(DRP); 50-457/90027(DRP)

Facility Name: Braidwood Station, Units 1 and 2

Inspection Conducted: December 17, 1990 through January 26, 1991

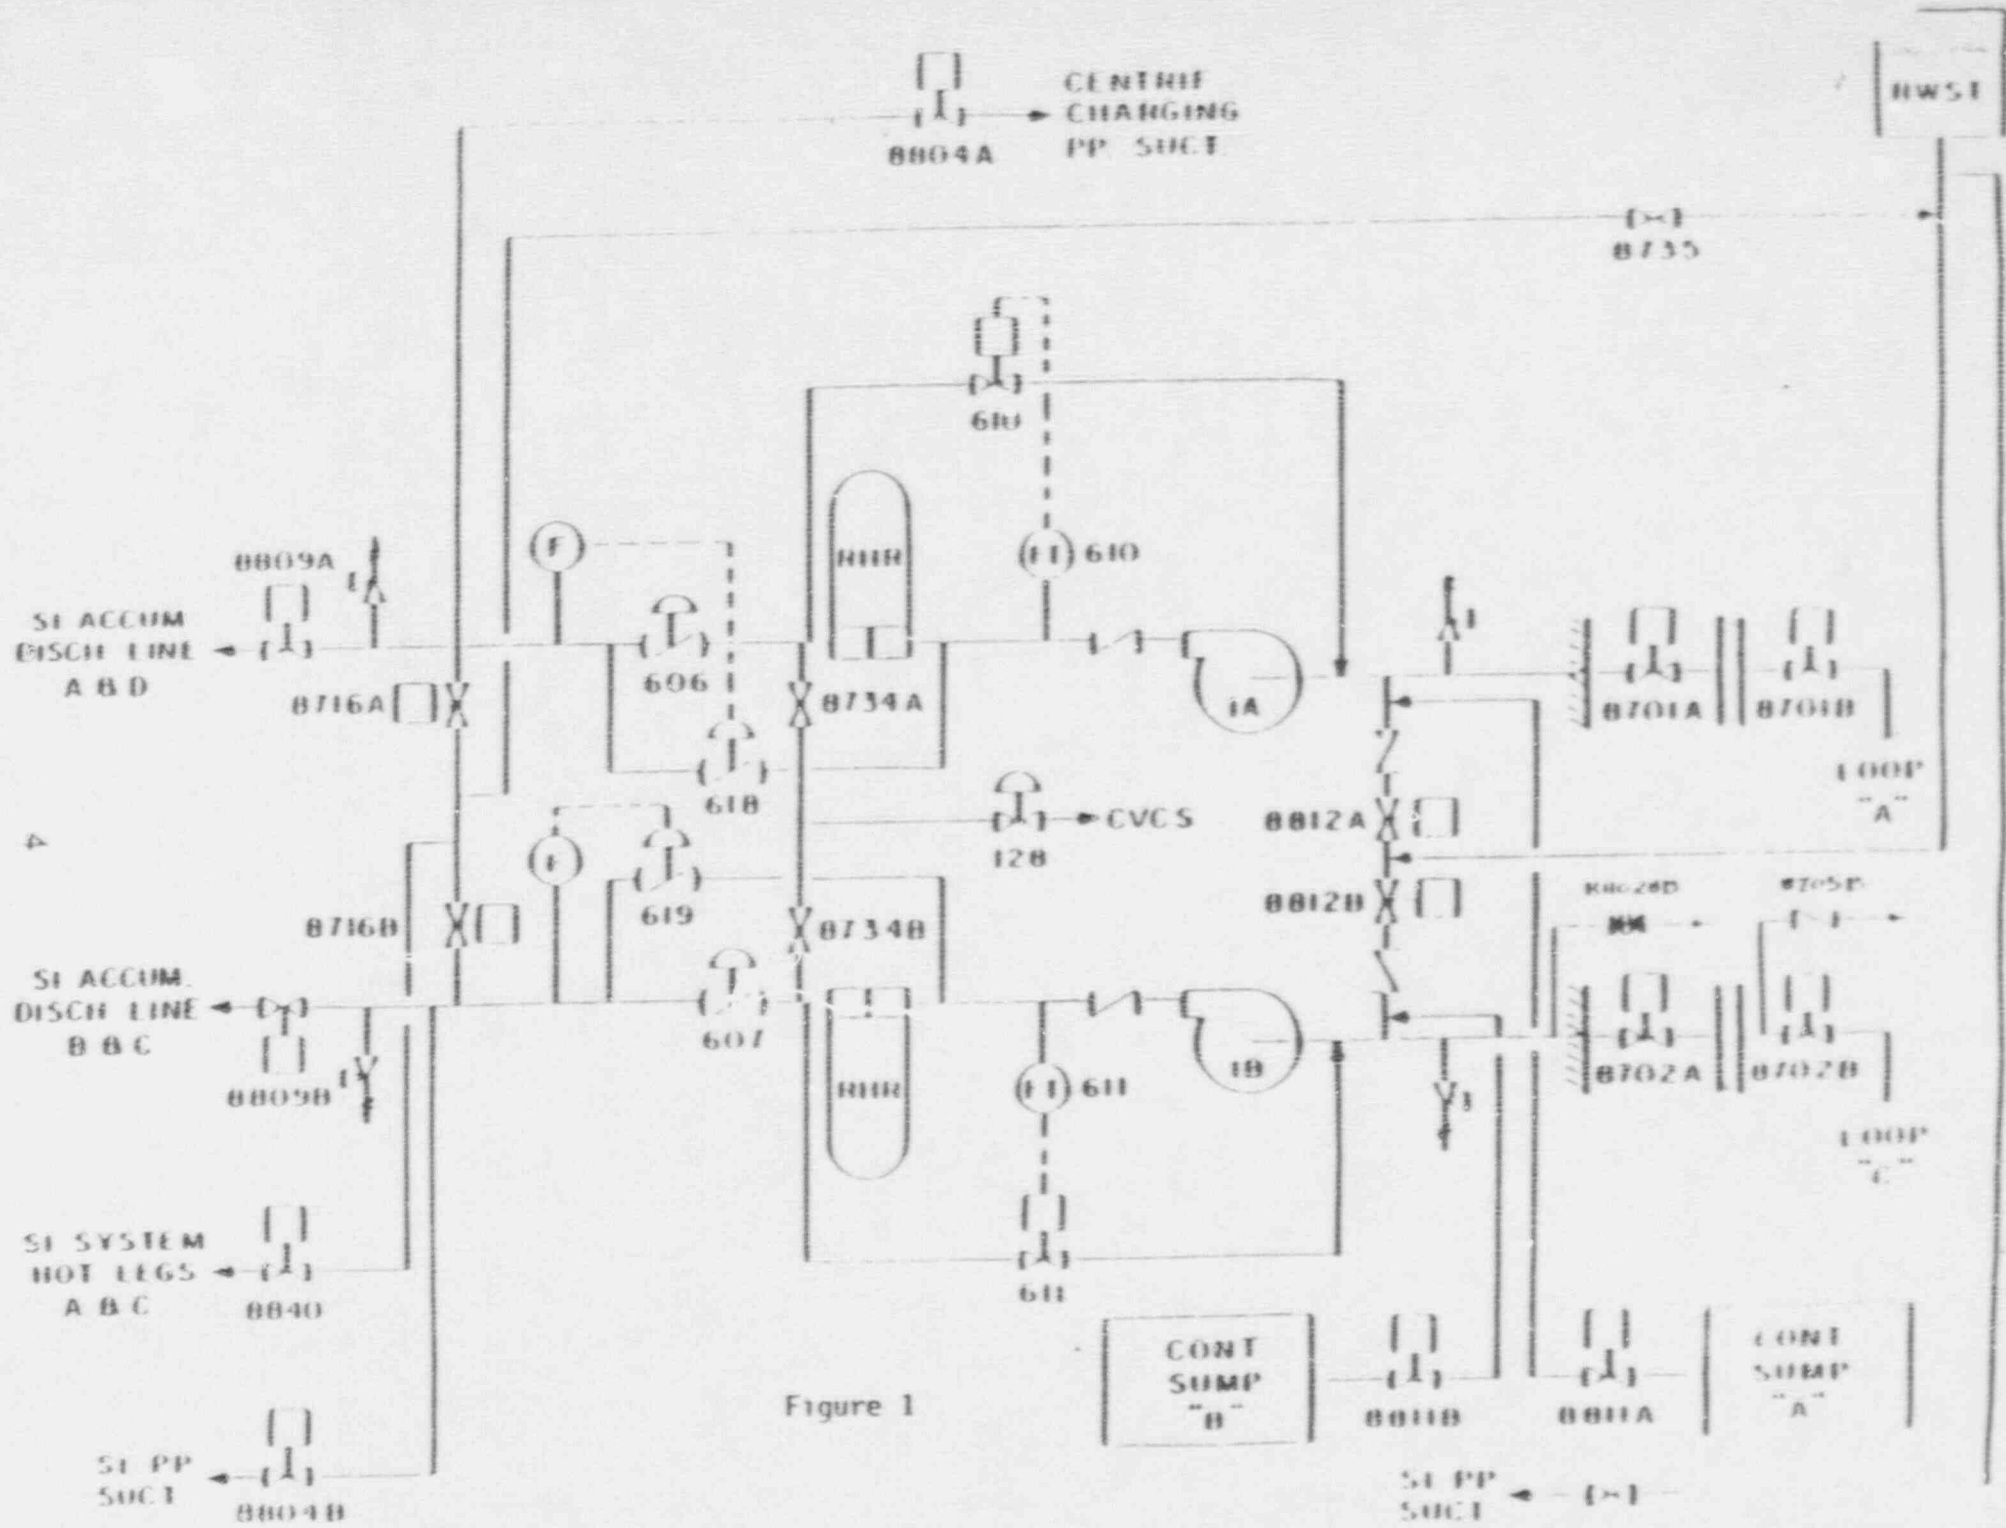
After the leakage check on the valves was completed, the EA, via TSE 3 stationed in the Auxiliary Building, was directed by way of radio communication at approximately 1:20 a.m., to close vent valve 1RH028B, which was being used to collect leakage from the closed valve 1RH8702B per Procedure BwVS 4.6.2.2-1, Step F.2.21, by TSEs 1/2 in the Unit 1 control room. After approximately 4 minutes elapsed, TSE 1 directed the Auxiliary NSO to stroke open valve 1RH8702B per Procedure BwVS 0.5-2.RH.2-1, Step F.4.3. This directive by TSE 1 to the Auxiliary NSO was not heard by TSE 2, who was awaiting confirmation of the closure of valve 1RH028B from TSE 3. Further, TSE 1 had not received confirmation that valve 1RH028B had been closed before issuing the directive to open valve 1RH8702B.

Opening valve 1RH8702B aligned the RCS to the inlet of the still open vent valve 1RH028B. During the time that the 1RH8702A valve was open and the 1RH028B valve was closing, leakage through the vent increased and burst the tygon tubing attached to the valve, resulting in personnel in the Auxiliary Building being sprayed with hot water. Total indicated loss of pressurizer level was 5%, from 40 to 35%, which represents an approximate loss of 600 gallons.

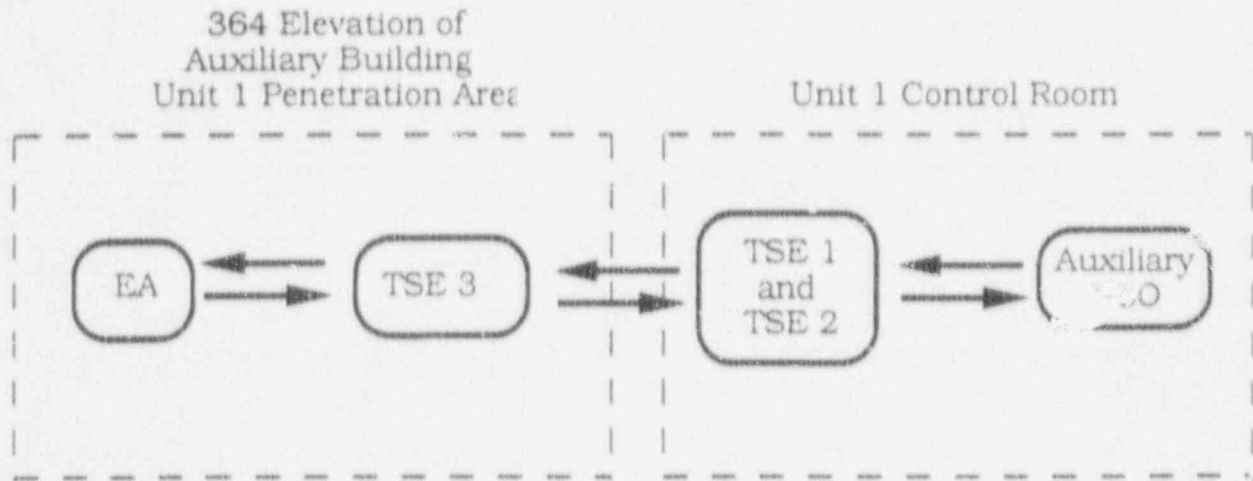
Figure 2. Communication patterns.

As illustrated in Figure 2, communication patterns at the time of the incident included direct communication between TSEs 1/2 and TSE 3 in the Auxiliary Building, between TSE 3 and the EA in the Auxiliary Building, and between TSEs 1/2 and the Auxiliary NSO in the Unit 1 Control Room. The Auxiliary NSO was not in direct or continuous communication concerning the execution of the two surveillances with any other operating staff personnel (e.g., NSO, SCRE, SA, and SE). This observation is substantiated by the fact that the NSO, SCRE, SA, and SE were unaware that two surveillances were being conducted in parallel. Also, it is important to note that the Auxiliary NSO and TSE 3 were not in direct communication with each other, but rather interfaced through TSEs 1/2. Figure 2 further illustrates that the standard command, control, and communication structure was bypassed, with the NSO, SCRE, and SE completely out of the command/control loop. As will be noted, this absence resulted in a lack of system redundancy or checks on the activities being performed by technical staff engineering personnel.

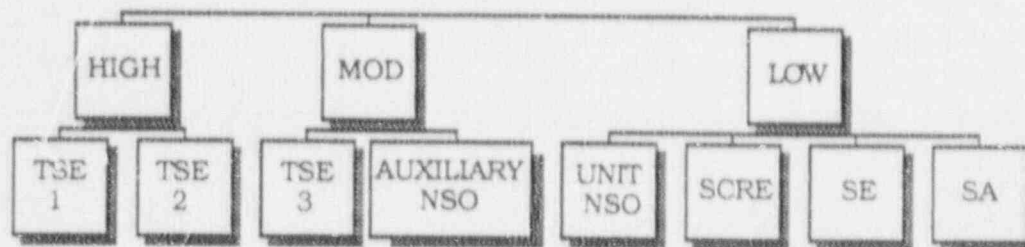
Figure 3. Personnel task awareness/involvement.

As depicted in the figure, the SCRE, Unit 1 NSO, SA, and SE had a low level of task involvement/awareness and in fact, were not even cognizant that both a leakage and a stroke surveillance were being conducted in parallel. This low task involvement/awareness appears to have been caused by an inadequate shift turnover, inadequate shift briefings, failure of the Auxiliary NSO to appraise the NSO of the extent of testing taking place, failure of the NSO to appraise himself of the exact nature of the tasks being conducted within the Unit 1 control room, and bypassing of the normal command, control, and communication structure.

TSEs 1/2 had a high involvement/awareness of the two surveillances. They were involved in monitoring all facets of the two procedures, issuing all procedural directives, performing all required calculations, signing off all completed procedural steps, acting as the critical communications interface between themselves and TSE 3 and the Auxiliary NSO, and continuously monitoring all changes in system configuration.

Based on this task involvement/awareness configuration, successful task performance was essentially dependent on the successful performance of TSEs 1/2. However, TSEs 1/2 performance was affected by attempting to coordinate a fairly complex dynamic task, as described in section 2.3.3, and in a possible state of physical and mental fatigue, suggested by the number of hours worked (approximately 19 and 17 hours, respectively). Also, this configuration
