U. S. NUCLEAR REGULATORY COMMISSION  
REGION I

Report No. 50-423/91-80

Facility Name: Millstone Nuclear Power Station, Unit 3

Areas Inspected: The AIT inspected those areas necessary to ascertain the facts and probable cause(s) of the December 31, 1990 event, involving the rupture of two six-inch diameter moisture separator drain lines. The team also evaluated the licensee's erosion/corrosion program analysis and corrective actions taken to recover from this event.

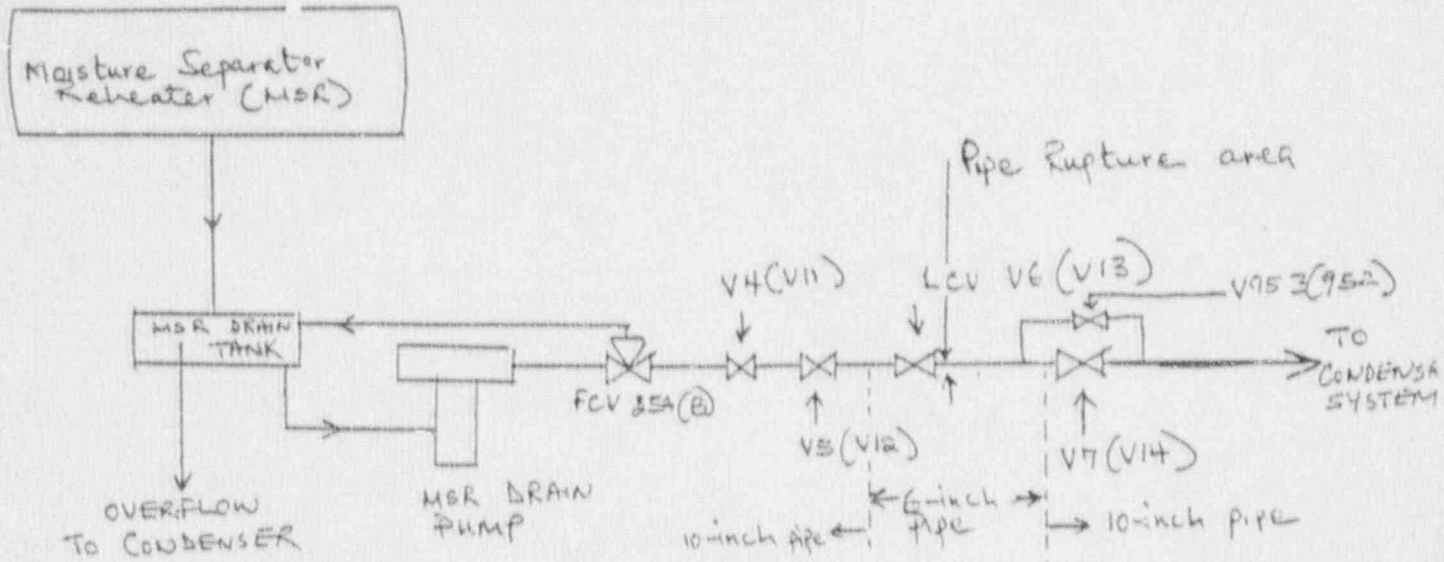
MSR Drain Pipe Configuration

The leak was found to be under the thermal insulation package around air operated level control valve, 3DSM-LCV-20A1 (LCV v6). This valve is in the discharge line of the "A" moisture separator reheater (MSR) drain pump, 3DSM-P1A. It is used to regulate the flow of water being returned to the condensate system, and automatically operates to control level within the moisture separator drain collection tank. This tank is the suction source for the moisture separator drain pump. A sketch of this configuration is shown in Appendix E.

Although the licensee had been taking action against a leak in the "A" MSR drain pump discharge line, lines from both the "A" and "B" MSR drain pumps were found to have failed due to severe pipe wall thinning. The failures occurred in near identical locations, in six inch diameter outlet pipes from the level control valves, 3DSM-LCV-V6 in the "A" sub-system and 3DSM-LCV-V13 in the "B" sub-system. The thinned piping in the "A" sub-system was found to have "peeled" open about 270 degrees of pipe wall; the "B" sub-system pipe failed 360 degrees circumferentially.

The configuration of each of the two ruptured pipes was a six-inch diameter control valve located in a six-inch diameter pipe installed in a ten-inch diameter piping system (See Appendix E). The total length of six-inch pipe in the "A" loop was seven feet six inches and in the "B" loop, nine feet six inches. The flow control valves (V6 and V13) are each one foot eight inches long. The system is not safety related and the pipes were installed per ANSI B31.1, Power Piping Standards. The technical requirements in the Valve's Design Specifications (U-12179-465C) specifies that all air operated control valves shall generally be no more than two nominal sizes smaller than the line in which installed. The As-built pipe specifications indicates that the installed control valves are of ASTM A-216, WCB carbon steel cast material. The valves' data sheets show that they are Masoneilan valves of A-216, WCB carbon steel material with a flow coefficient of 240.

The inspectors examined the failed six-inch diameter Schedule 40 pipes in loops A & B. The fractures in both pipes were circumferential breaks. The pipes appeared to fail in a similar manner at areas in which the wall had been significantly reduced. The failed ends in both loops were located 1/4" - 1/2" downstream of the pipe to valve weld. The failure in the "A" line was about 270 degrees around, while the "B" line was a complete 360 degree break. The pipe was specified A106 Grade B, carbon steel pipe. Although localized minor pitting was observed on the inside diameter surface of the valve outlet, no pitting was found in the area adjacent to the fractured ends of the pipe. After removing a 29" long section of the failed six-inch diameter pipe from each location, several metallurgical samples were removed from one of the pipes (downstream of valve 3DSM-LCV-20B1N) which included the fracture and the opposite end of the pipe. Microscopic examination indicated the following:

- The wall thickness at the failed end was .041" compared to the opposite end which measured .175"; ASTM A106 requires .280" nominal.
- The failure appeared to be ductile in nature as evidenced by the slight "necking down" at the fractured end.
- The microstructure consisting of ferrite and pearlite was typical of as-rolled, carbon steel. Severe strain lines associated with the necked down were observed at the fracture edge.
- No evidence of decarburization or other anomalies was observed at or away from the fracture.

Failure of the pipes in MSR loops A & B was attributed to a loss of wall thickness caused by erosion. The pipes which were found to be typical of ASTM A106 Grade B carbon steel pipe, exhibited no deficiencies or anomalies.
