UNITED STATES
 NUCLEAR REGULATORY COMMISSION
 REGION II
 101 MARIETTA STREET, N.W.
 ATLANTA, GEORGIA 30323

Report Nos.: 50-325/90-51 and 50-324/90-51

Facility Name: Brunswick 1 and 2

Inspection Conducted: December 3 to 7, 1990

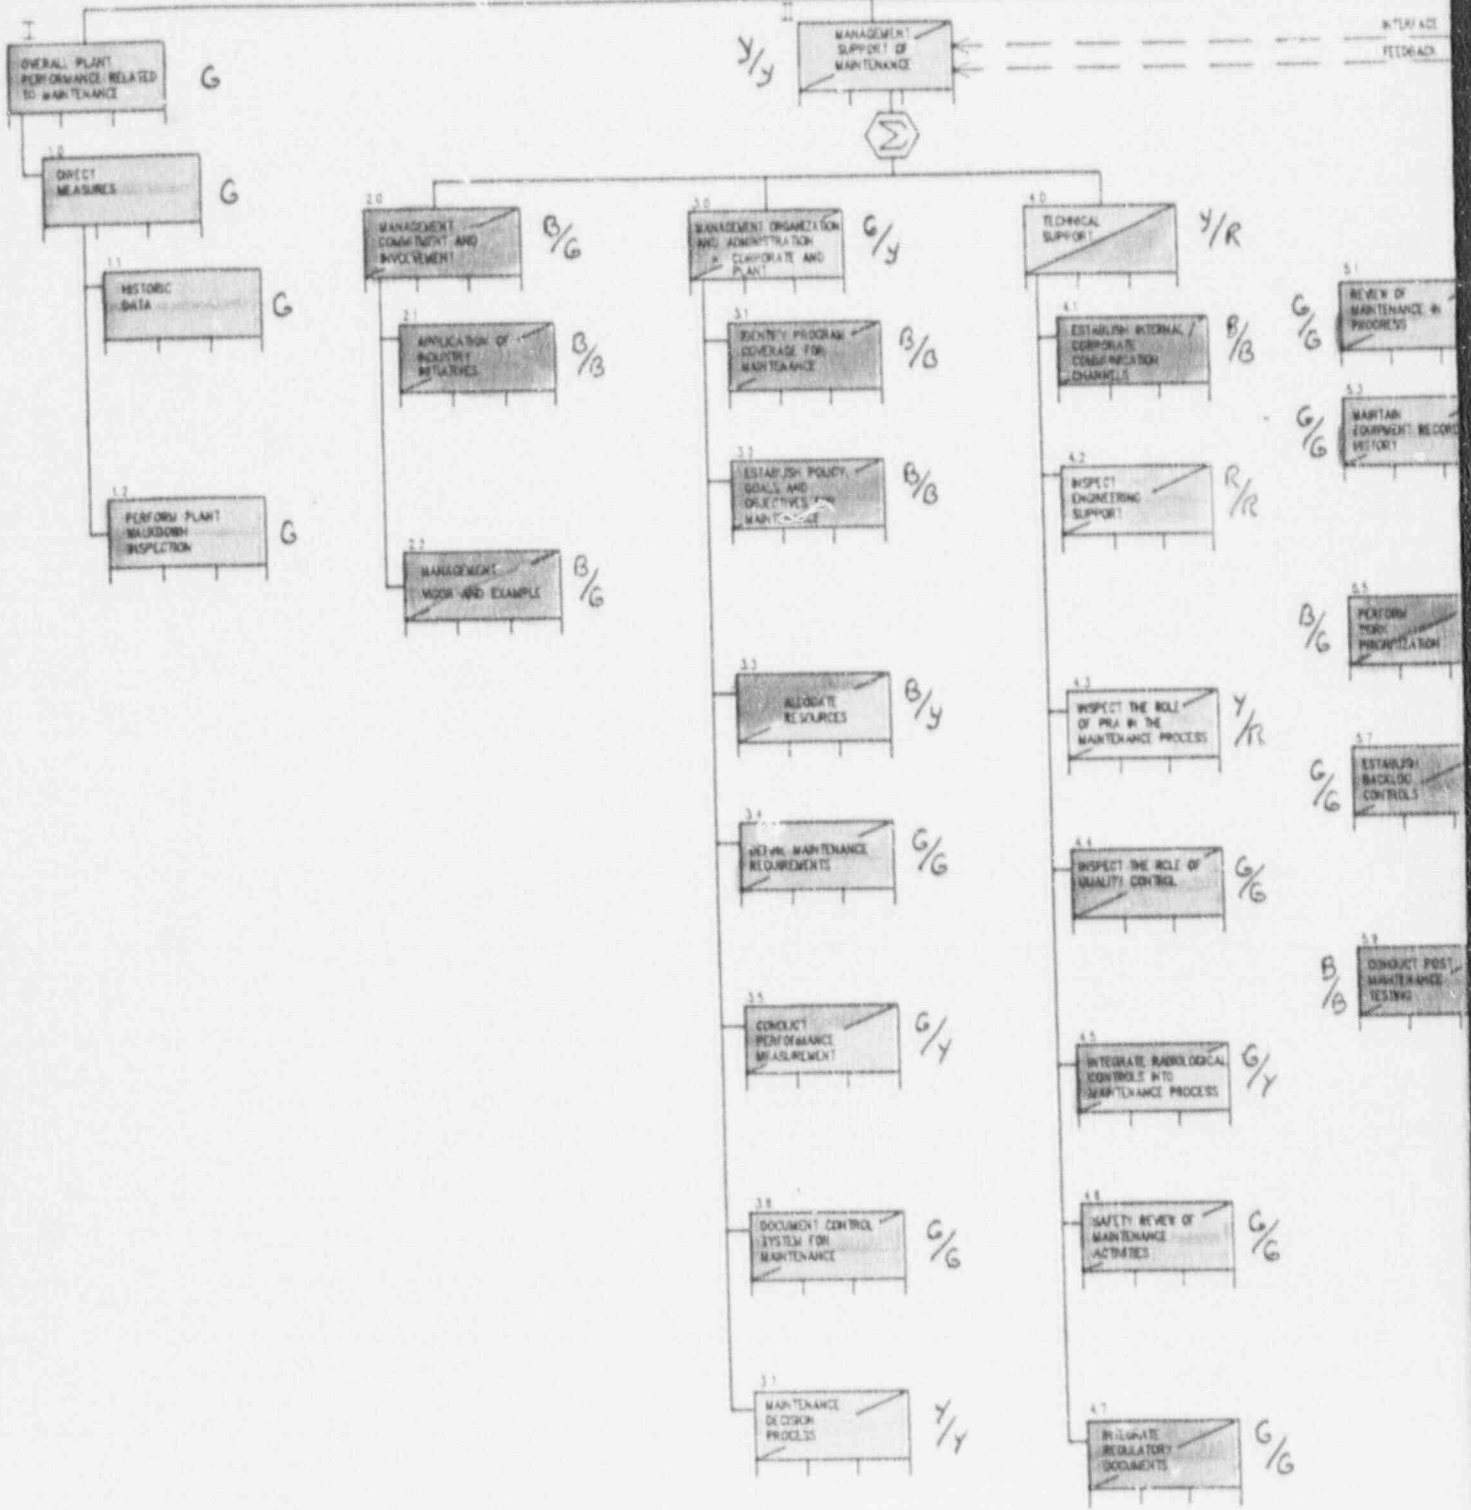
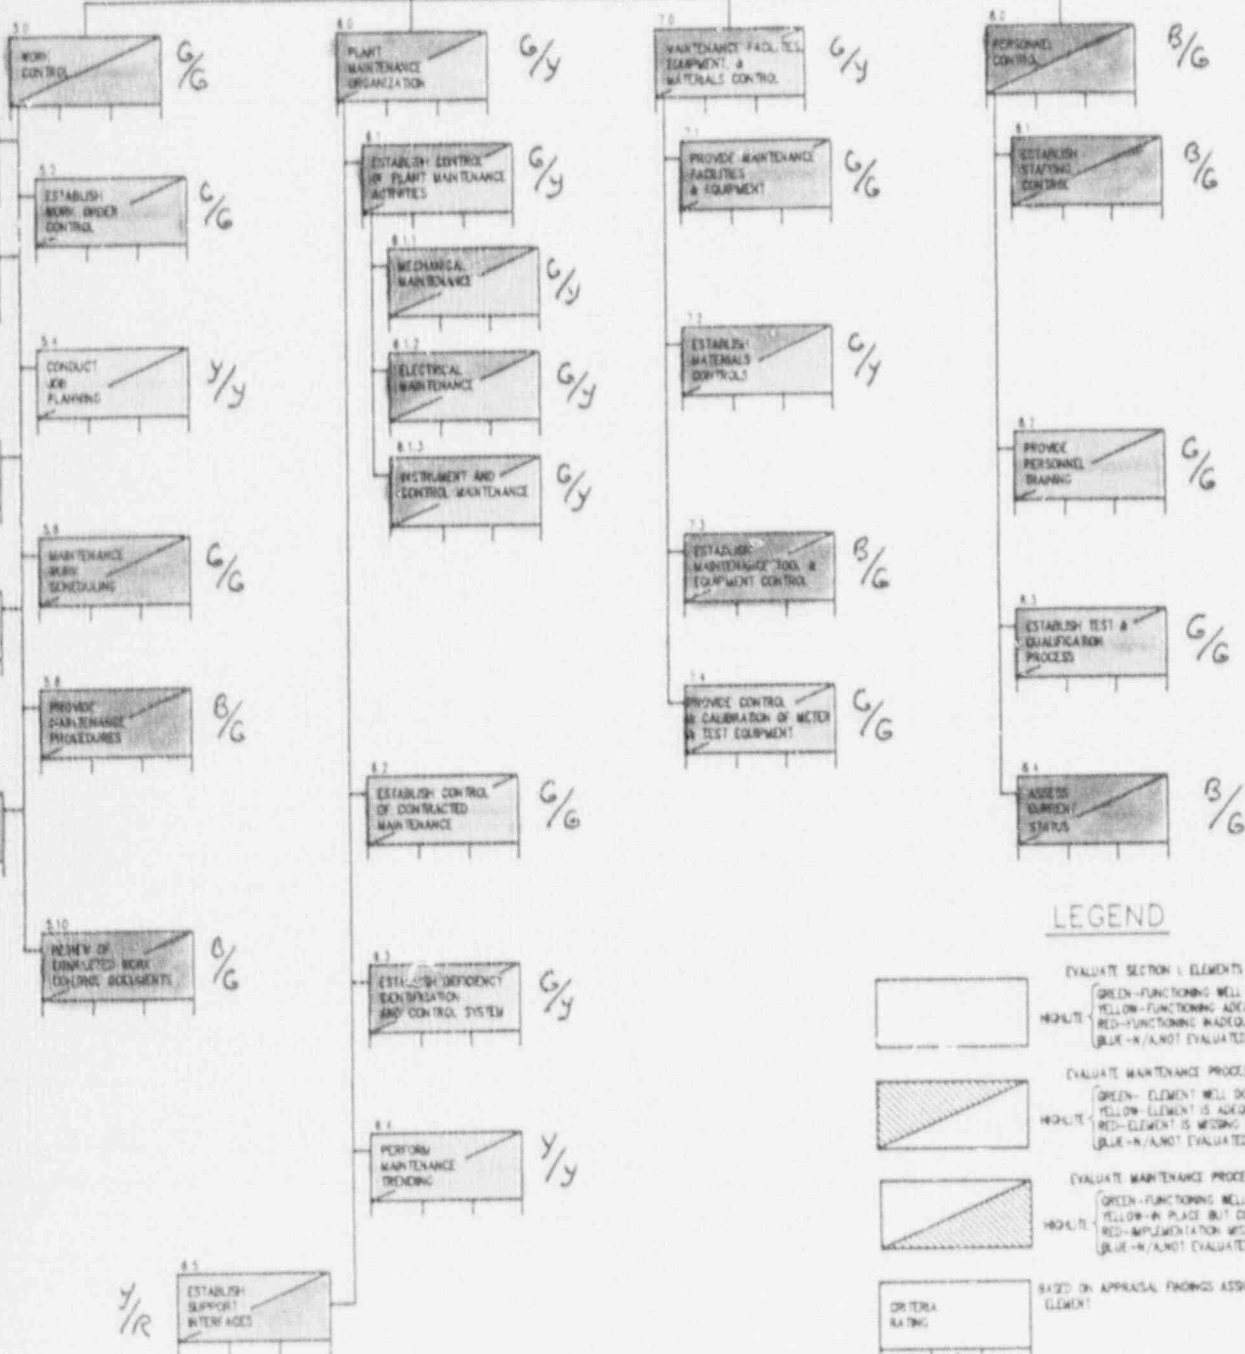
BRUNSWICK
50-325,324 / 90-51
FIGURE 1
ORIGINAL MTI TREE

The inspectors concentrated the assessment in the following areas: 1) Material Condition of the Plant; 2) Maintenance Areas that were evaluated as poor, or missing during the original inspection; and 3) Areas that were not evaluated during the original inspection. The Maintenance Inspection Tree generated during the original inspection is included as Figure 1 to this report.

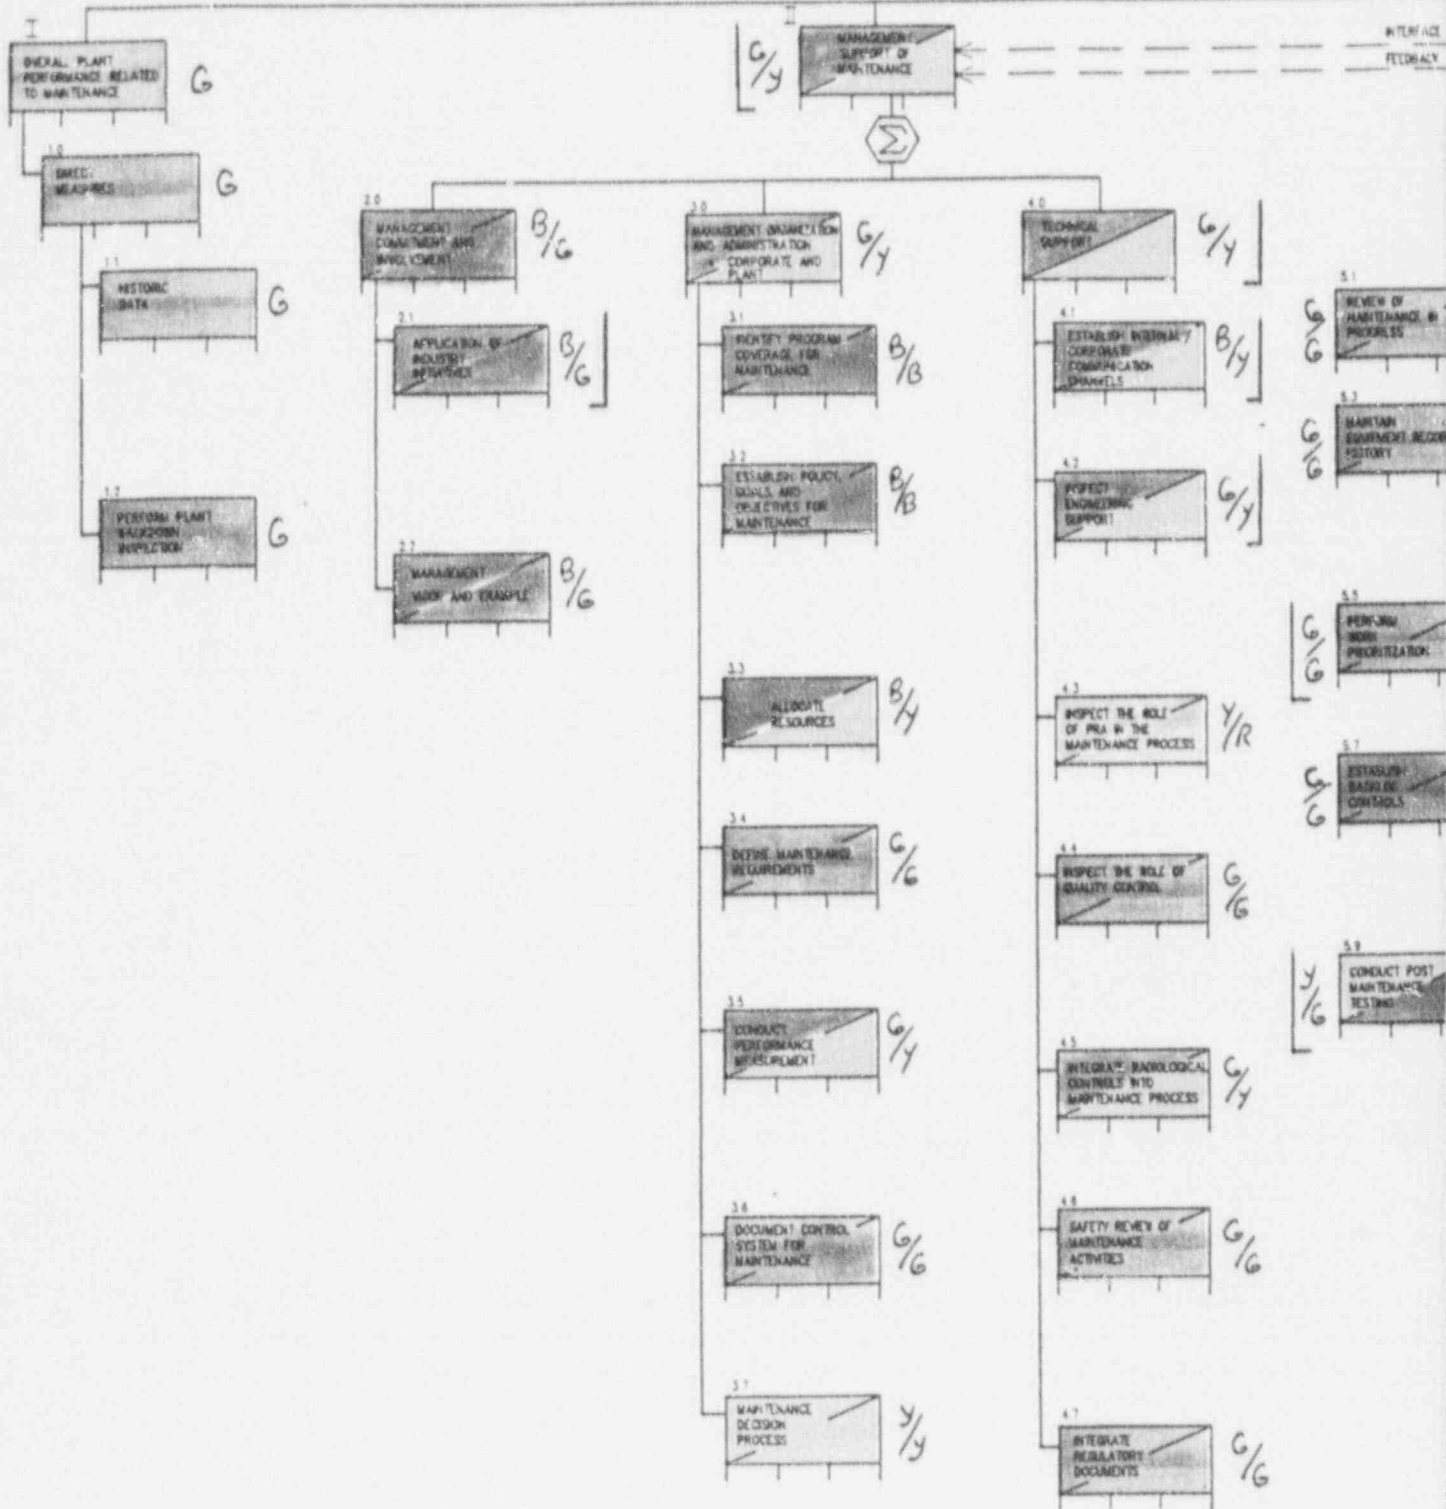
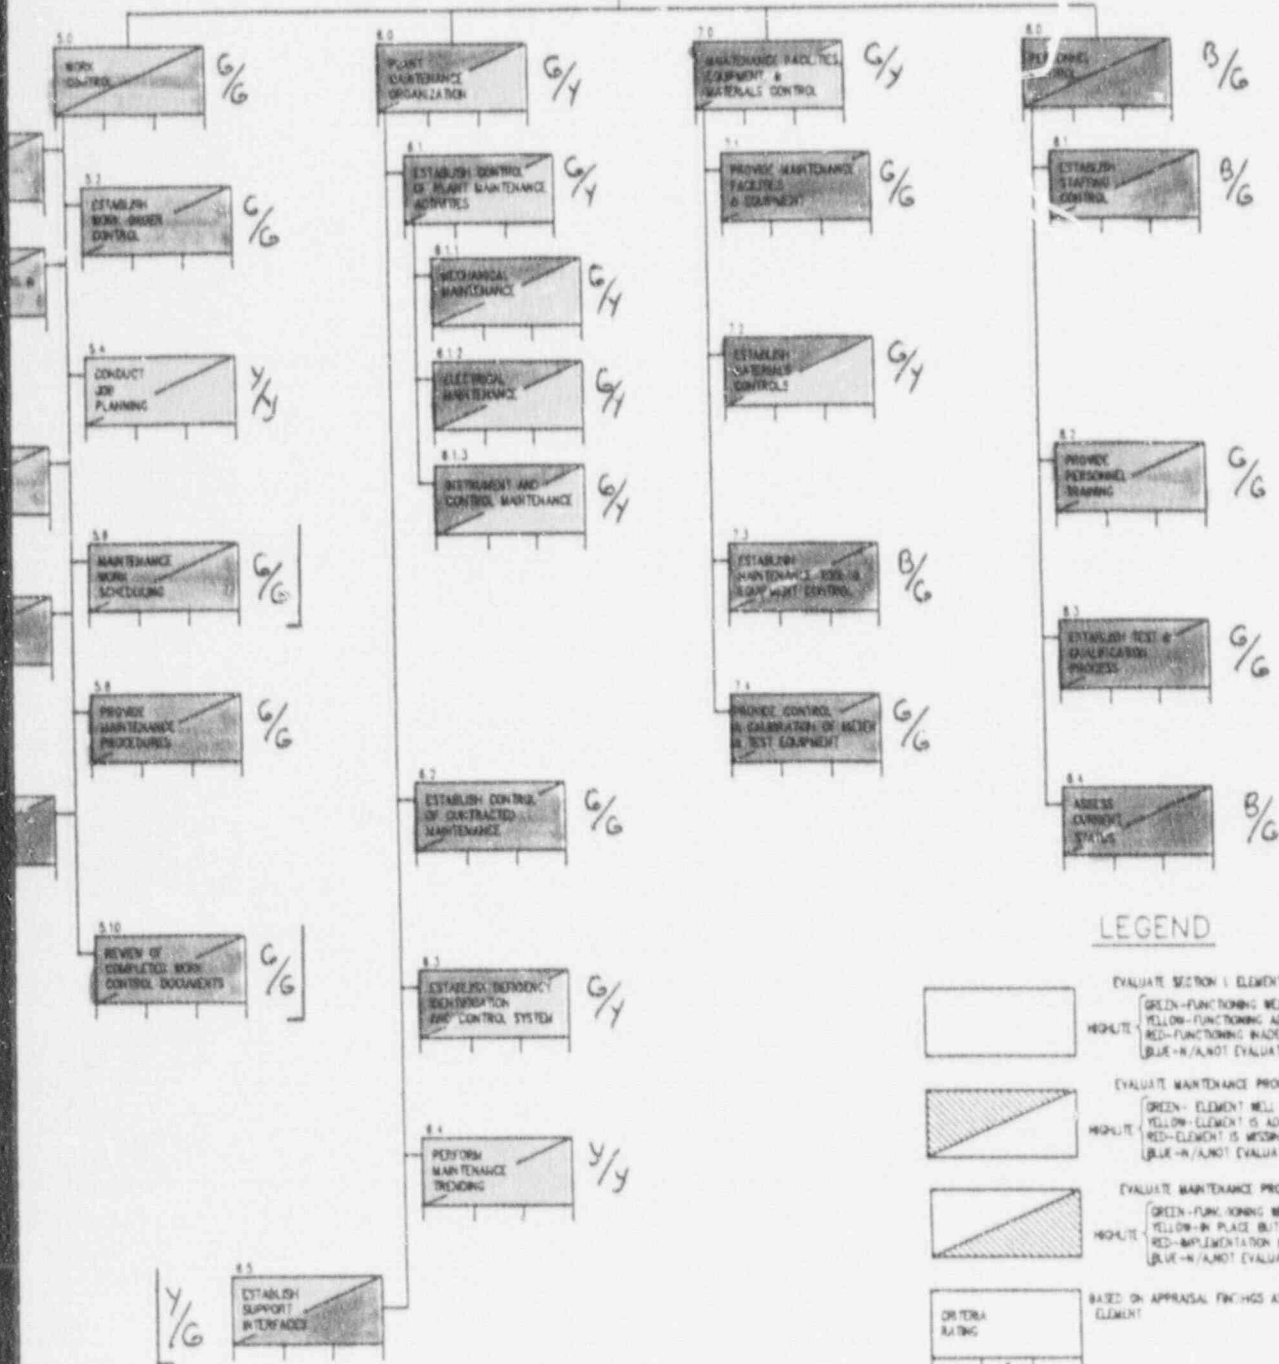
FIGURE 2
REASSESSMENT MTI TREE

A Maintenance Inspection Tree generated during this reassessment is included as Figure 2 to this report.
