LABORATORIES SCIENTIFIC SERVICES & SYSTEMS GROUP

ANALYSIS OF CABLES AND CONNECTORS FOLLOWING
ACCIDENT TEST CONCLUDED ON MARCH 31, 1982
AND
EXTENDED ACCIDENT TEST CONDUCTED
FROM MAY 10 THROUGH 18, 1982
ON
ELECTRICAL PENETRATION ASSEMBLY, TYPE B-M
FOR
DUKE POWER COMPANY

VOLUME II

Test ReportREPORT NO. 45869-1WYLE JOB NO. 45869CUSTOMER P. O. NO. 8828.05-3PMPAGE i OF 89 PAGE REPORTDATE September 10, 1982SPECIFICATION(S) See References,Paragraph 5.0.1.0 CUSTOMER Duke Power CompanyADDRESS 422 Church Street, Charlotte, NC 282422.0 TEST SPECIMEN Electrical Penetration Assembly, Type B-M, Twelve Electrical
Plug Kits3.0 MANUFACTURER D. G. O'Brien

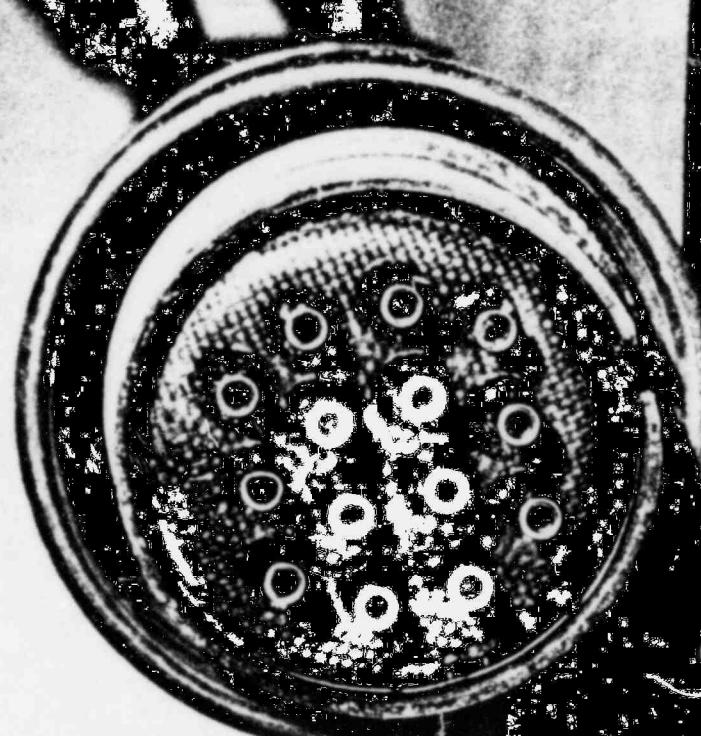
PHOTOGRAPH II-3.1
K PLUG AFTER FIRST ACCIDENT TEST

3.2.1 The thickness of the grommet was measured and found to be 0.230 inch versus a new grommet thickness of 0.250 inch, and the grommet displayed some surface indentations indicating it had expanded some during the Accident Testing.

The examination of the K module plug did not show problems with extrusion of the grommet material or problems with stripping of the conductor insulation. The attached photograph shows each half of the accident tested K plug on the left and right. A section of a K plug that had been thermally aged but not subjected to accident testing was placed in the photograph between the accident tested K plug sections for comparison purposes. See Appendix II-3 for photographs of the K plug.

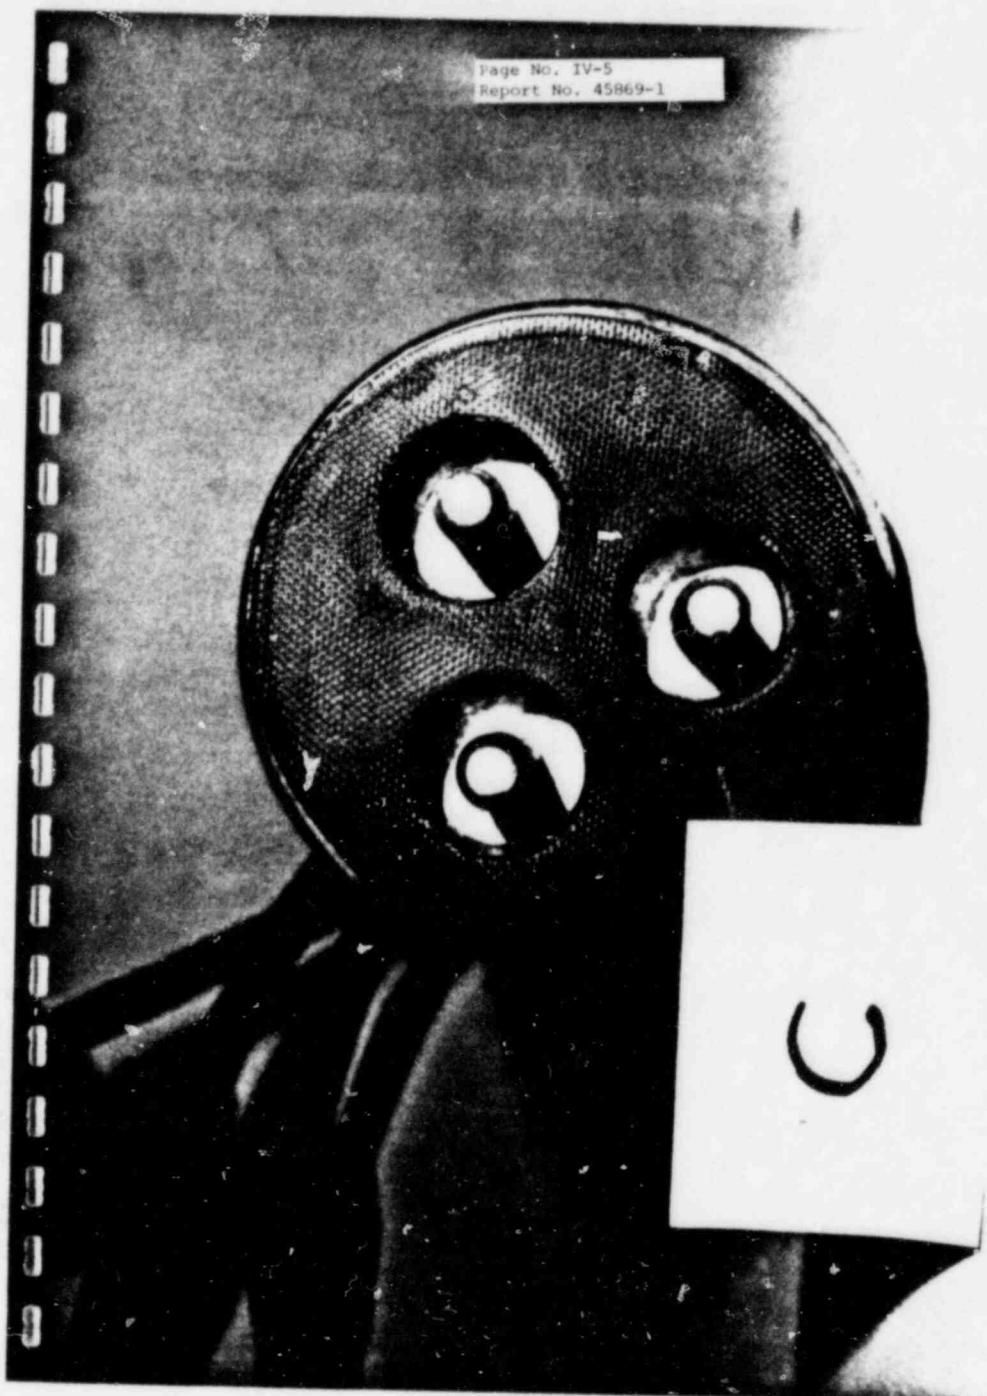
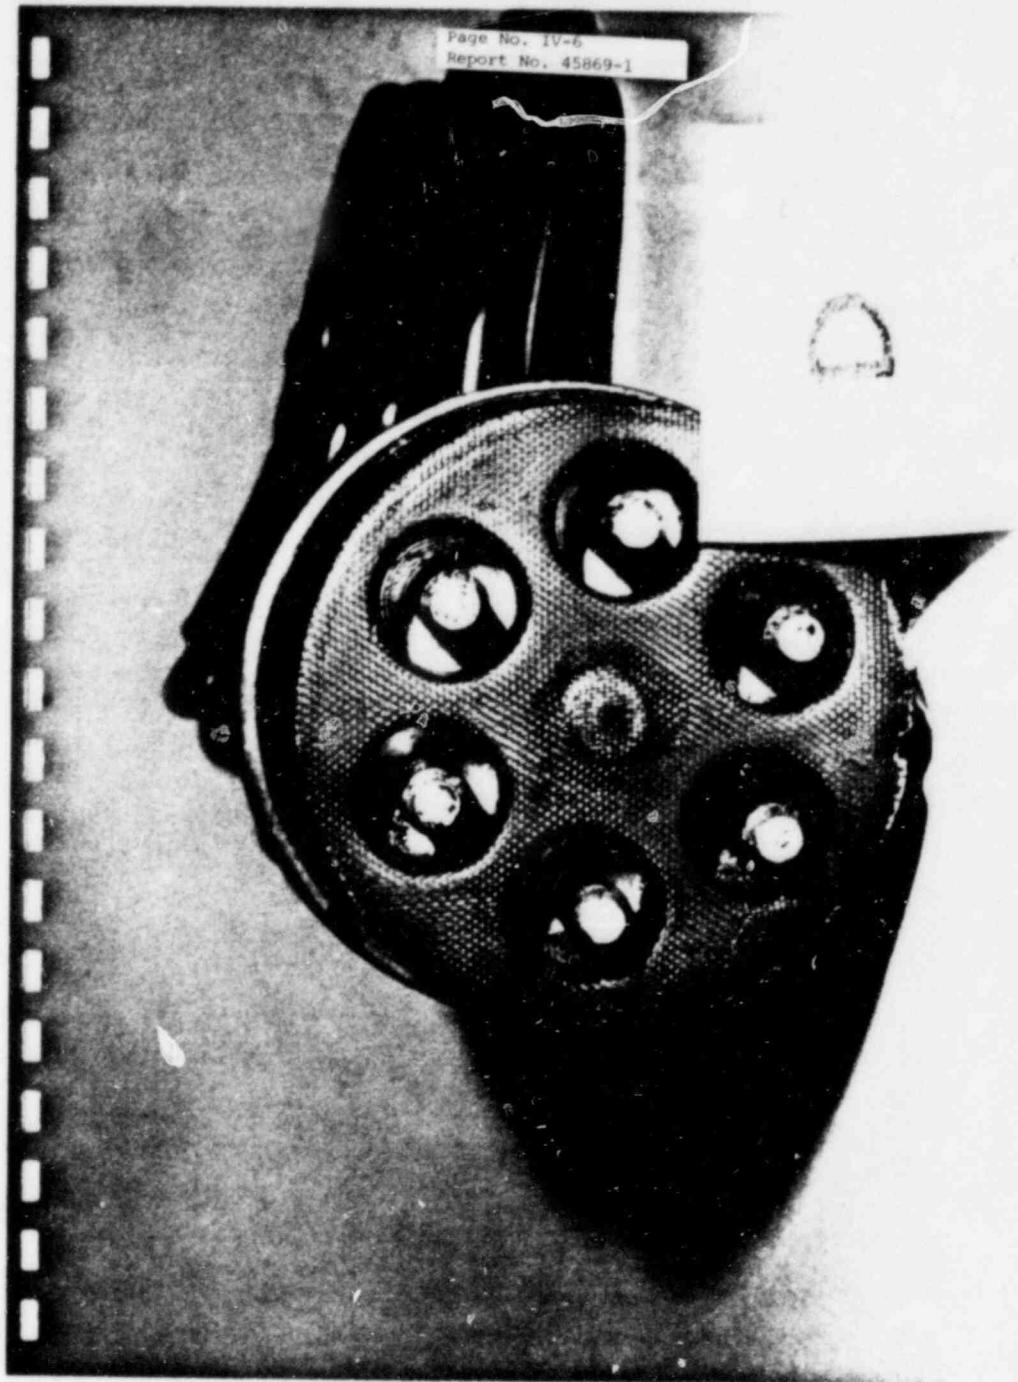
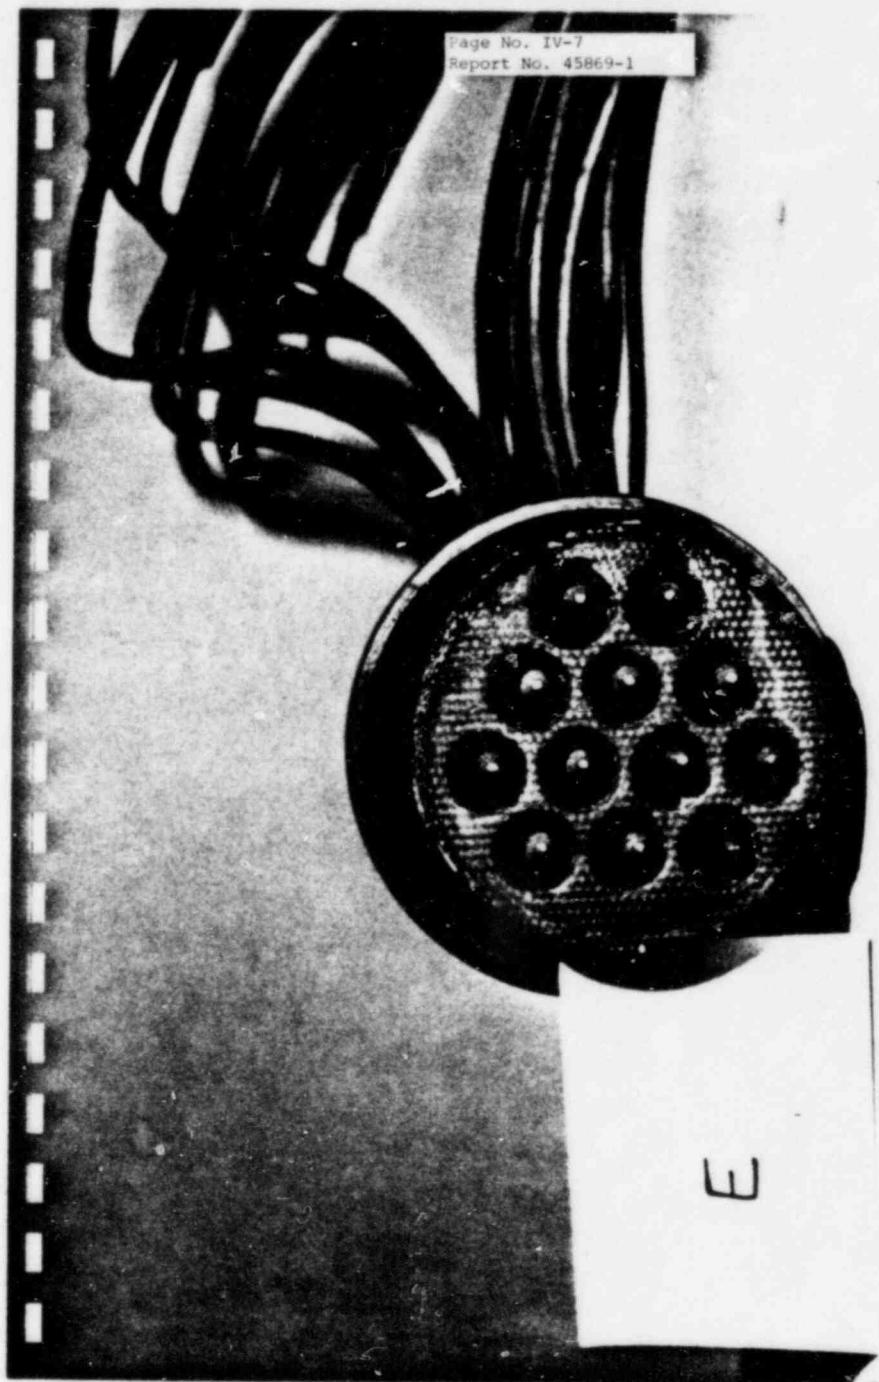
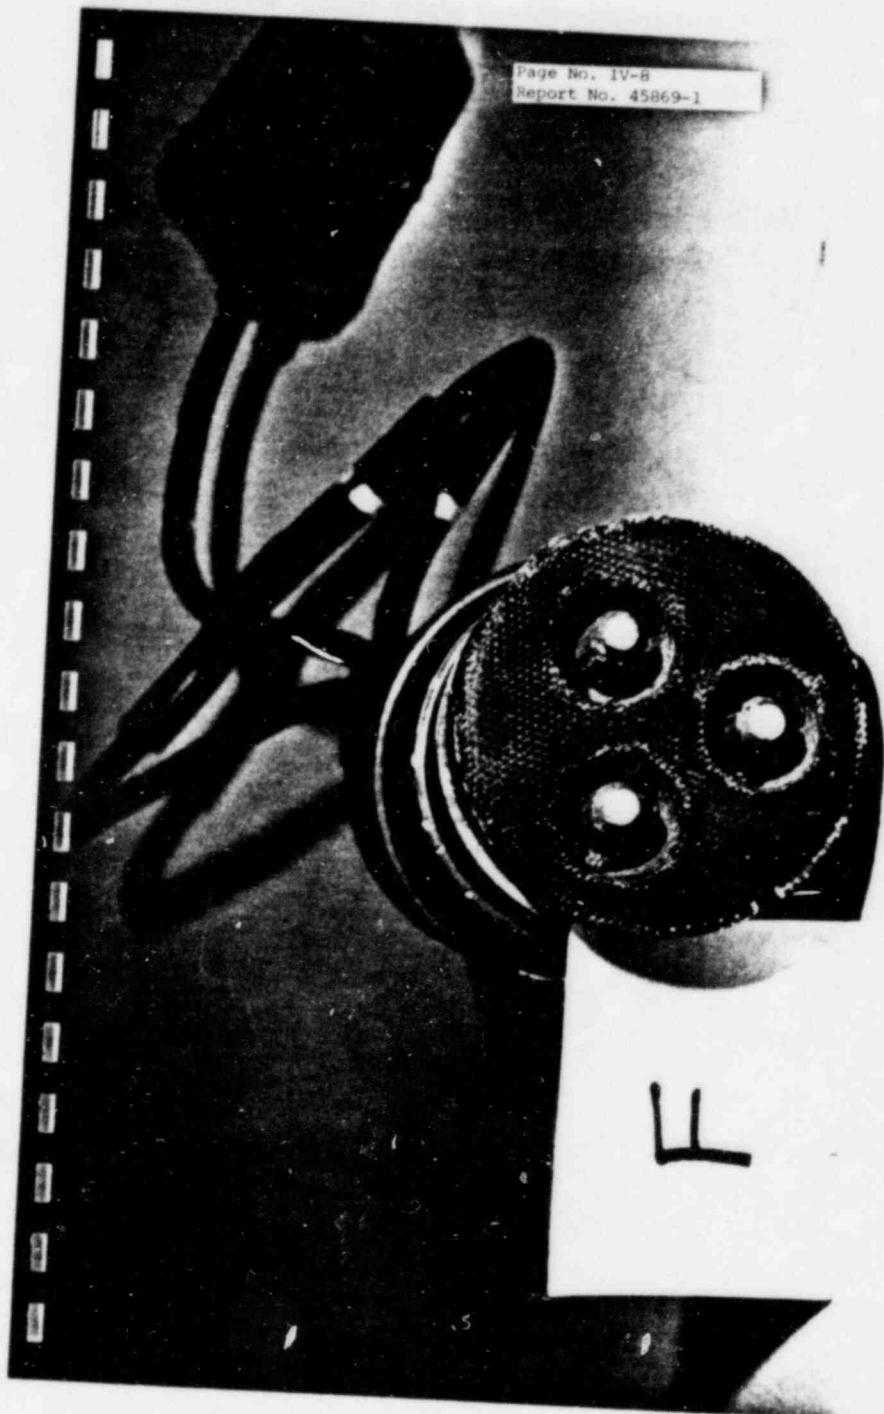
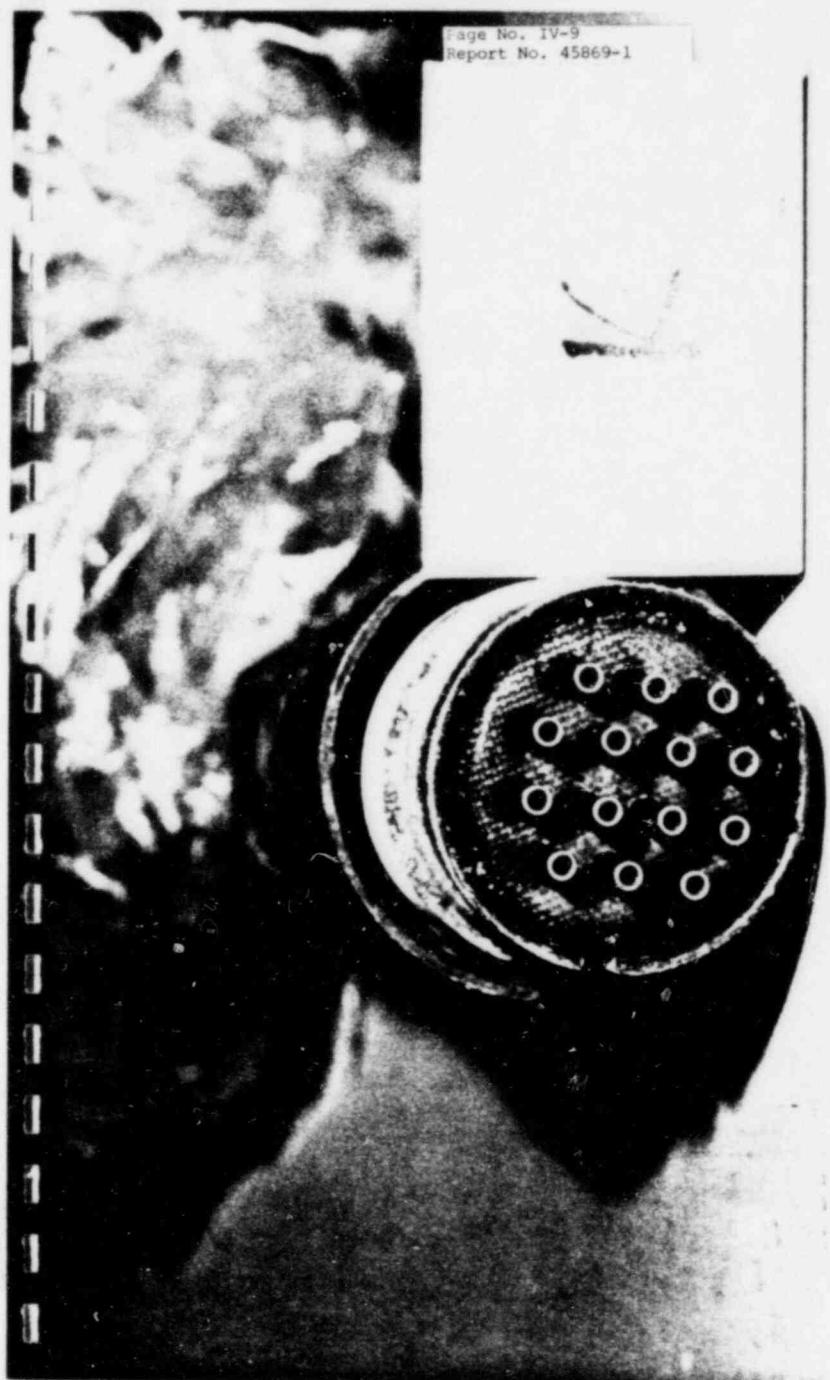
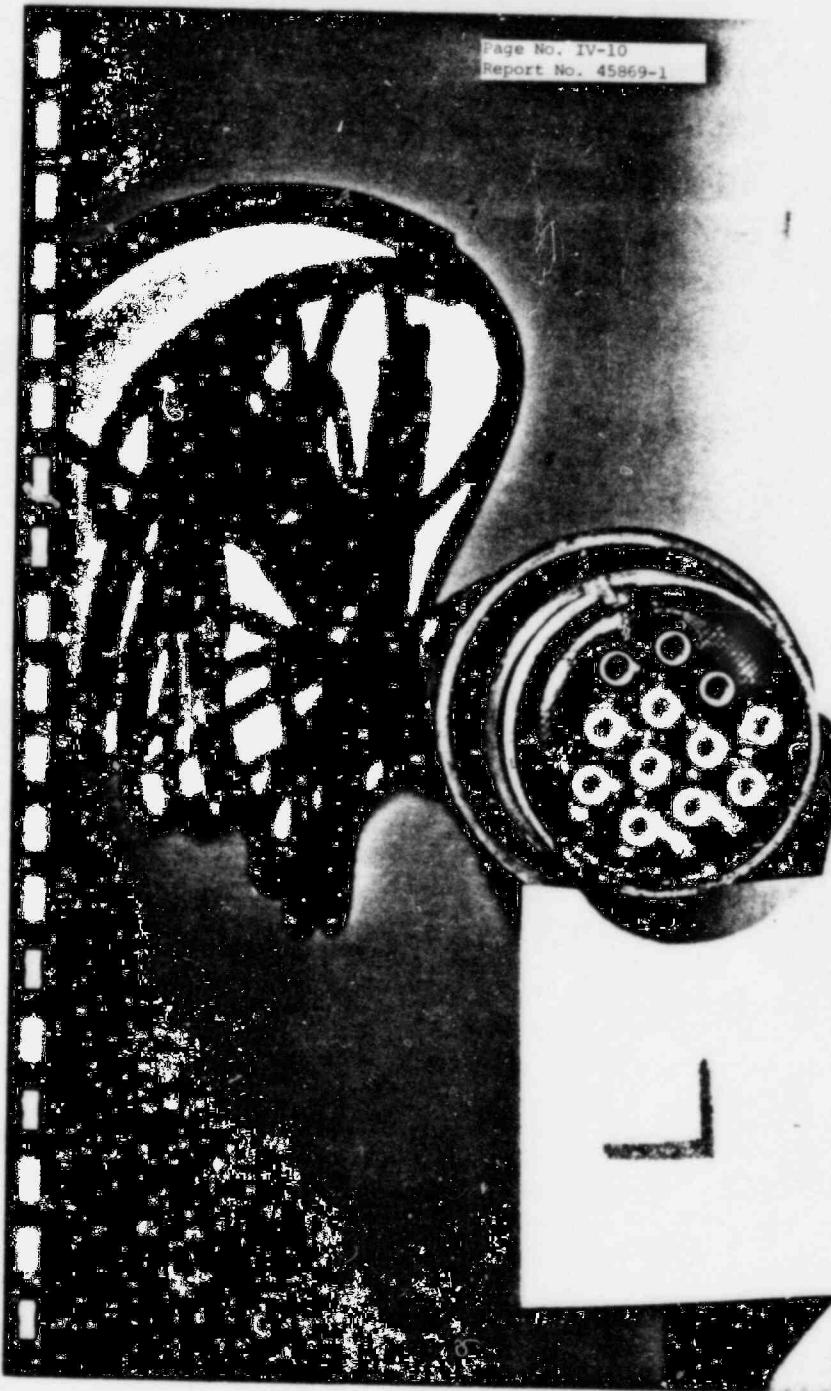
All modules were found to be in excellent condition with the exception of the E plug module. Examination of the E plug revealed a blackened area on the insulator near Pins 9 and 12 (see Photograph in Appendix IV-1). There was also a severe cut in the insulation of Conductor No. 12 under the backshell clamp. This cut could have allowed moisture to enter the connector and caused the erratic behavior of Module E. See Appendix IV-1 for photographs of all the connectors.
