Portland General Electric Company
Trojan Nuclear Plant
71760 Columbia River Hwy
Rainier, Oregon 97048
(503) 556-3713

WRR-035-91
January 31, 1991

Trojan Technical Specification (TTS) 3.7.8.2, "Spray, Sprinkler, and/or Deluge Systems", requires, in part, the submittal of a special report if the Cable Spreading Room Deluge System(s) is inoperable for more than 14 days. Deluge System 21 was removed from service on December 18, 1990 after an unplanned actuation. The other two Deluge Systems (20 and 22) for the Cable Spreading Room were also removed from service on December 18, 1990 while investigating and correcting the cause of the unplanned actuation of Deluge System 21. These three systems have been out of service since that date.

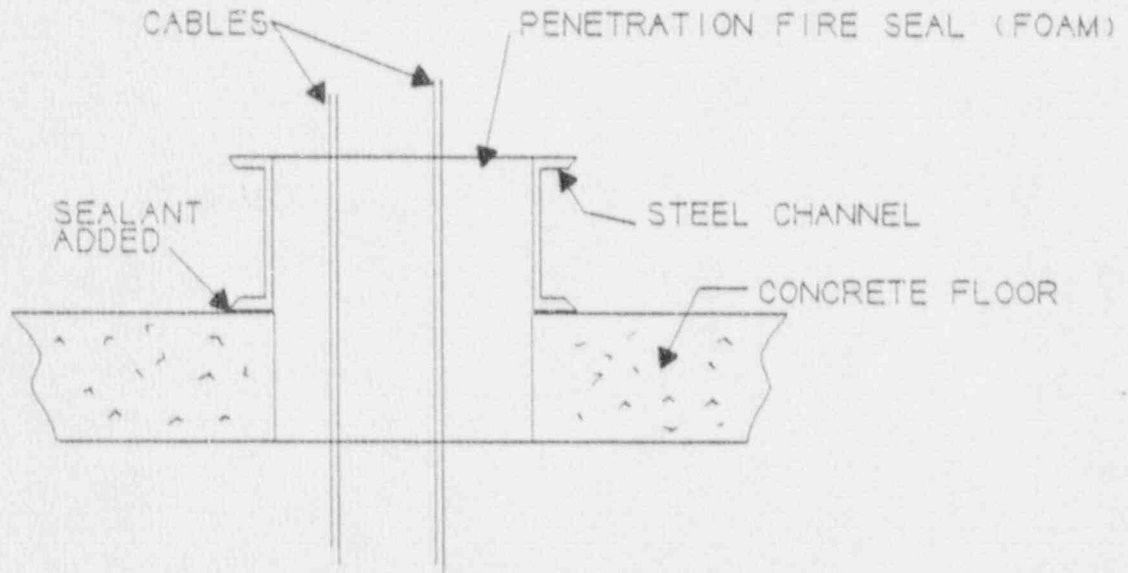
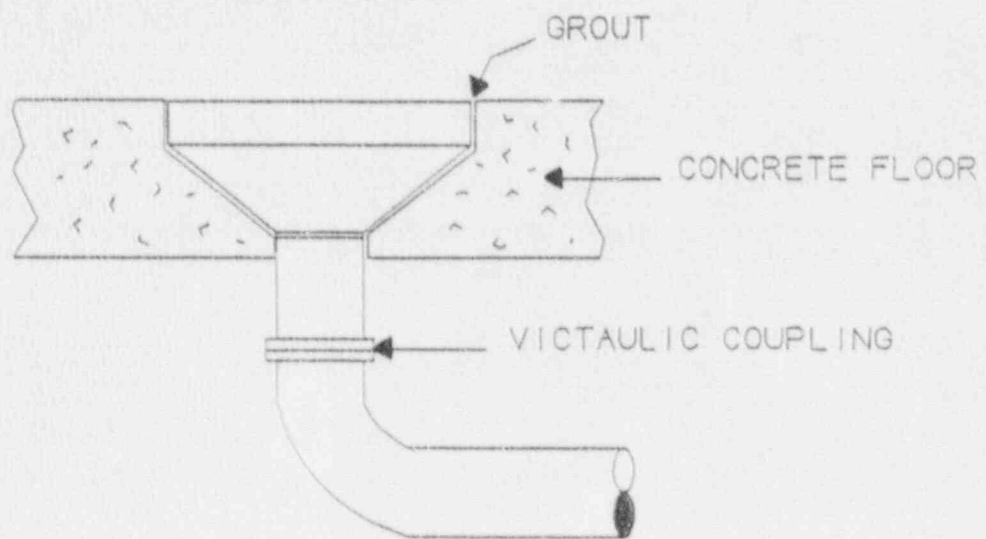
FIGURE 1

The unplanned actuation of Deluge System 21 was apparently due to a drop light being placed too close to the "Protectowire" actuation circuit for Deluge System 21. A "Protectowire" actuation circuit consists of two wires, individually insulated, twisted together within an outer jacket. The actuation logic is one-out-of-two circuits. A fire (heat) destroys the insulation on each wire, allowing the wires to contact each other. This shorting of the wires causes actuation of the deluge system. Investigation of this event identified that the "Protectowire" individual wire insulation had melted, and the only known source of heat was a drop light. The drop light was used while working on a penetration fire seal to restore it to service.

Personnel responding to the unplanned actuation of Deluge System 21 reported that there was standing water on the floor of the Cable Spreading Room, and that some water had leaked into the Electrical Switchgear Room located beneath it. Both cables and floor drains penetrate the floor (See Figure 1). The leakage was determined to be from leaking "Victaulic" couplings on the floor drain piping. A potential flow path beneath the steel collar around cable floor penetrations (see Figure 1) was also identified.

1. Frayed/damaged "Protectowire" identified in the Cable Spreading Room was repaired or replaced.
2. Water was poured down each floor drain in the Cable Spreading Room to identify any leaking "Victaulic" couplings. Repairs (tightening of the couplings) were made as necessary. Also, the potential flow path beneath the steel collar around cable floor penetrations was sealed (see Figure 1).
