Southern California Edison Company

February 2, 1991

Subject: Docket Nos. 50-361 and 50-362
Reply to a Notice of Violation
San Onofre Nuclear Generating Station, Units 2 and 3

Reply to a Notice of Violation

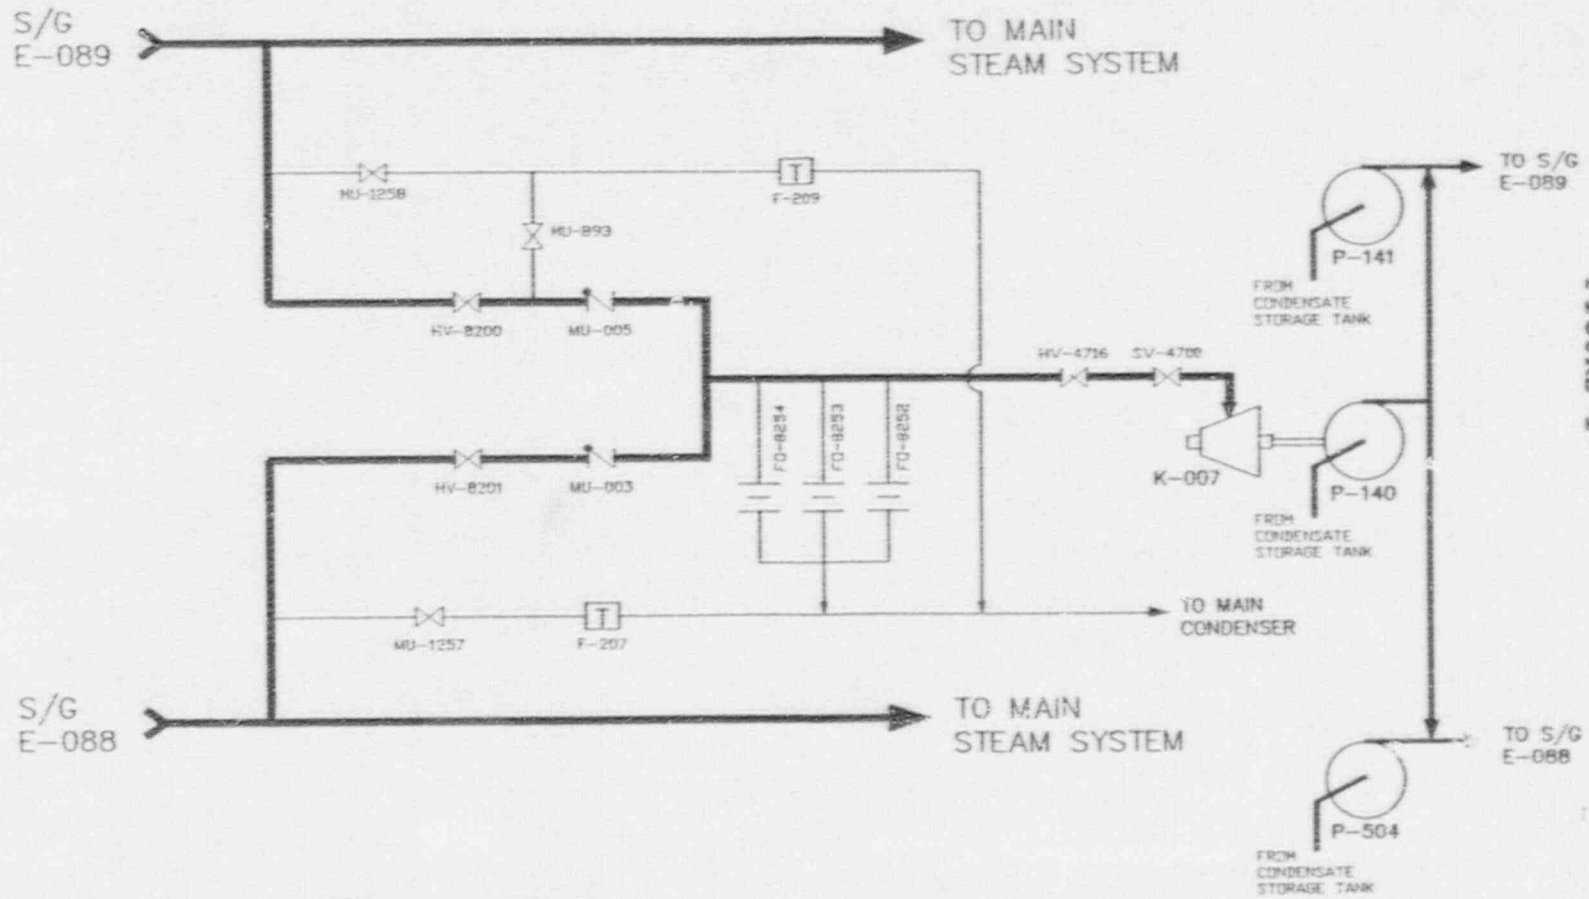
FIGURE 1

Procedural Deficiency (Refer to Figure 1)

With the unit in cold shutdown, steam trap F-207 isolation valve MU-1257 and steam trap F-209 isolation valve MU-1258 were closed in accordance with procedure SO23-2-18 in order to apply a nitrogen blanket to steam generator E-088. The procedure was deficient in that it failed to include the requirement to reopen MU-1257 and MU-1258, or to direct use of another procedure which would have reopened the valves, when returning the steam generator to service.

Accordingly, the Main Steam System was returned to service and Unit 2 entered Mode 3 with MU-1257 and MU-1258 isolated on August 31, 1990.

AFWPT STEAM SUPPLY DRAIN SYSTEM

Upon discovery of the condition on October 21, MU-1257 was promptly opened returning steam trap F-207 to service. Condensation in the piping associated with F-207 was drained.

The Steam Generator (SG) nitrogen blanketing procedure SO23-2-18 was revised to ensure that all valves are repositioned to their normal position when returning the steam generator to service.
