GULF STATES UTILITIES COMPANY

River Bend Station - Unit 1
Docket No. 50-458

Supplemental Report of a Defect Per 10CFR21
Standby Diesel Generator Rotor Winding

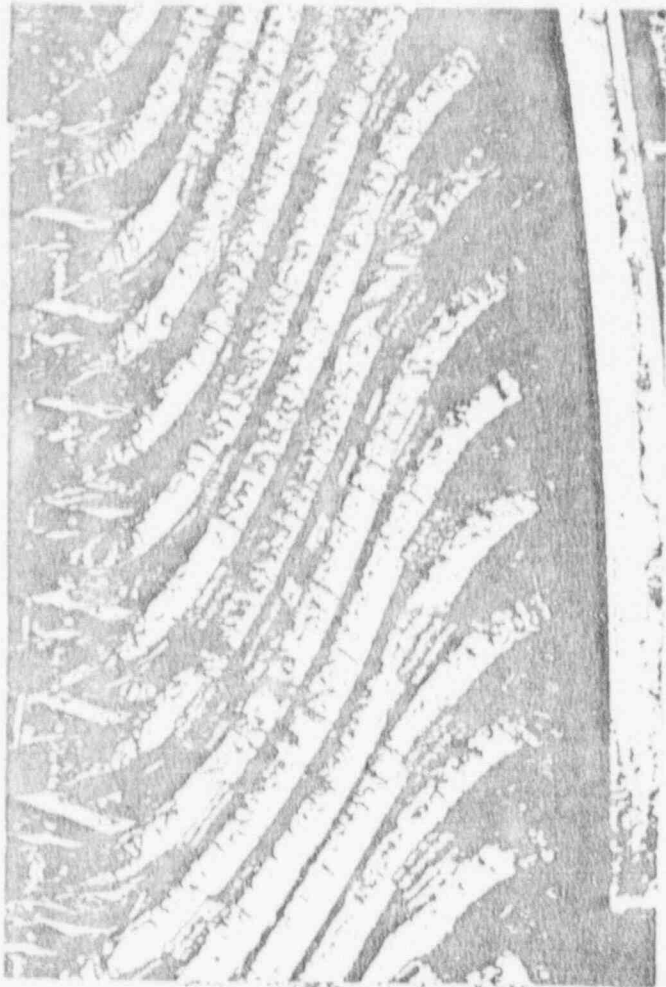
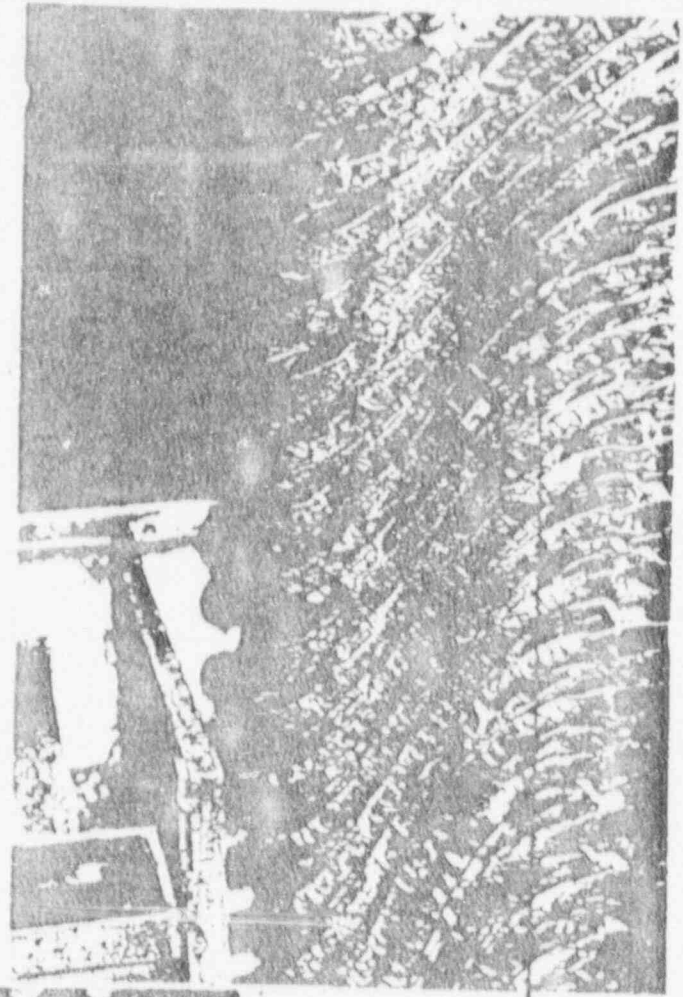
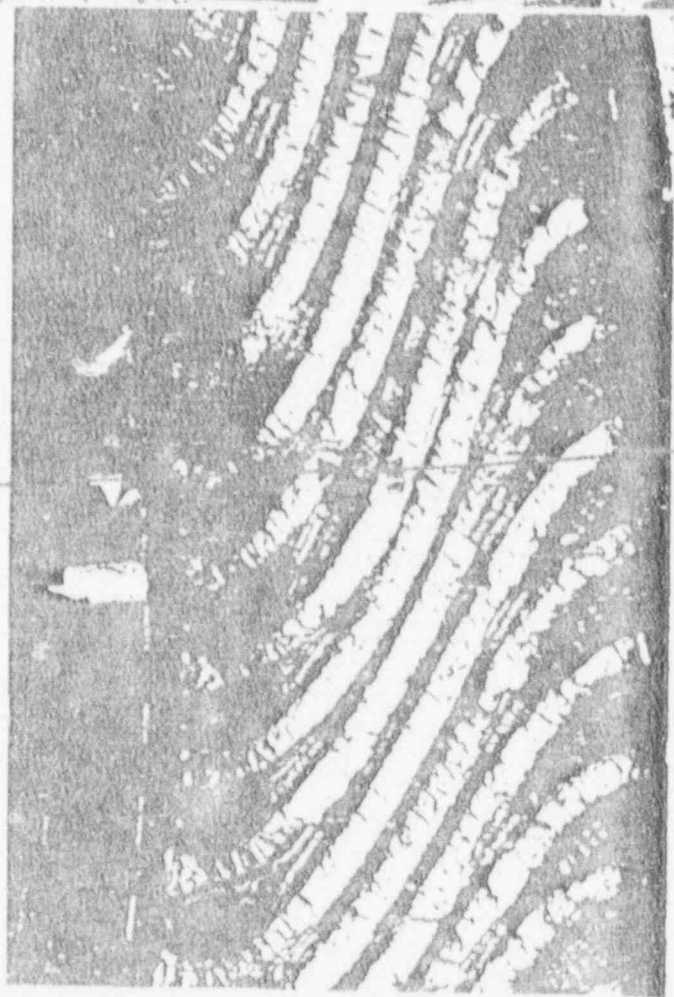
Stator winding
 movement, opened
 up here. adjacent
 coils are touching.

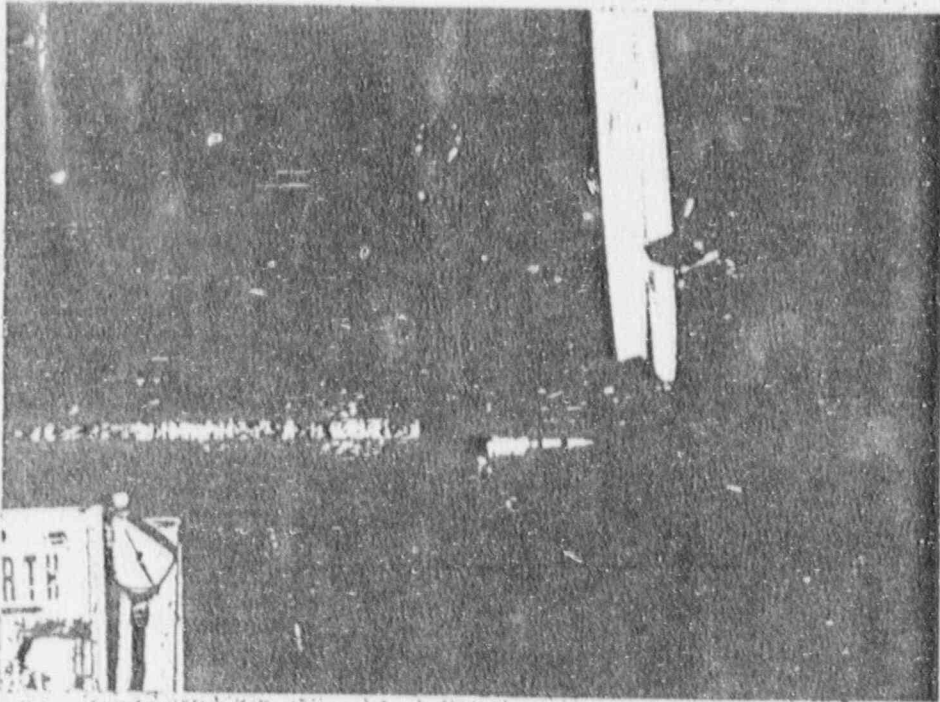
Rotor
during
removal

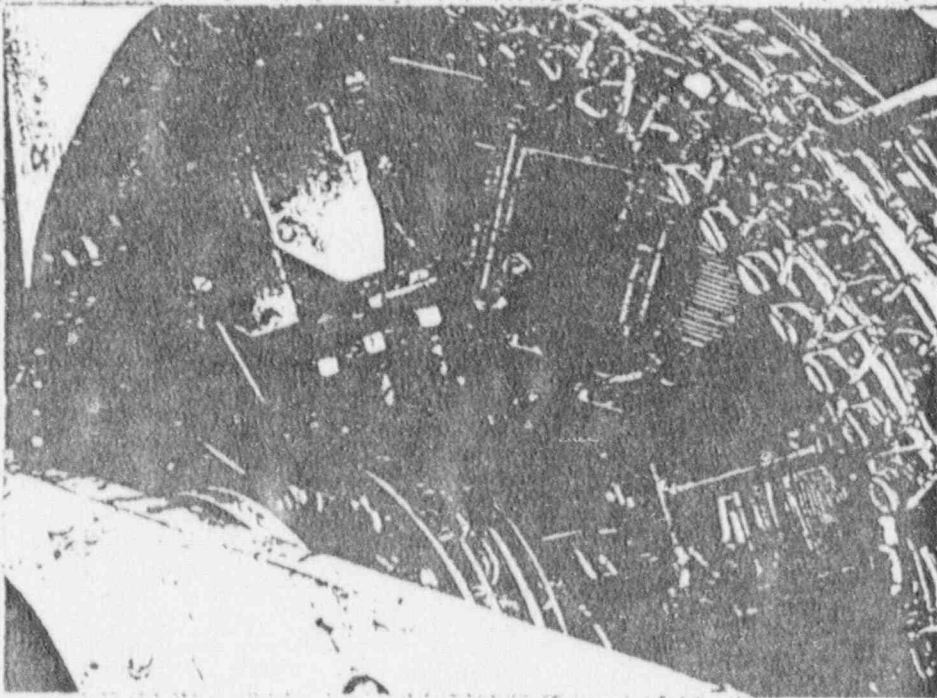
Rotor
Slip Ring
Eng.

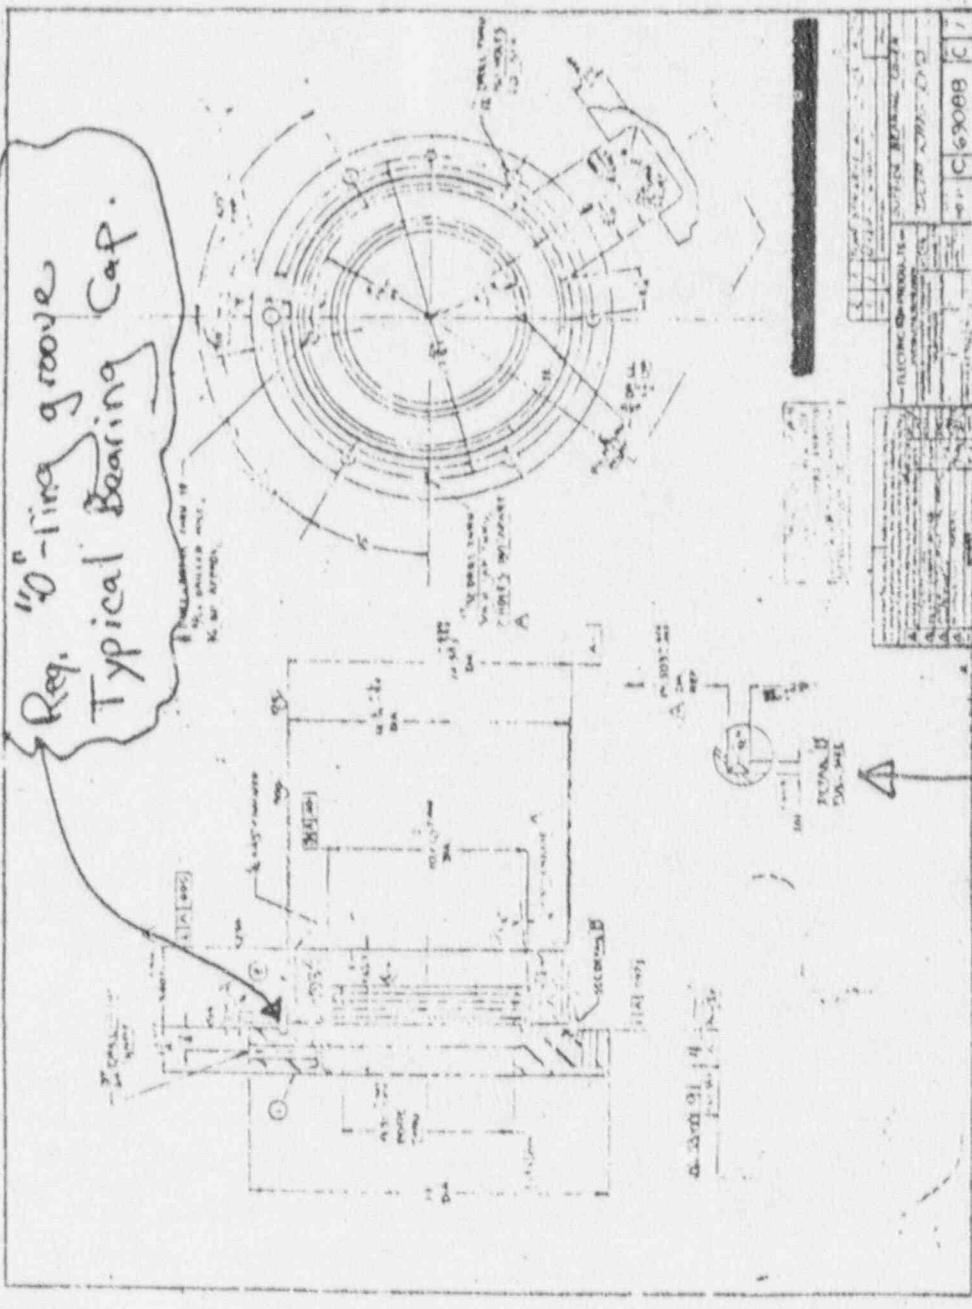
"D" ring groove detail
