Commonwealth Edison

Zion Generating Station
Shiloh Blvd. & Lake Michigan
Zion, Illinois 60099
Telephone 708 / 746-2084

LICENSEE EVENT REPORT (LER)

Title (4)
Inoperable Safety Injection Pumps Due to Low Recirculation Flow

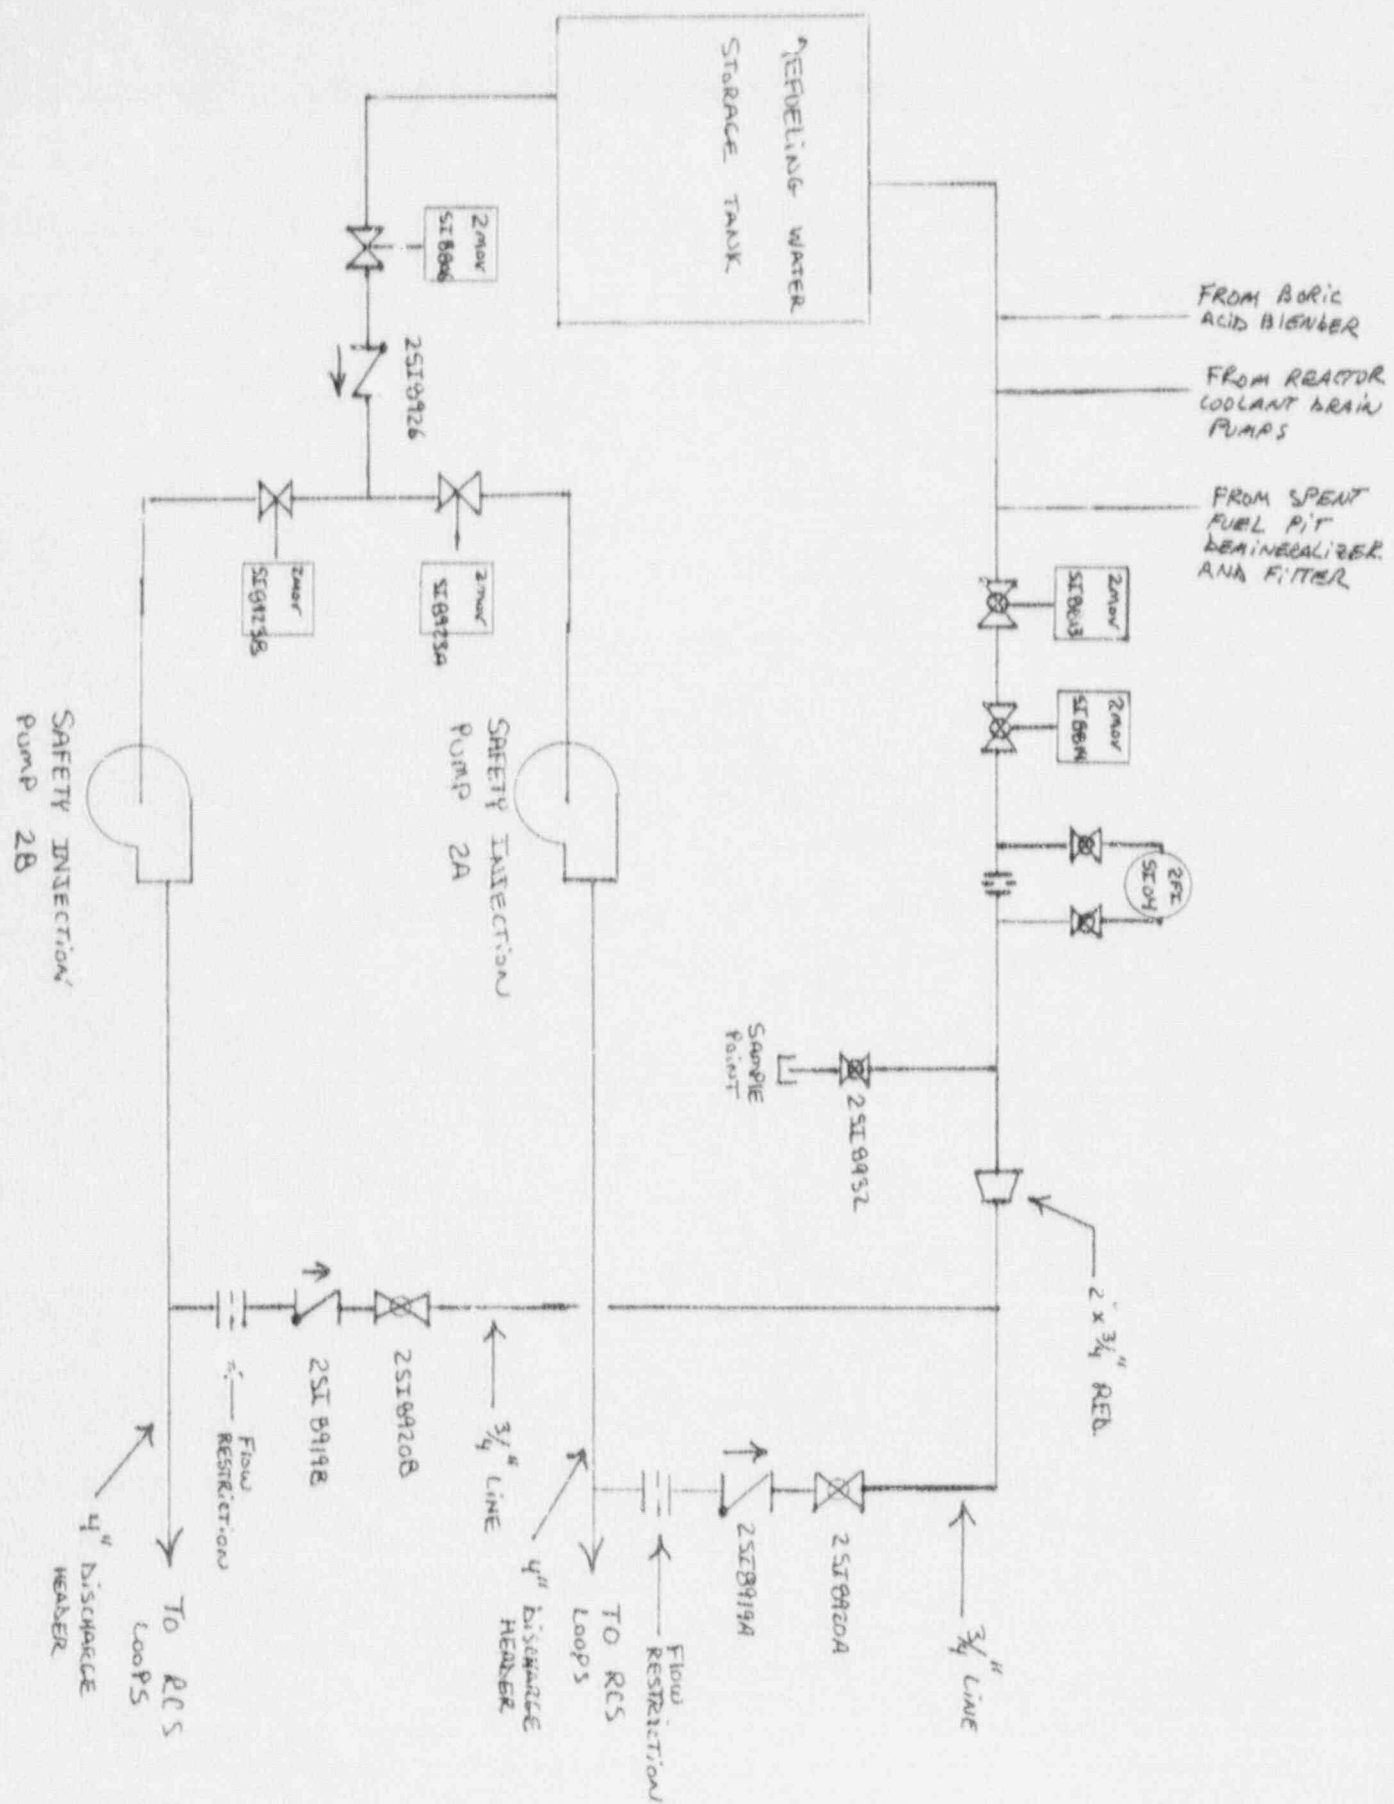
SI DIAGRAM

As a result of the investigation, the apparent cause of the low recirculation flow in the Unit 2 SI pumps was a restriction in the SI recirculation line, downstream of the flow indicator 2FI-SI04. It was concluded that the restriction was dislodged or eliminated from the recirculation line during the investigation as evidenced by the sudden decrease in pressure while the 2A SI pump was operating.
