Re: 10CFR50.73(a)(2)(iv)
January 30, 1991
MP-91-93

LICENSEE EVENT REPORT (LER)

FACILITY NAME (1) Millstone Nuclear Power Station Unit 3										DOCKET NUMBER (2) 0 5 0 0 0 4 2 3			PAGE (3) 1 OF 0 5	
---	--	--	--	--	--	--	--	--	--	--------------------------------------	--	--	----------------------	--

TITLE (4)
Manual Reactor Trip Due to Moisture Separator Reheater Piping Line Breaks

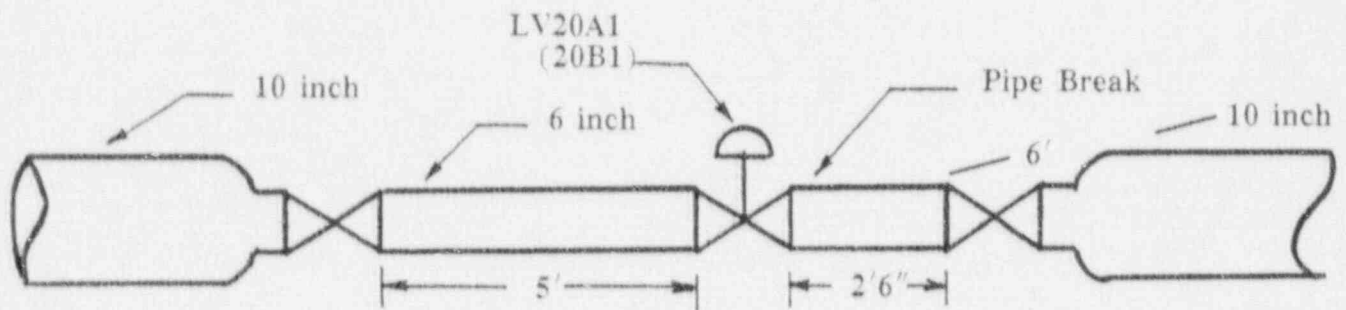
DSM Control Valve Piping Configuration

The cause of the failure of the DSM lines was severe wall thinning downstream of the control valves. The wall thickness of the carbon steel, six inch, schedule 40 pipe had decreased from a nominal thickness of 0.280 inches to 0.020 inches at the failure sites. The cause of the thinning is attributed to single phase erosion/corrosion. A number of factors contributed to the erosion/corrosion including piping design, fluid temperature, high fluid velocity, and oxygen content of the fluid. Original piping design in the early 70's had not considered the significant reductions in fluid oxygen levels that would be achieved by the time the unit was ready for operation. The minimum thickness occurred adjacent to the control valve(s), and increased by 0.011 inches per inch downstream from the valve(s).

The configuration of the failed piping was a horizontal run of 10" piping which reduced to 6" piping upstream of a 6" control valve. The 6" piping extended up to a 6" manual isolation valve, then expanded to 10" piping, before tying into the Condensate System. While it is normal to reduce the line size of piping directly upstream of a control valve, in typical piping designs, the piping is increased to the original line size immediately downstream of the associated control valve (see Figure 2). The fluid velocity in the piping downstream of the control valves has been calculated to be in the range of 17 ft/sec, which when coupled with the low oxygen levels produces a high erosion rate.
