Houston Lighting & Power

South Texas Project
Unit 1
Docket No. STN 50-498
Licensee Event Report 94-001
Regarding Small Gaps in the Reactor
Containment Building Emergency Sumps Screens

LICENSEE EVENT REPORT (LER)

TITLE (4) Small Gaps in the Reactor Containment Building Emergency Sumps Screens

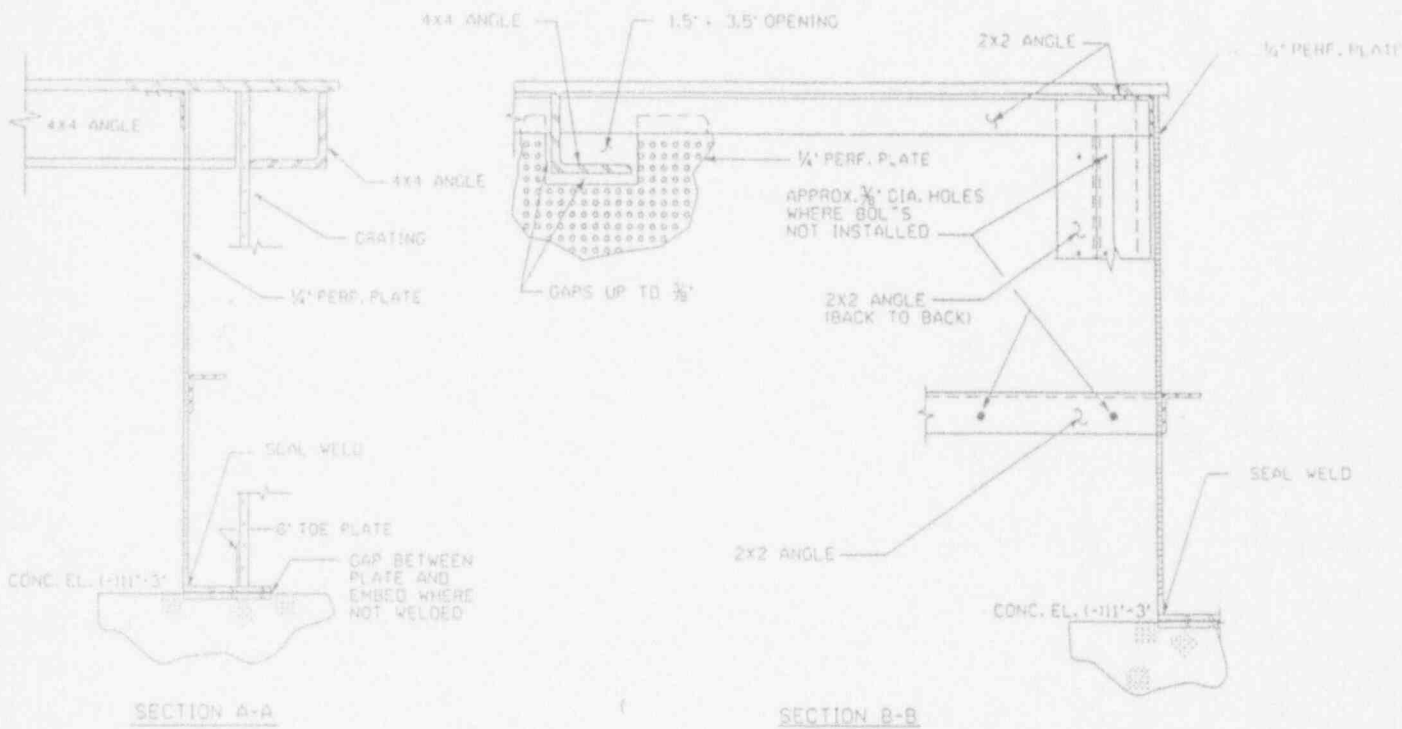
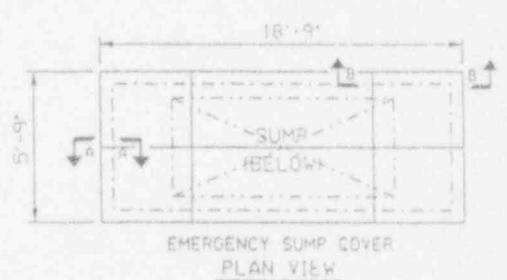
Figure 1

The six 1.5" x 3.5" holes near the top of the structure do not significantly degrade the integrity of the screen because of the arrangement of the screen design and the normal flow configuration. A 4" x 4" structural angle on the outer edge of the screen structure directs the normal flow path below the 1.5" x 3.5" openings and entrained matter is caught on the 1/4" perforated screen as intended. See Figure 1.

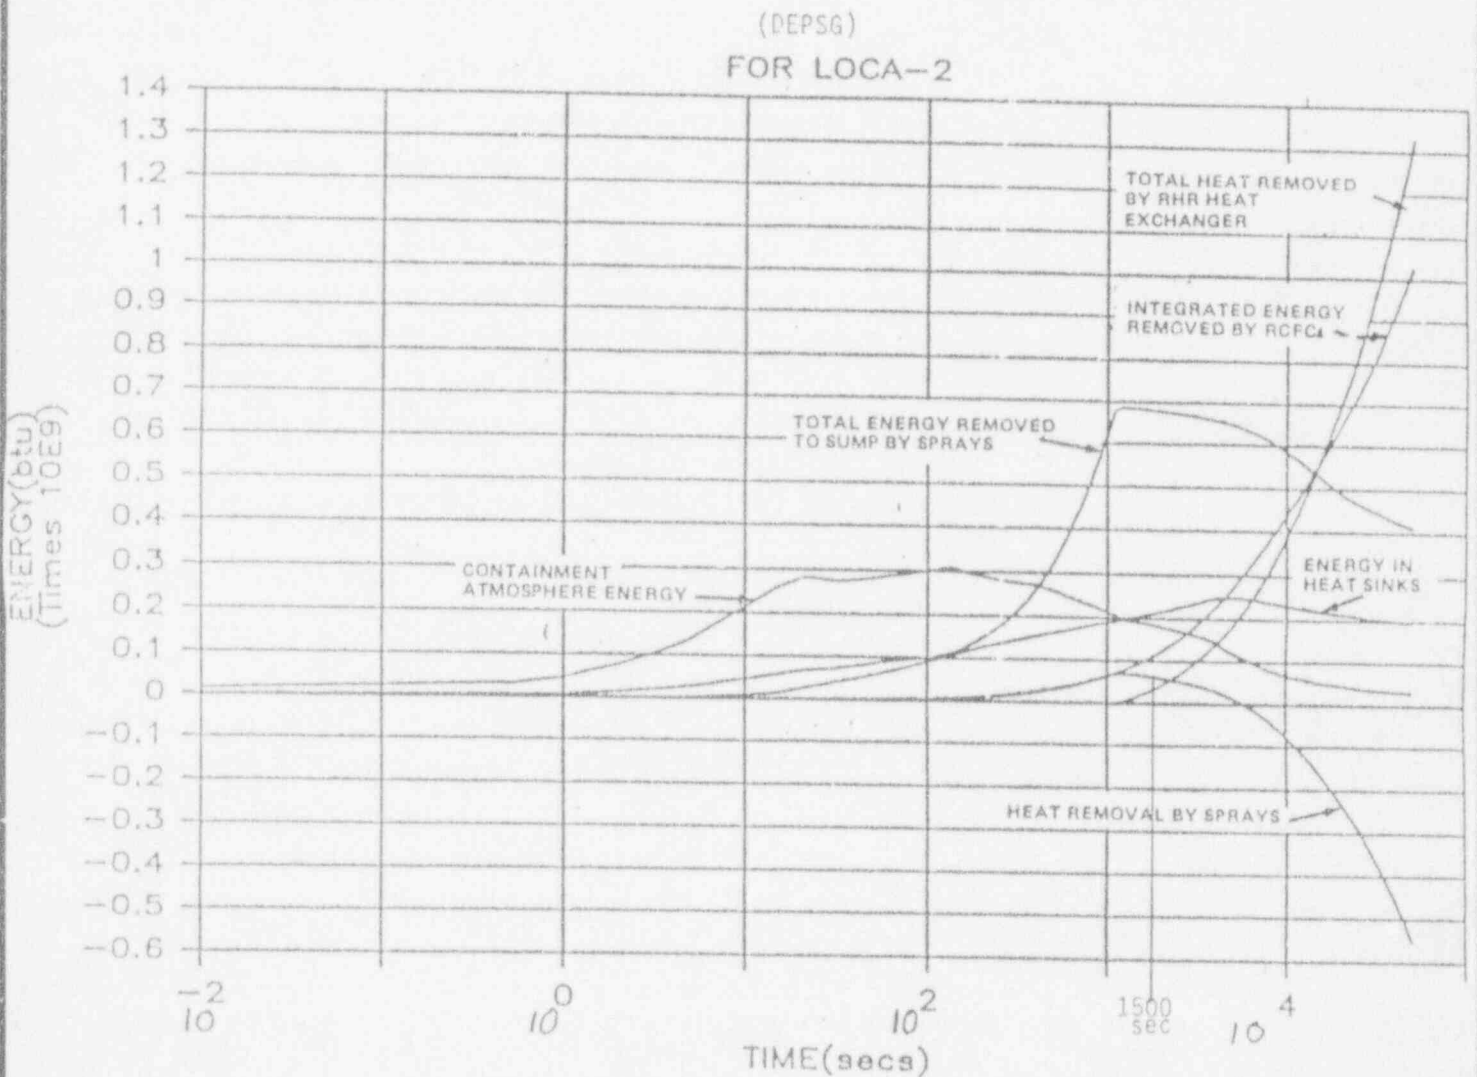
One of the functions of the Containment Spray System (CSS) is heat removal from Containment following a design basis accident (DBA). Per UFSAR Section 6.2.1, the Containment DBA is a double-ended pump suction guillotine rupture (LOCA 2). The energy inventory for this accident is depicted in Figure 2 (UFSAR Fig. 6.2.1.1-1A) and the Containment vapor and sump temperatures for this accident are depicted in Figure 3 (FSAR Fig. 6.2.1.1-11).

At the assumed time of initiation of recirculation with suction from the Containment sumps (1216 seconds), the Containment sump temperature is significantly higher than Containment vapor temperature and heat removal by Containment spray begins to decrease (and is essentially zero at 8000 sec) as shown in Figure 2.

A loss of Containment spray capability by total blockage of the spray header nozzles at the initiation of recirculation flow will not have a negative impact on energy removal capability following a DBA and is, therefore, not a safety concern.
