Duke Power Company
McGuire Nuclear Station
12700 Hagers Ferry Rd. 1
Huntersville, NC 28078-8985

Subject: McGuire Nuclear Station Unit 1 and 2
Docket No. 50-369
Licensee Event Report 369/90-26-01

LICENSEE EVENT REPORT (LER)

TITLE (4): Removal Of The Emergency Air Penetration Access Plate Rendered The Annulus Ventilation System Inoperable Because Of A Design Deficiency

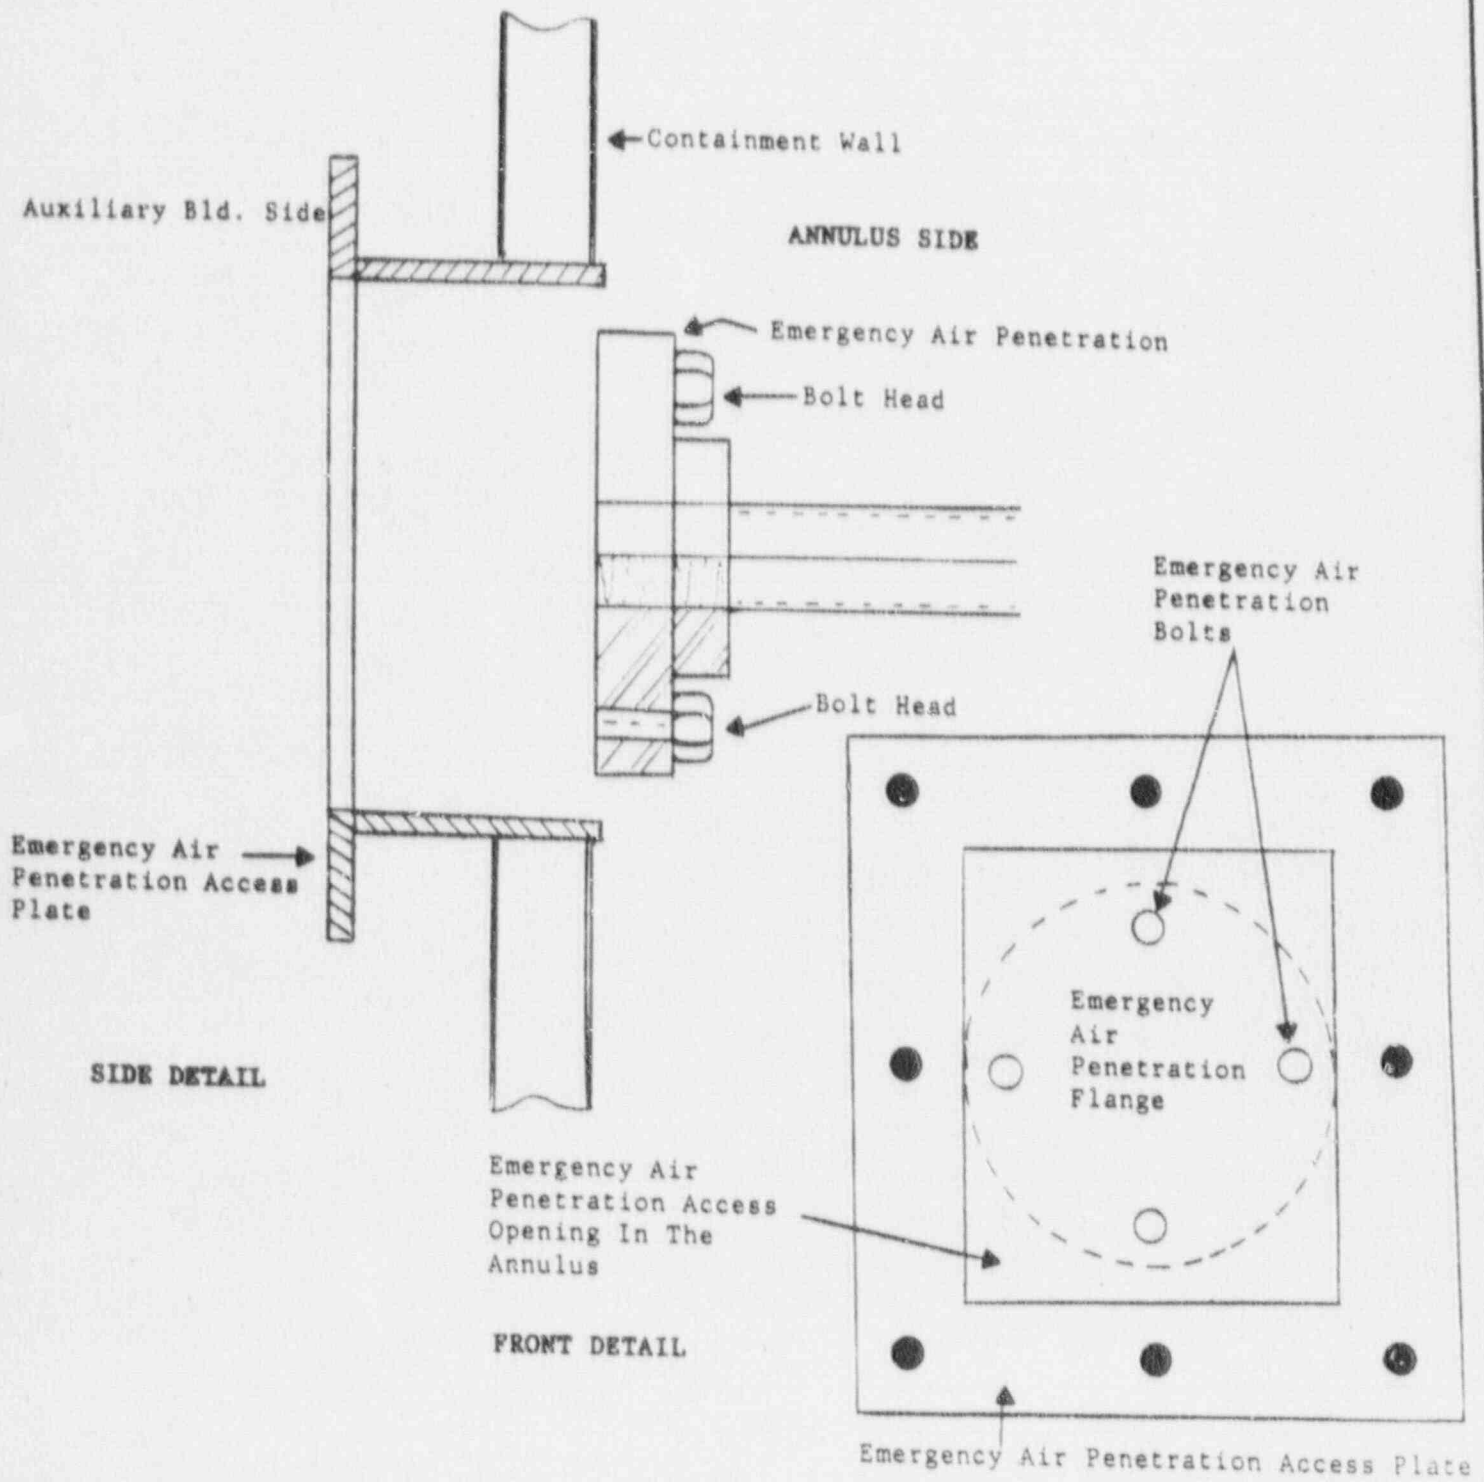
EMERGENCY AIR PENETRATION

The method used by Performance personnel to perform the Lower PAL Leak Rate Test has been to leave the Emergency Air Penetration Access Plate hanging on one bolt and just swing it out of the way. Then the flange was removed. However, to remove the flange, because of the bolt arrangement on the flange and the physical restrictions to the flange, the Bypass Leakage Enclosure CAD door had been opened for access to remove the nuts from the bolts and to install the test rig. The Bypass Leakage Enclosure CAD was opened again to remove the test rig and re-install the Emergency Air Penetration flange (see page 7 of 7).

This event is assigned a cause of Design Deficiency because of an unanticipated interaction of systems due to a design oversight. The Emergency Air Penetration flange is physically located flush with the Bypass Leakage Enclosure wall. The access plate opening into the Annulus physically restricts personnel from reaching through to place a tool on the bolt heads on the backside of the air lock flange (see page 7 of 7). Therefore, personnel were required to access the Annulus to hold the bolts in place. When station personnel performed this task, the Bypass Leakage Enclosure CAD door was used as access to the Annulus to perform this function. This also required the Bypass Leakage Enclosure CAD to be held open because of the physical location of the Emergency Air Penetration flange. When this

McGuire Exempt Change Variation Notices (MEVNs) 2547 and 2548 were written on the Unit 1 and Unit 2 Emergency Air Penetration flanges to weld the bolt heads to the backside (Annulus side) of the flanges; thereby, eliminating the need to open the Bypass Leakage Enclosure CAD during the performance of the leak rate test. Although the system will remain inoperable during testing, the dose consequences is below 10CFR100 guidelines. NSMs 12335 and 22335 are still being pursued to install a pressure barrier (boot seal) in Unit 1 and Unit 2 Emergency Air Penetration Access Areas, respectively.

Subsequent: MEVNs 2547 and 2548 on Unit 1 and Unit 2, respectively, were implemented by welding the bolt heads on the Annulus side of the penetration flange.
