Subject: McGuire Nuclear Station Unit 1 and 2
Docket No. 50-369
Licensee Event Report 369/90-24-01

LICENSEE EVENT REPORT (LER)

TITLE (4) **Inleakage On Train A Of The Control Room Ventilation System Exceeded Acceptable Levels Because Of An Unknown**

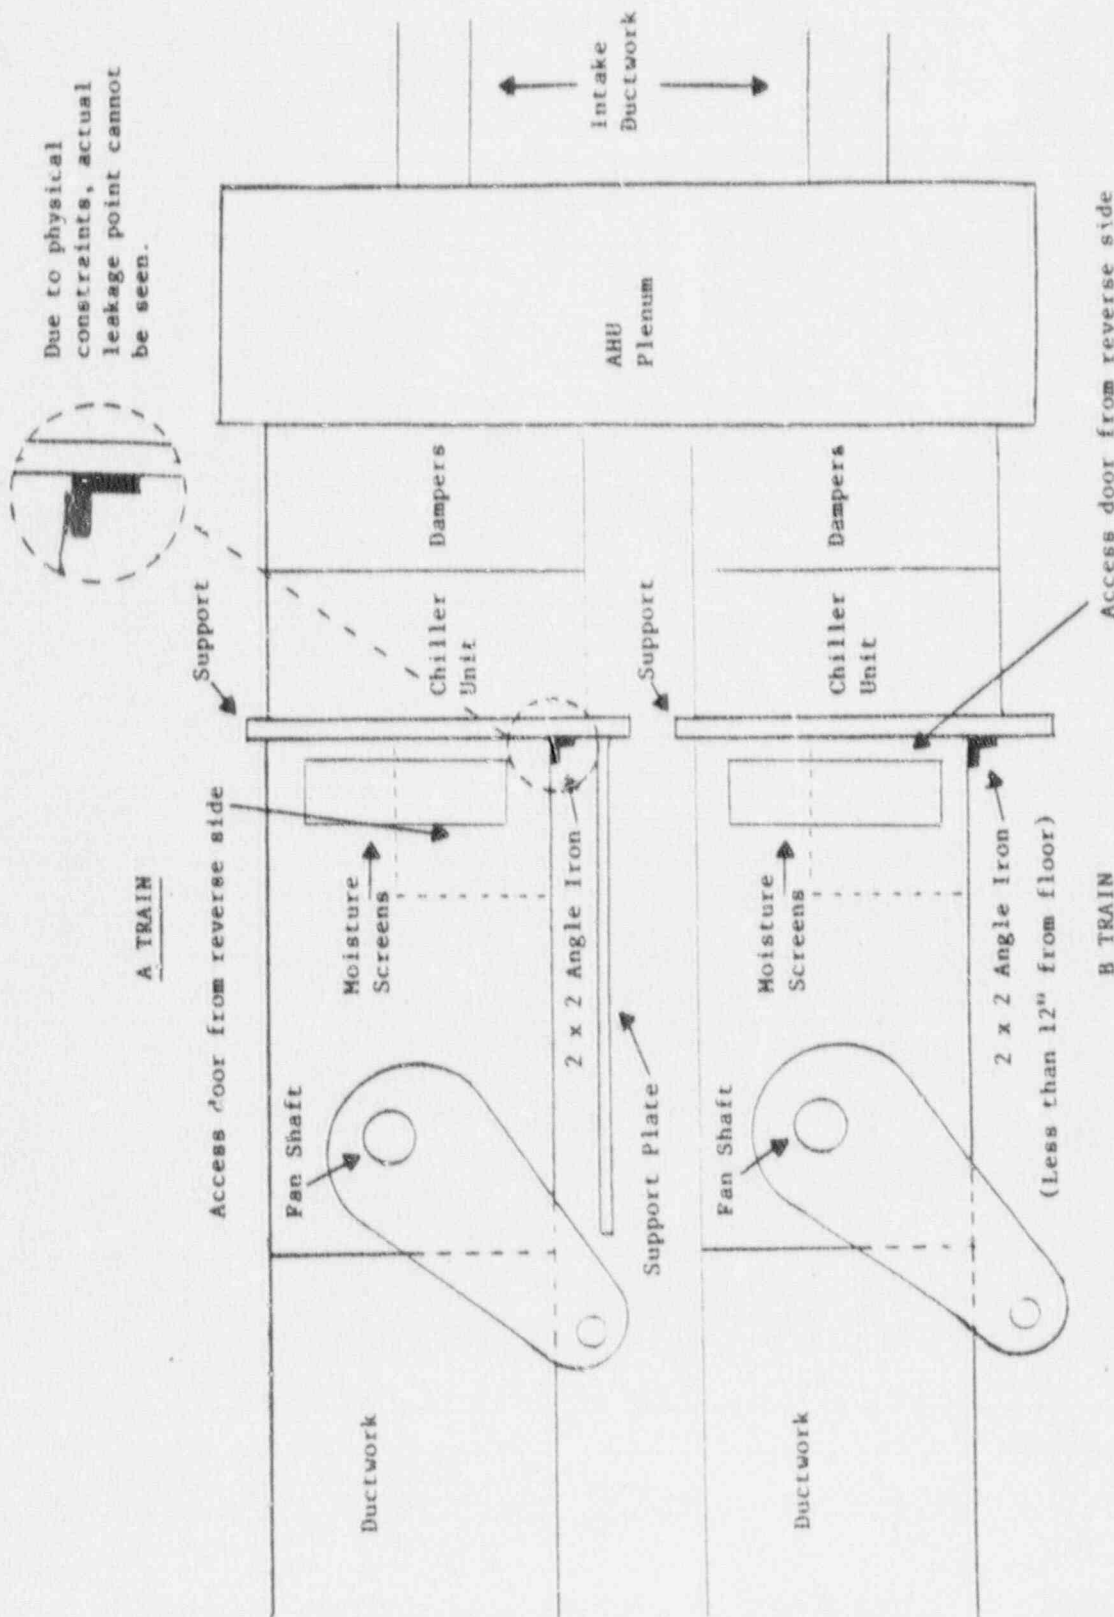
The VC system Train A was declared inoperable on August 21, 1990 at 1705 because of a damaged motor [EIIIS:MO] bracket. On August 22, 1990, MNT personnel were repairing the damaged motor bracket as documented in Licensee Event Report (LER) 369/90-23. During this repair, an audible leak was identified by MNT personnel at approximately 1400. MNT personnel discovered a small amount of leakage on the top hatch of the VC system Train A AHU [EIIIS:AHU] fan [EIIIS:FAN] housing. MNT personnel then notified Performance personnel of this leakage. At 1400, Performance personnel generated Work Request 503951 to seal the inleakage on the VC system Train A AHU at the top hatch and any other locations discovered by inspection (smoke stick). At approximately 1445, MNT personnel, according to Work Request 503951, while using a smoke stick, discovered inleakage at the bottom of the AHU fan housing between the chiller unit [EIIIS:CHU] and the fan housing (see page 7

of 7). MNT personnel estimated this leakage to be several hundred cfm. Even though the VC system Train A was declared inoperable on August 21, 1990, at 1705, this inleakage rendered Train A inoperable for an indeterminable time period.

The inleakage on the VC system Train A AHU was due to a separation between the fan housing plate and a 2 x 2 angle iron stiffener. The angle iron stiffener is tack welded on one side to the supports [EIS:SPT] for the fan housing and the chiller unit. On the other side the angle iron stiffener supports the fan housing. Because of physical constraints which limit maintenance and visual inspections on the VC system AHUs, MNT personnel were incapable of determining how the fan housing and angle iron stiffener separated which allowed the inleakage to develop. The inleakage on the Train A fan housing on the VC system was sealed by MNT personnel using Dow Corning RTV Sealant 732. MES and Design Engineering Site personnel will further investigate a probable failure or deficiency cause for the fan housing damage. MES personnel will perform a visual inspection of the VC system Train B fan housing. Design Engineering personnel will write a Station Problem Report (SPR) to recommend a more permanent sealing method for the Train A fan housing. The McGuire Safety Review group will write an addendum to this report when the investigation performed by MES personnel and Design Engineering personnel is complete.

This separation between the fan housing and the stiffener allowed unfiltered air from the Control Room Area to leak into the AHU at an estimated rate of several hundred cfm. This source of leakage was promptly corrected.

The following information addresses planned corrective action number 4. This event has been reassigned a cause of Possible Design/Construction/Installation Deficiency because of MES and Design Engineering personnel's investigation results. MES personnel concluded that the leaking joint on CR-AHU-1 resulted from a design deficiency which was aggravated by poor workmanship during installation of the equipment.

The AHU and its moisture separator were apparently purchased as separate components. Despite the fact that the inlet to the AHU is smaller than the outlet of the moisture separator, no specific design provisions were made to ensure that the respective mating surfaces formed an air tight seal. The installers attempted to resolve the problem by assembling the different sections with bolted steel angle. No gasket of any type was used and the joints were not welded. Based on the above, it appears that the joint could have been leaking since the unit was installed.

On August 22, 1990, MNT personnel sealed all inleakage areas on the VC system Train A AHU fan housing using Dow Corning RTV Sealant 732. This sealant was approved for the job by Maintenance Engineering Services (MES) Ventilation personnel. MNT personnel performed a functional verification for leakage on the AHU using smoke sticks. No further leakage was found.

Subsequent: MNT personnel stopped the unfiltered air inleakage on the VC system Train A AHU by sealing the gap on the fan housing using Dow Corning RTV Sealant.

This conclusion could not be verified due to the difficulty of accessing the inside surface of the joint. All joints on the AHU have been checked by means of smoke tests and sealed if needed. These joints were sealed with RTV sealant. Additionally, Design Engineering personnel are evaluating alternate methods of sealing leaks in leaking joints.
