**North
Atlantic**

Subject: Licensee Event Report (LER) 94-01-00: "Reactor Trip and Safety Injection Due to Inadvertent MSIV Closure"

TITLE (4)
Reactor Trip and Safety Injection due to Inadvertent MSIV Closure

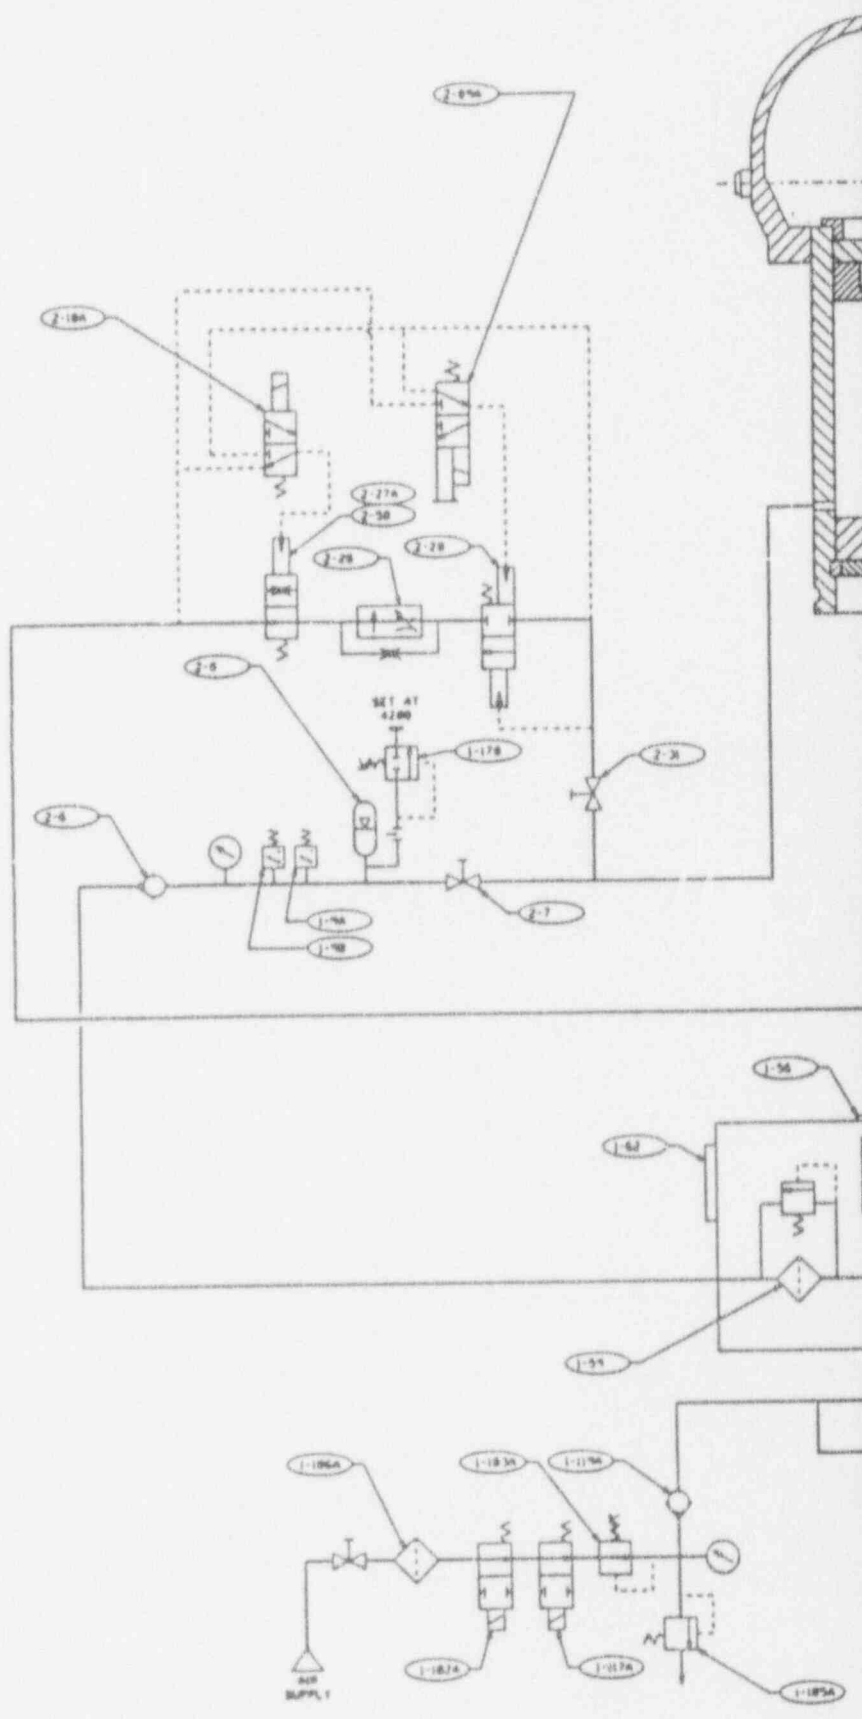
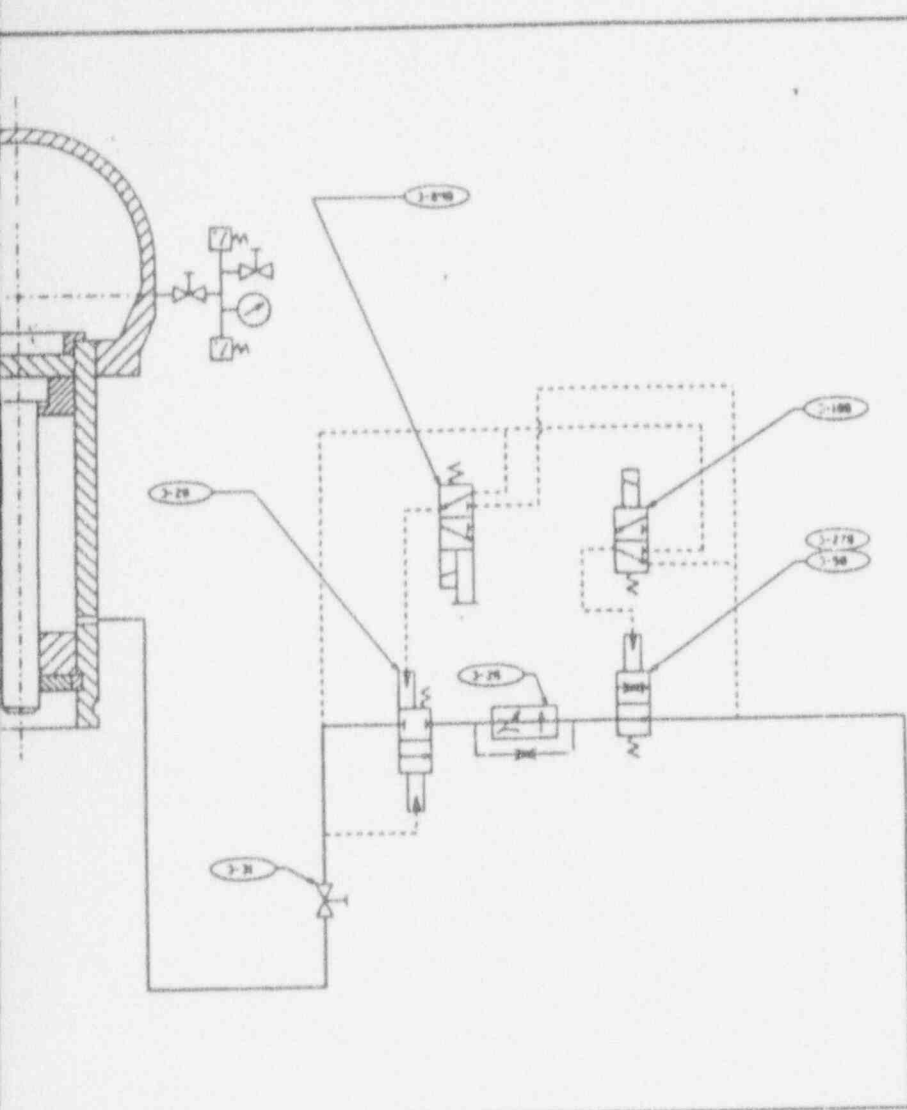
PUMP SIDE MANIFOLD
"A" TRAIN

Contaminated hydraulic fluid: The hydraulic fluid was found to be contaminated with foreign material. This contamination was determined to originate from externally introduced sources, internal valve wear products, and a silicon based contaminant. No chemical degradation of the hydraulic fluid was identified.

The train B main dump valve was determined to be sticking. The valve's disc was both out of tolerance (0.001 inches over maximum allowable size) and it had a machining burr and scoring on the outside surface.

The train B main dump solenoid pilot valve was found to exhibit seat leakage. Foreign material was found on the valve seat and in the air side of the valve shifting mechanism.

The hydraulic pump did not provide adequate capacity thereby delaying the repressurization of the hydraulic system. The pump's discharge filter was deformed and the filter material was split. Brass filings were found inside the hydraulic pump's air motor.

The piston in the hydraulic system's thermal accumulator was found in a fixed position.

After the solenoid pilot valves and the main dump valve were disassembled for MS-V86, North Atlantic sent the hydraulic manifolds for all four MSIVs to the valve manufacturer's facility for inspection, cleaning, and rebuilding as necessary. At the manufacturer's facility the hydraulic manifolds were inspected for foreign material, worn/damaged components, and selected machining tolerances. The solenoid pilot valves were also inspected and rebuilt as necessary. Any worn/damaged parts were replaced as was the pipe thread sealant on all hydraulic subsystem mechanical joints. North Atlantic provided Quality Control oversight at the valve manufacturer's facility during the inspection/rebuilding effort.

North Atlantic also performed a series of flushes of the MSIVs' main actuating cylinders using a temporary flushing rig with high efficiency filters. Additionally, the air subsystem components in-line with the hydraulic pump air motor were inspected and rebuilt. The air supply system was evaluated and determined to be adequate. North Atlantic also inspected and renewed environmental seals on the valves' electrical components.

North Atlantic reassembled the MSIVs when the hydraulic manifolds and solenoid pilot valves were returned from the manufacturer. The hydraulic subsystems of each MSIV were flushed by stroking the valves. The valves were then adjusted for timing and limit switch settings and slow and fast closure tests were conducted to establish valve operability.
