AEOD CASE STUDY C-90-01
OPERATING EXPERIENCE FEEDBACK REPORT
SOLENOID-OPERATED VALVE PROBLEMS
AT U.S. LIGHT WATER REACTORS

December 1990

ABSTRACT

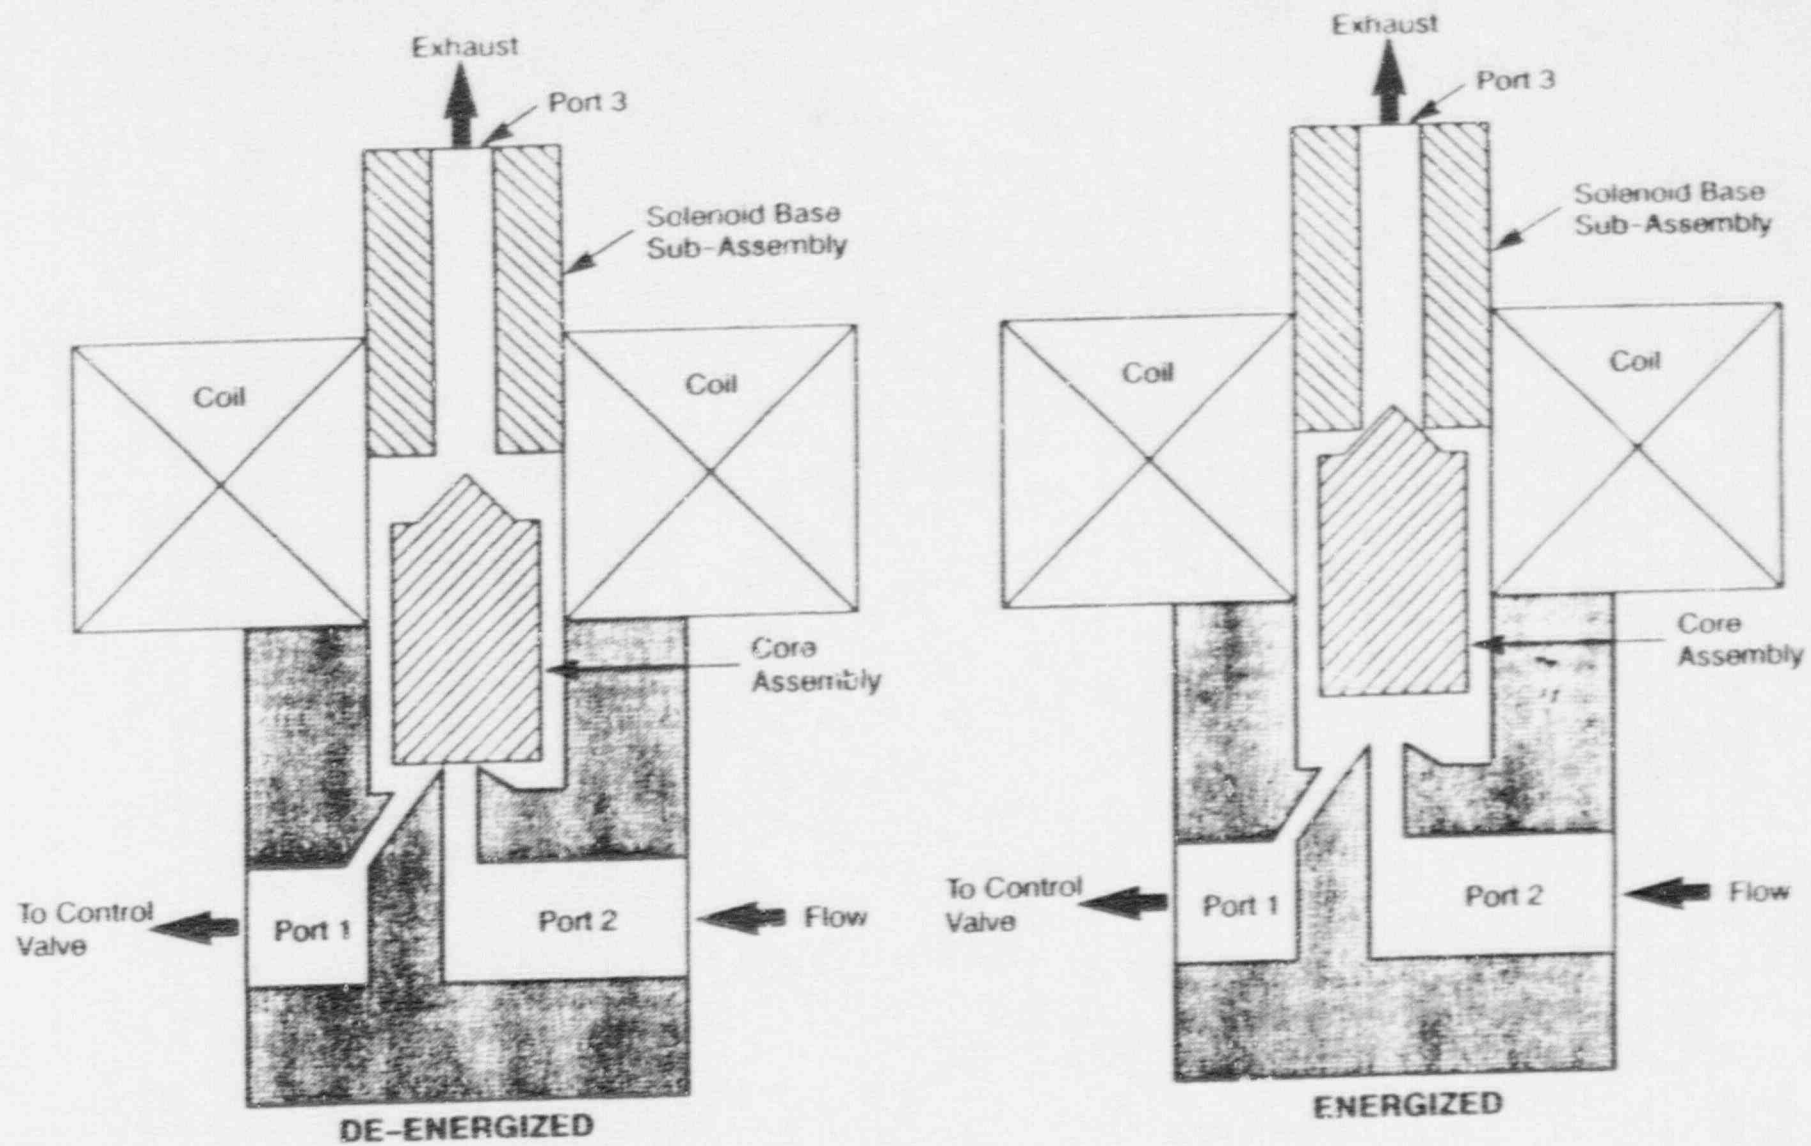
Figure 6 Schematic of a solenoid-operated valve illustrating effect of operating pressure differentials.

Many plants have experienced conditions in which SOVs failed or could have failed to perform safety-related functions because of excessive operating pressure differentials. Figure 6 is a schematic diagram of an SOV, illustrating how an operating pressure differential in excess of its maximum operating pressure differential (MOPD) can cause an SOV to malfunction. When the SOV is in the de-energized position, pressurized fluid enters the valve at port 2 and is blocked by the core assembly. If the pressure differential between ports 2 and 3 exceeds the MOPD, the overpressure could lift the core assembly, resulting in leakage of fluid from port 2 to port 1 and port 3.

valve openings were caused by excessive pneumatic (nitrogen) supply pressure to the SOV controlling the SRV. The high nitrogen pressure exceeded the SOV's MOPD, causing the SOV to shift position, which caused the SRV to spuriously open.
