REPORTABLE OCCURRENCE 78-31

PORT ST. VRAIN NUCLEAR GENERATING STATION
PUBLIC SERVICE COMPANY OF COLORADO
P. O. BOX 361
PLATTEVILLE, COLORADO 80651

REPORT NO. 50-267/78-31/03-L-0

IDENTIFICATION OF
OCCURRENCE:

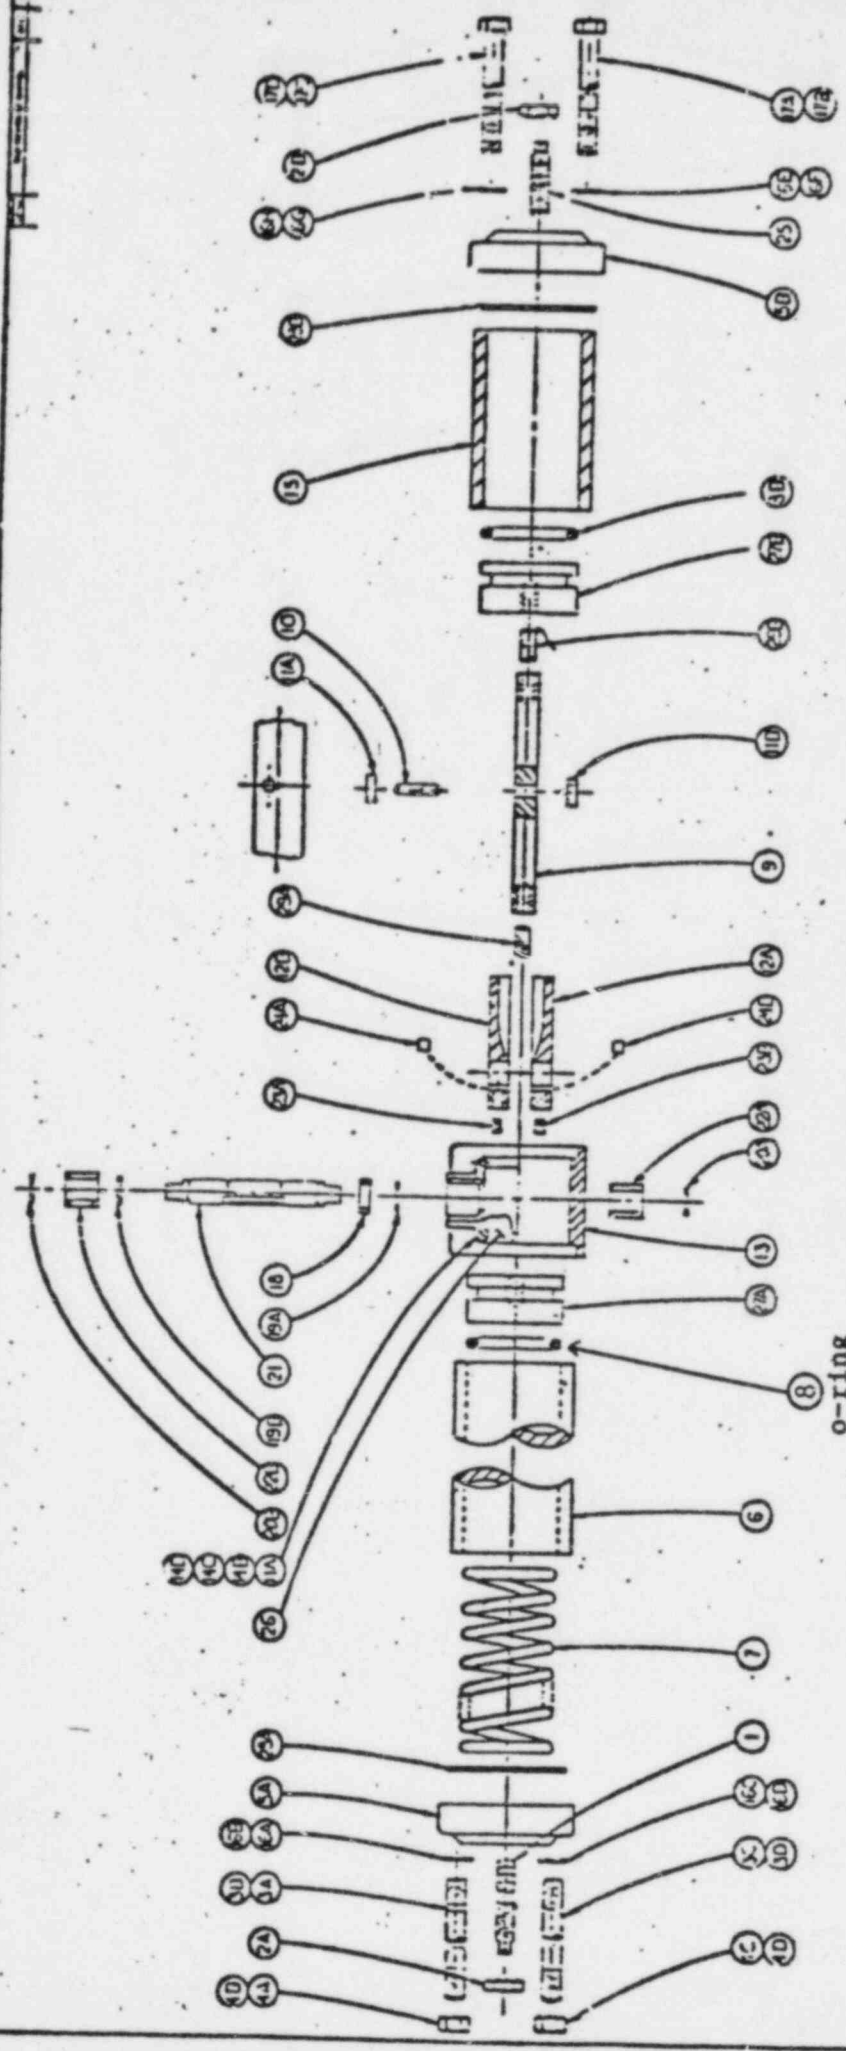
Figure 1

See figure 1. A faulty o-ring in the damper actuator assembly jammed the actuating shaft in place, holding the damper open.

1 0 | A Contromatic pneumatic spring return actuator (part number 198-00-353) jammed open

1 1 | due to a faulty o-ring that slipped, locking the shaft in position. The o-ring was

The faulty o-ring was replaced, the damper placed back in service and the surveillance was successfully completed.

1 2 | replaced and the actuator returned to service.
