"Experience in Decontamination
and Repair of Radwaste Concentrator
at Millstone Unit No. 1"

J. Summa Northeast Nuclear Energy Company

K. Kallfisch Unitech Division, Ecodyne Corp.

Presented at the 1978 Annual Winter Meeting of
the American Nuclear Society in Washington, D.C.
(Log Number 00681)

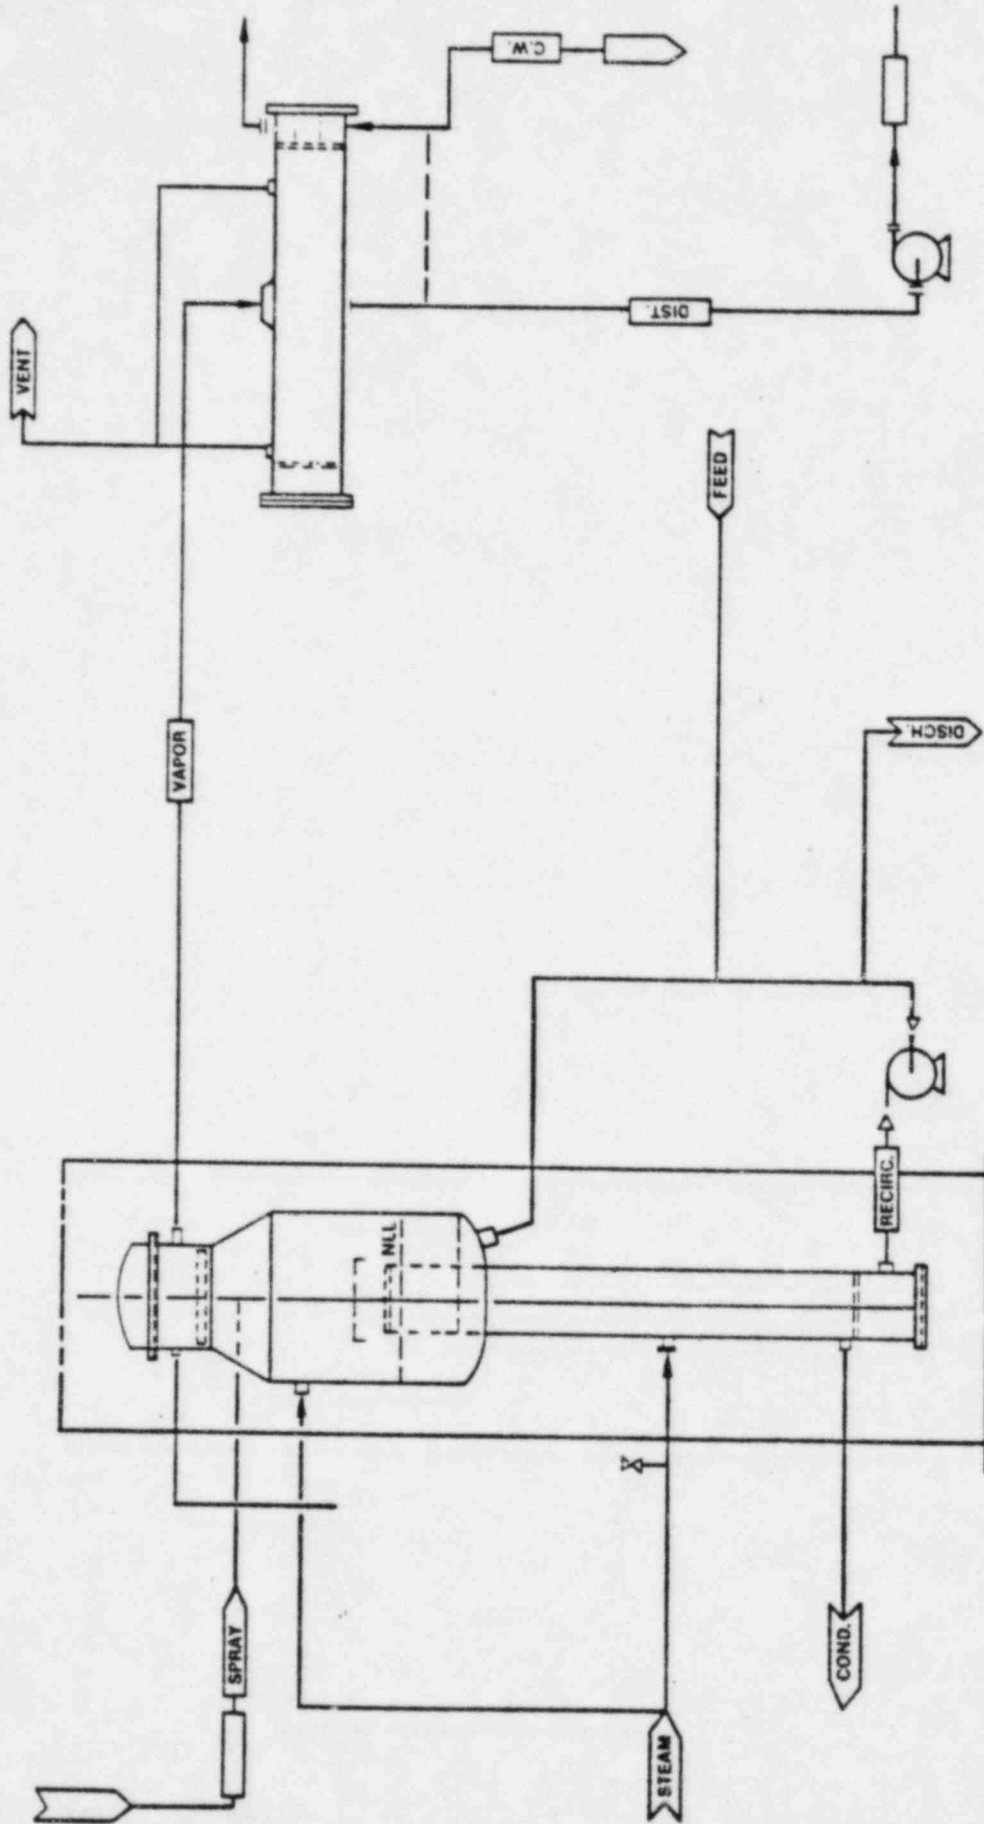
SLIDE 1

in the evaporator's design. The evaporator is a single pass vertical tube forced circulation unit with a non-submerged tube design (Slide I). This means that, although there is boiling in the tubes of the heater, the concentrate is pumped through the tubes. The ratio of recirculation rate-to-evaporation rate is high enough to maintain a liquid film on the tube wall. Therefore, the tubes are never boiled dry. The high liquor and vapor velocities in the tubes minimize scale build-up.

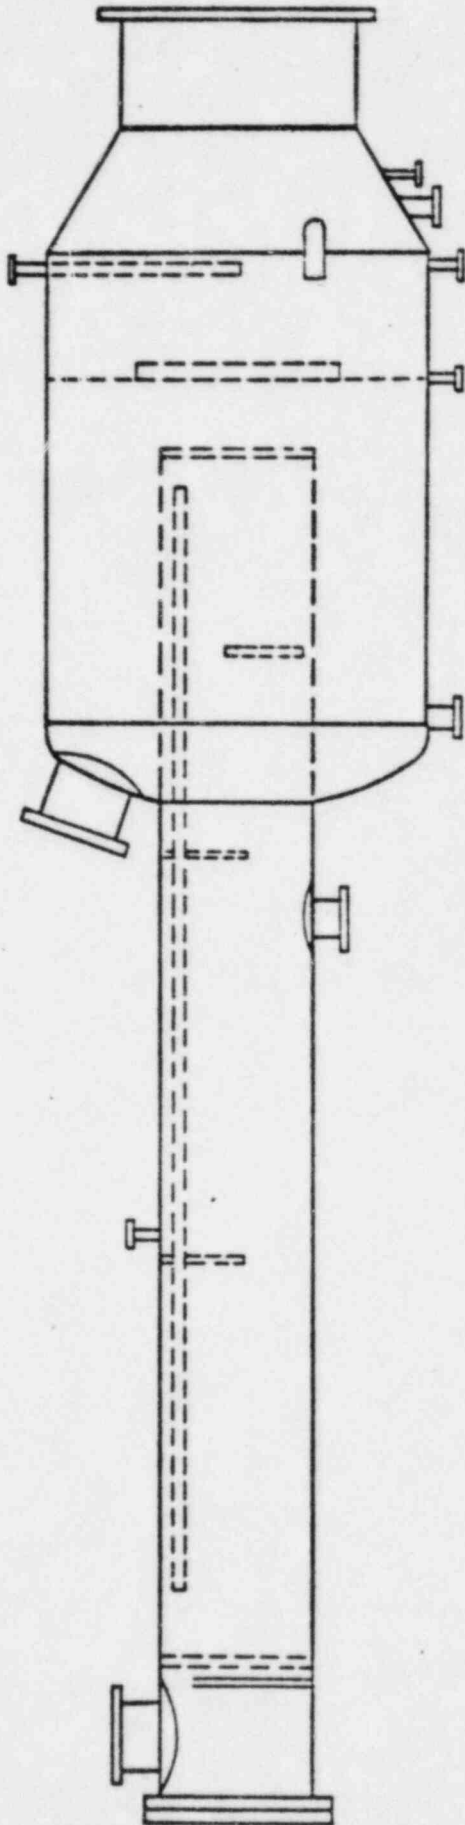
SLIDE IV

Entry, inspection and repair would be carried out through a flanged accessway in the top of the vessel (Slide III). This permitted removal of the mesh pad which was tack welded via support bars to the removable dished head (Slide IV). This would permit visual examination of the vessel prior to entry, which would diminish the man-rem exposure.

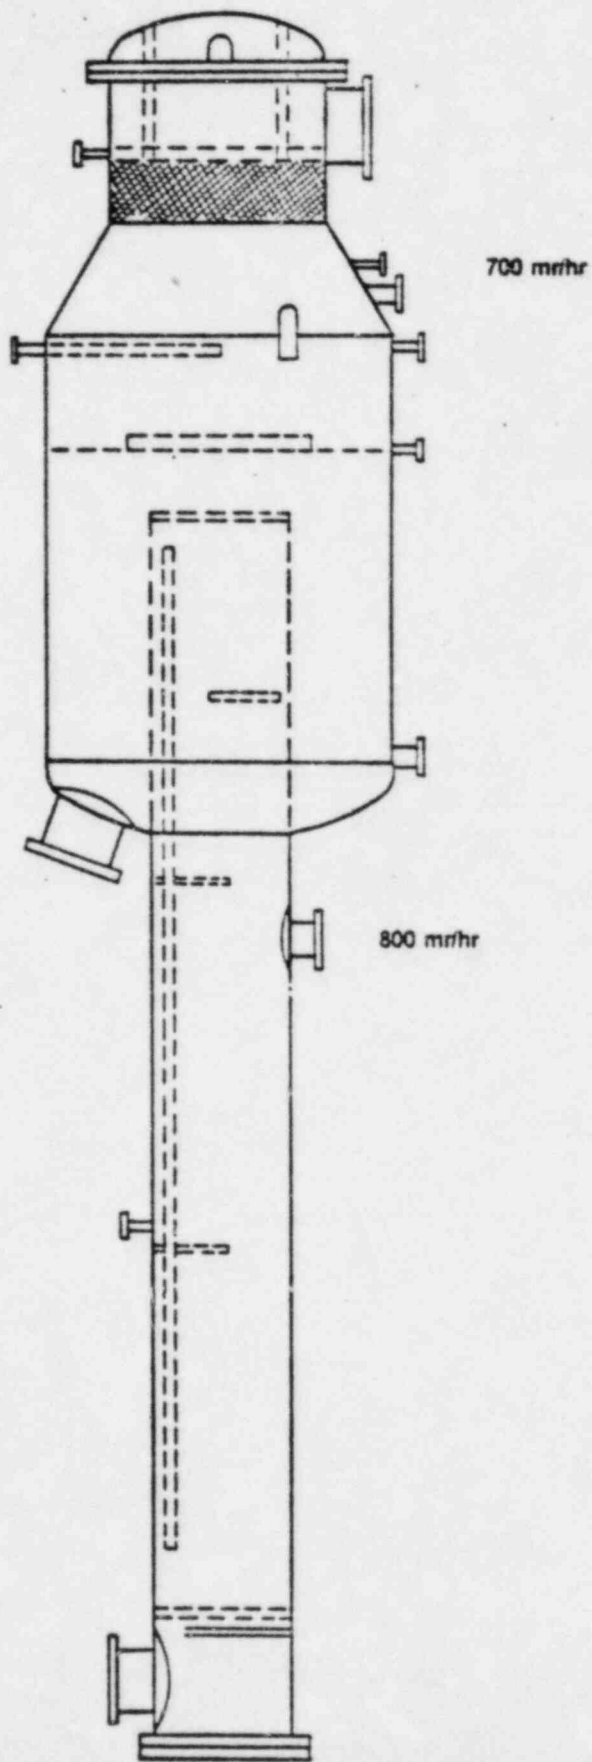
SLIDE V

Readings were taken by Health Physics prior to the water wash. It was found that the concentrator read between 700 and 800 mr per hour on contact during operation (Slide V). The unit was emptied and then flushed for a half hour using the demister spray nozzles. After this, (Slide VI), the reading dropped to between 500 and 600 mr per hour on contact. The unit was then put through the warm water decon for 7 hours

OPERATION

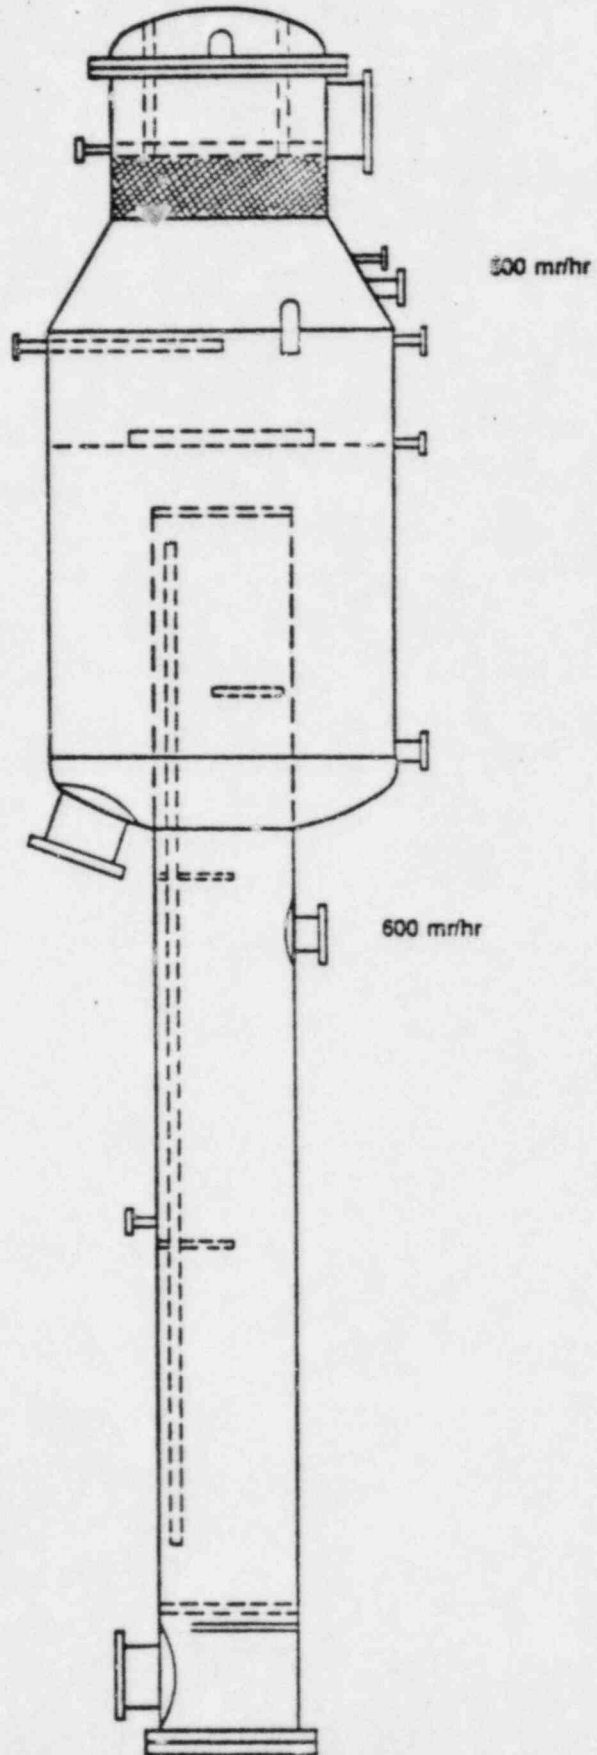
SLIDE VI

AFTER DISCHARGE FLUSH

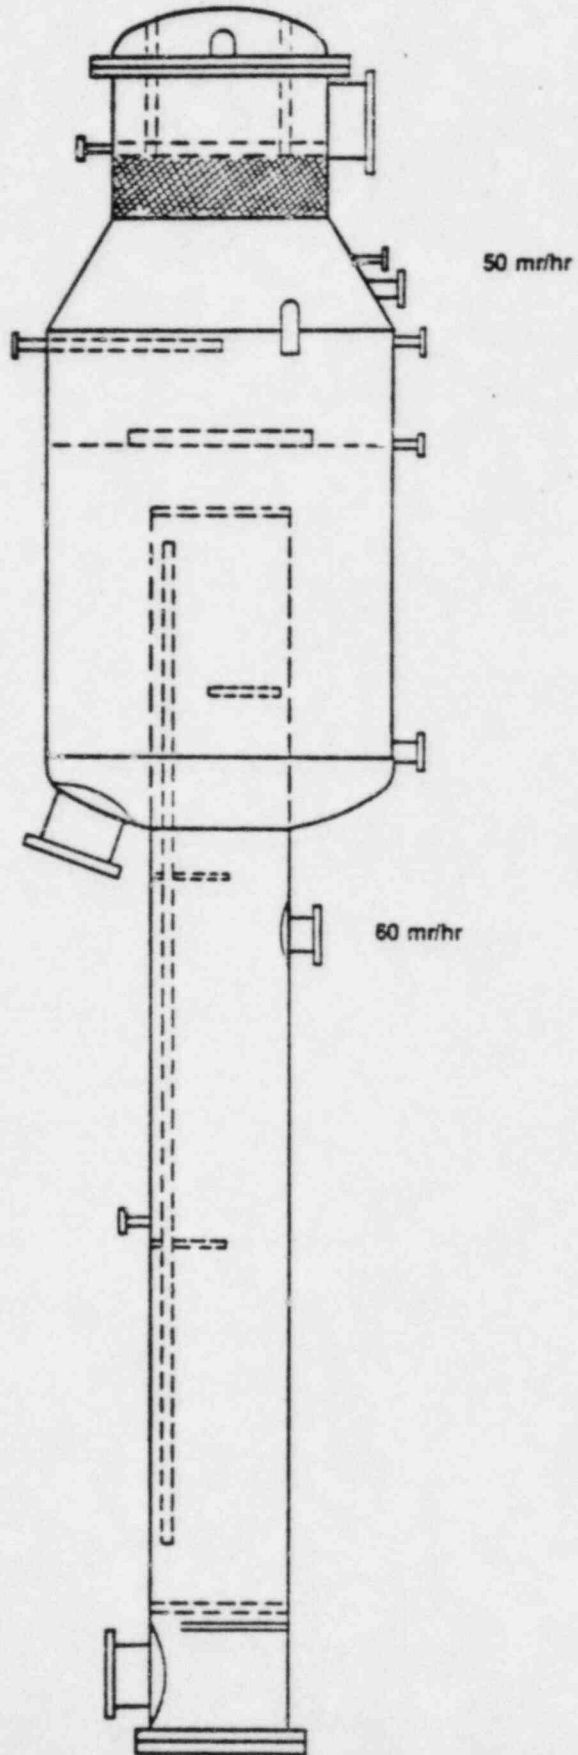
SLIDE VII

at a water temperature of 180°F. After this the water was discharged to storage. Readings (Slide VII) indicated that the concentrator's dose rate had dropped to between 50 and 60 mr per hour on contact. Work could proceed on the concentrator with no further chemical decontamination washes required.

AFTER WARM WATER WASH

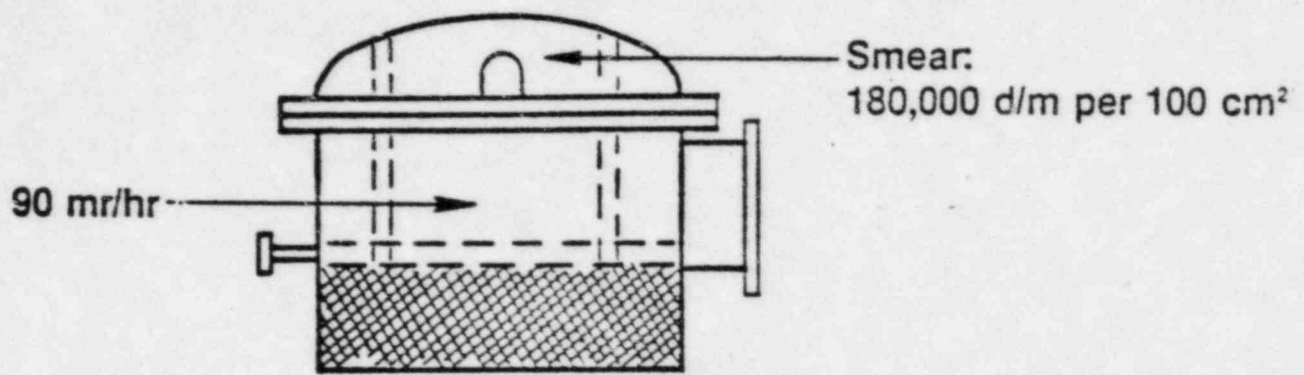
SLIDE VIII

The head was raised sufficiently to permit a radiation count on the inside of the vessel and to take a smear sample of the mesh pad. The dose rate (Slide VIII) between the cover and the pad was 90 mr per hr. and the smear showed 180,000 d/m per 100 sq cm on the inside of the dished head. At the same time the mesh pad was examined visually (from a distance) and appeared to be badly plugged crud.

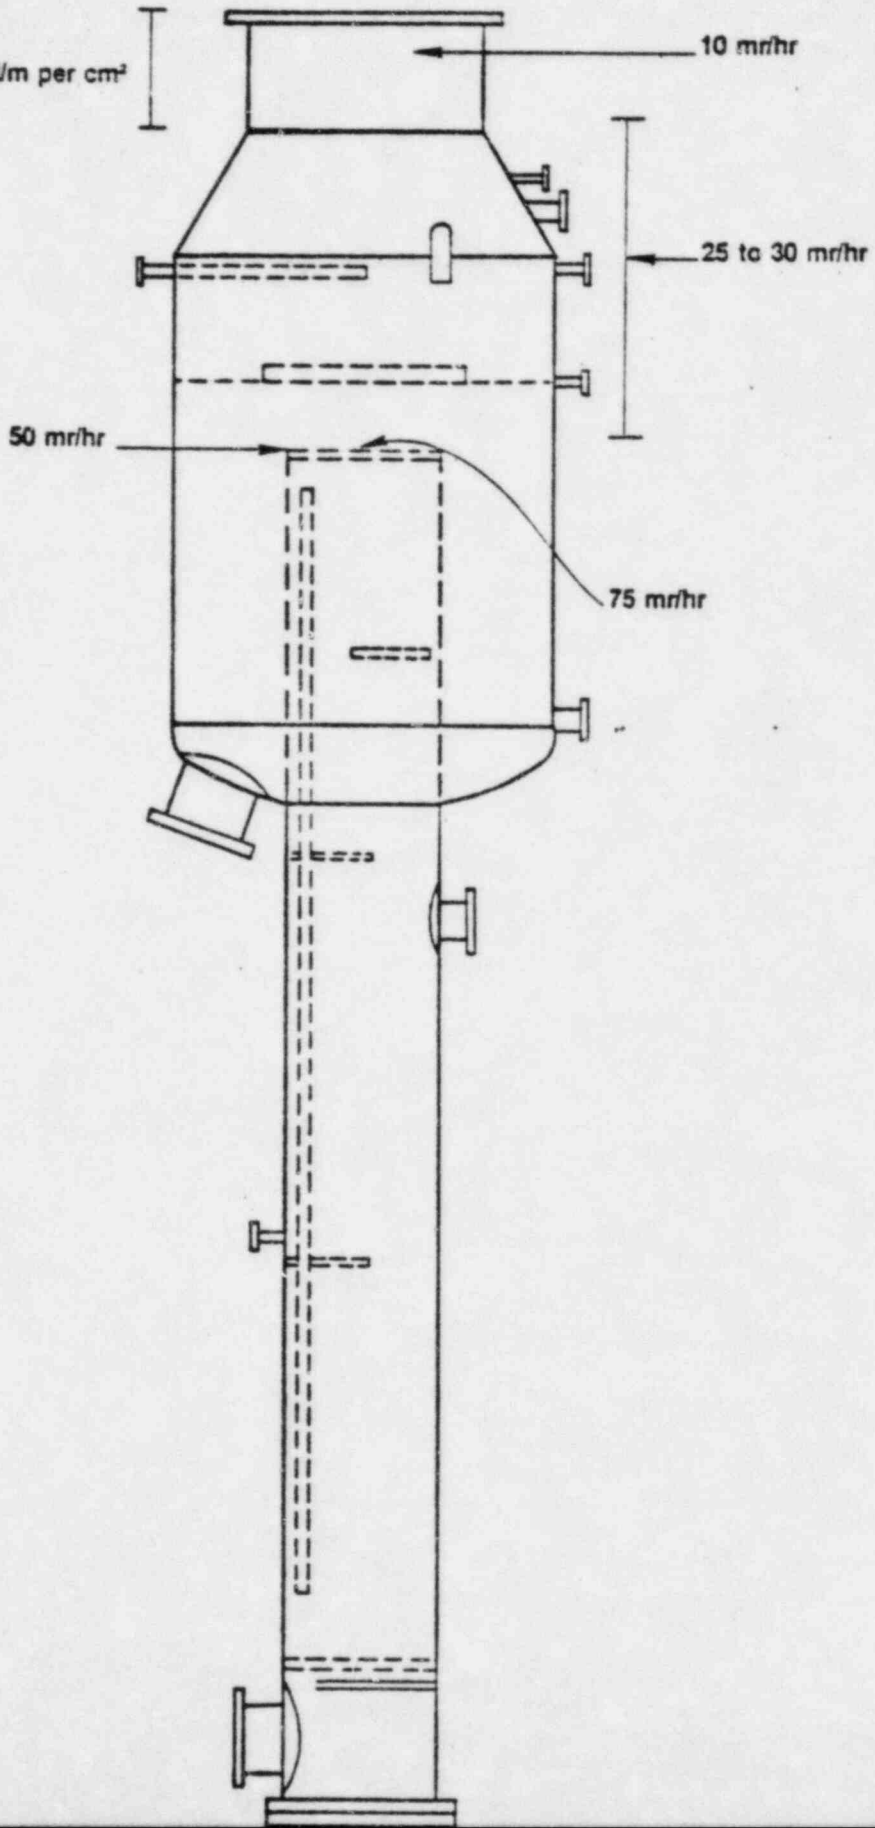
SLIDE IX

The concentrator vessel was again measured and smears were taken. The reading (Slide IX) inside the flange head was 10 mr per hour on contact, the vessel walls were between 25 and 30 mr per hour, increasing as the tube bundle was approached. The tube bundle was 50 mr per hour and the tube sheet was 75 mr per hour. The smears showed that the upper vessel walls were 470,000 d/m per 100 sq.cm. To protect the maintenance personnel, respirators, full PC's and plastics were required to enter the vessel.

Smear
470,000 d/m per cm²
