PEACH BOTTOM 2 & 3

REGENERATIVE HEAT EXCHANGERS

CHEMICAL DECONTAMINATION

Mark M. Rohner  
Philadelphia Electric Company  
June 6, 1978

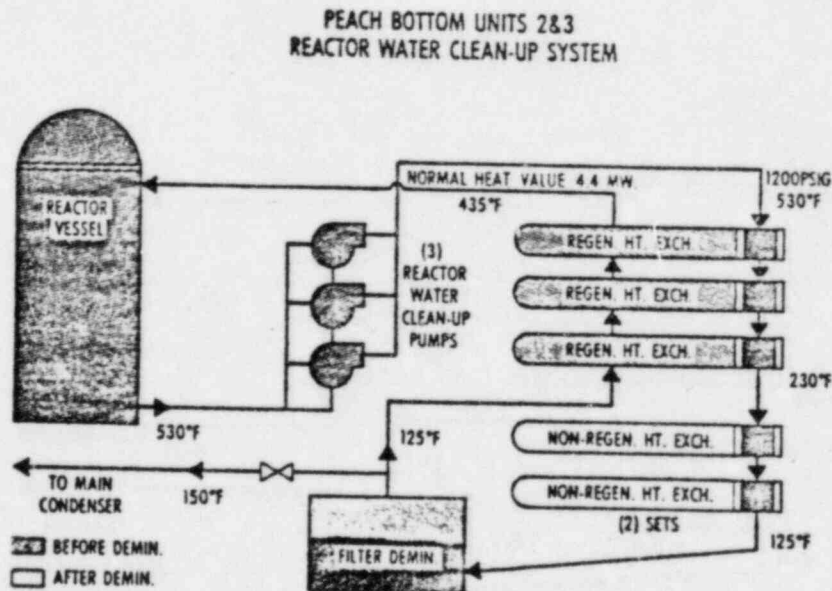
FIG. 1

The Regenerative Heat Exchangers form an integral part of the Reactor Water Clean-Up (R.W.C.U.) System. They are located in the reactor building just outside the drywell. Their purpose is to cool reactor water before it enters the demineralizers and then reheat it on its way back to the reactor. This regeneration recovers approximately 4.4 MW's worth of thermal energy. Because this system is the reactor's "kidney", removal of the system for more than 48-72 hours cannot be performed without seriously effecting reactor water chemistry. The absence of a clean-up system for this period usually causes the reactor water conductivity to approach limits which require shutdown. Figure 1 shows the relationship of the Regenerative Heat Exchangers to the R.W.C.U. System.

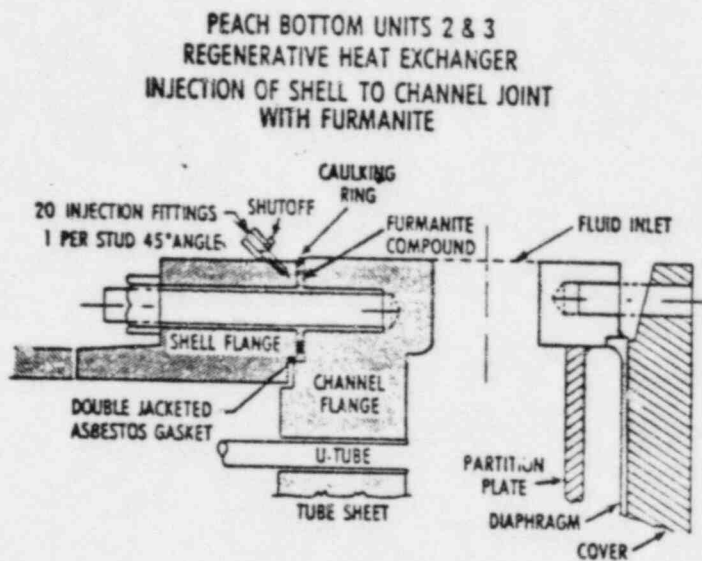
FIG. 2

to 3,000 MR/HR on contact with the heat exchanger flanges. The cost to prepare and inject one heat exchanger with Furmanite was about \$15,000. Approximately \$130,000 was spent over an eleven month period to keep Units 2 & 3 heaters sealed. Travel time and Health Physics training represented a high portion of this expense due to a turnover rate of 2-3 men/shift. Figure 2 illustrates the positioning of injection fittings and a caulking ring used in the Furmanite injection process.

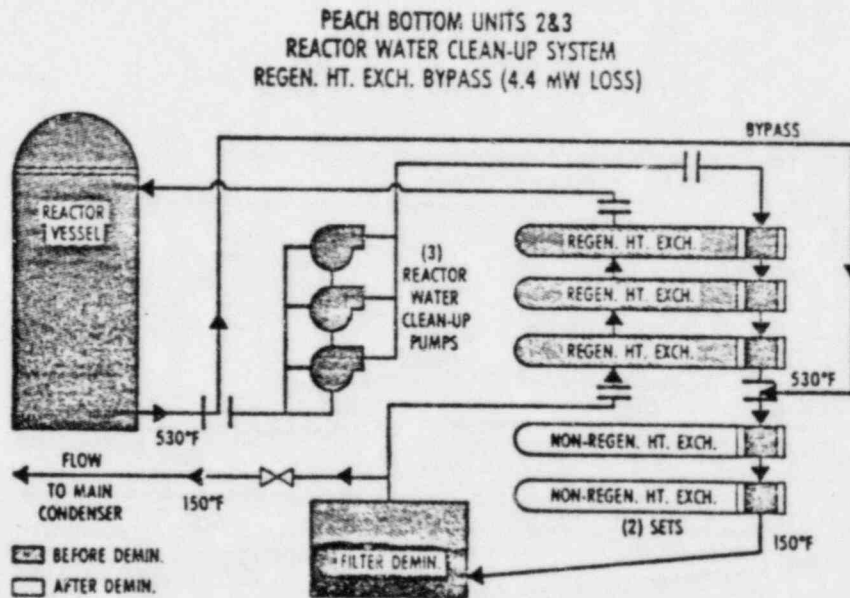
FIG. 3

Because of the failure of Furmanite compound at Peach Bottom to act as a permanent seal, repair alternatives were studied and a bypass line was installed around the Reactor Water Clean-Up pumps and the Regenerative Heat Exchangers. Mechanical seal problems on the R.W.C.U. pumps necessitated their inclusion in the bypass scheme. Figure 3 illustrates this bypass. The energy loss, due to the loss of regenerative heating, amounted to 4.4 Mwt.

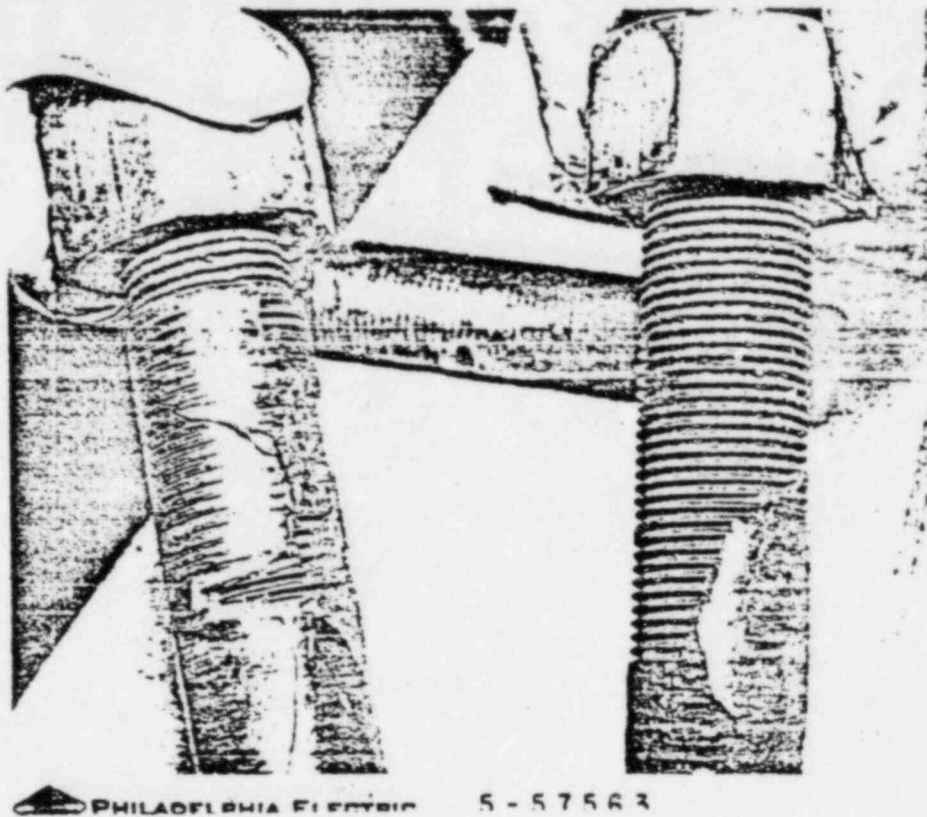
FIG. 8

Approximately 25 shifts utilizing 10 craftsmen/shift were required to remove 60 (1-5/8") flange bolts and to remove Furmanite from the flange faces and bolt holes. Figure 8 illustrates Furmanite adhering to the bolting.
