Subject: Installation of New Cobalt-60 Source in Theratron 780 (AECL)

Reference: NRC License #20-01412-03
Baystate Medical Center:SHWW Unit
Date of Expiration: July 31,1984

REPORT OF TELETHERAPY TESTS AND SURVEYS

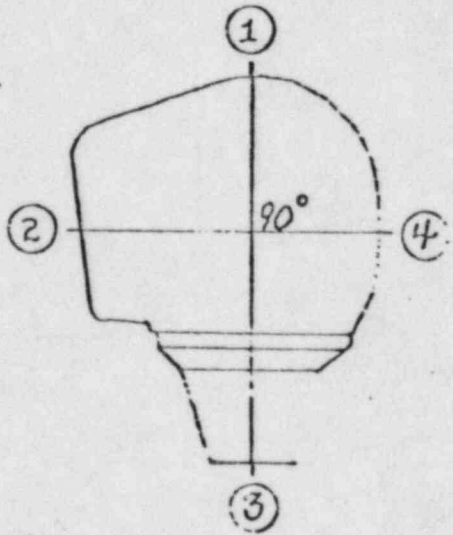
View A - Vertical from left side

Position No.	Radiation Level (mR/hr)
View A 1	0.4
2	1.2
3	0.6
4	0.3

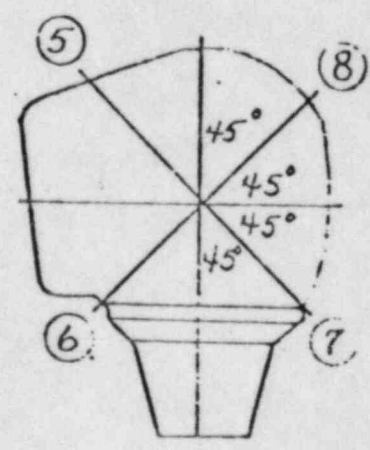
View B - Vertical from left-front

View B 5	1.1
6	1.4
7	0.5
8	0.4

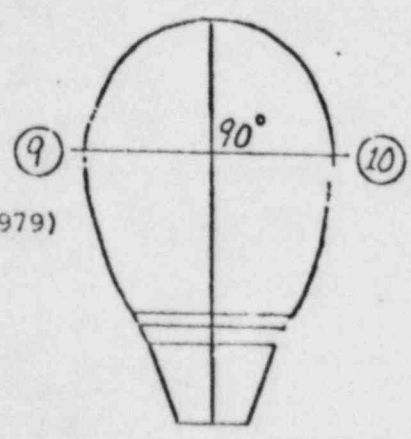
View C - Vertical from front

View C 9	0.8
10	0.7

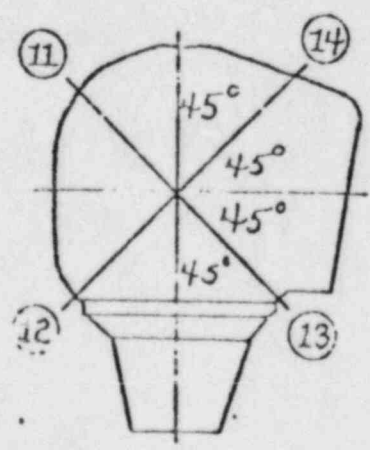
View D - Vertical from right-front

View D 11	0.2
12	0.4
13	1.2
14	0.9

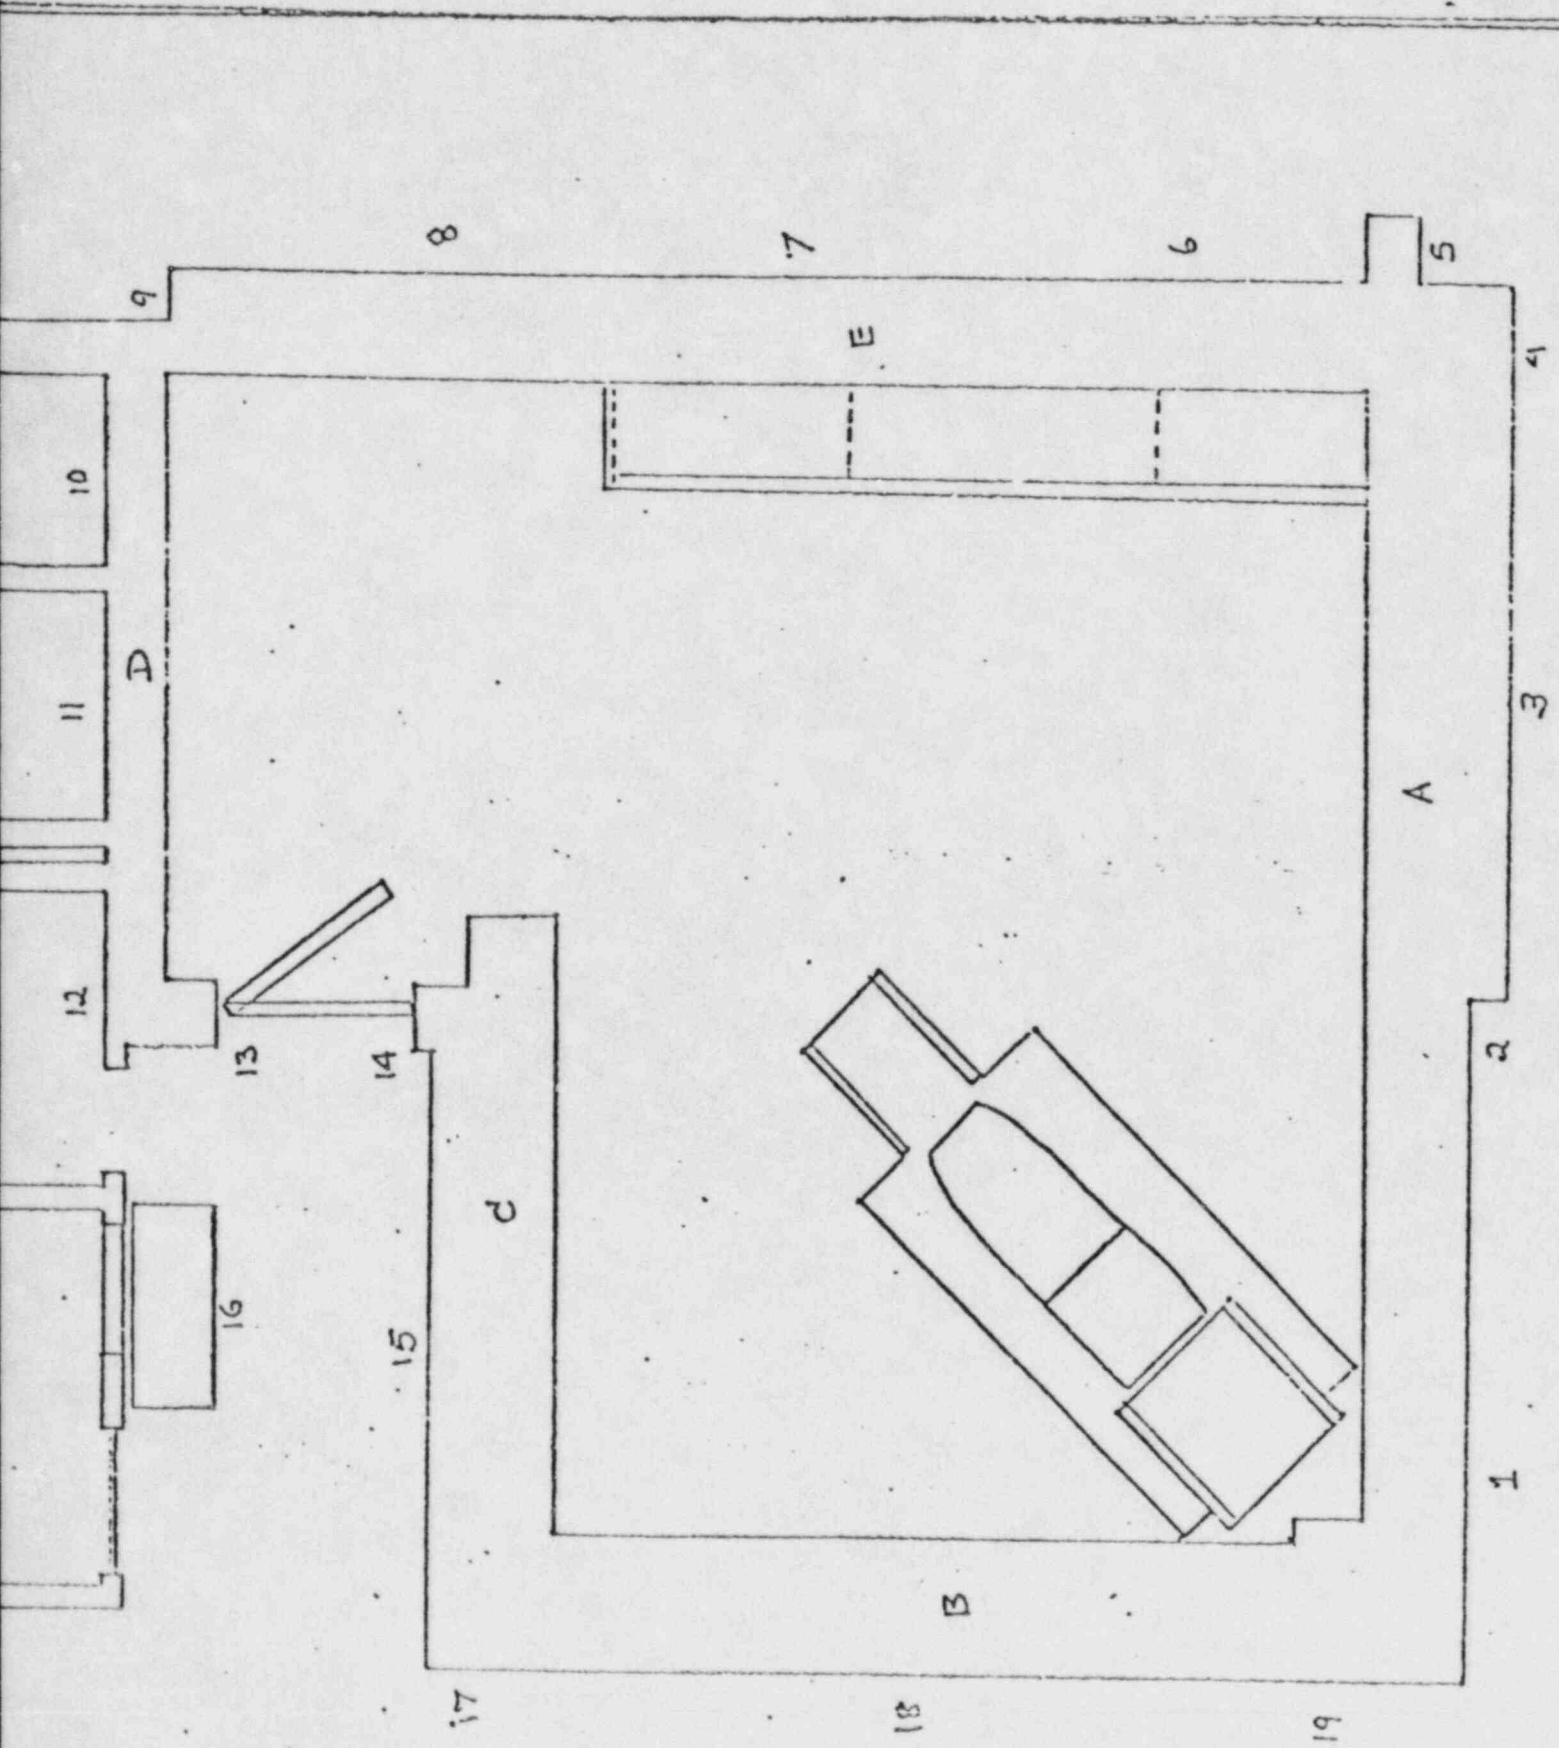
COBALT-60 RGN - GROUND LEVEL

LOCATION	SURVEY POINTS	ESTIMATED EXPOSURE
I <u>Cobalt-60 Room:</u> (Ground Level)	All the survey points from 1 through 20 in rotational mode and fixed mode. Survey points 2, 3 & 4 when the source-head was rotated 60° & primary beam directed to wall "A". Estimated operation in this mode is <u>2 hr/wk</u>	No measurable radiation levels detected. pt: 2:0.5 mr/hr pt: 3:0.9 mr/hr pt: 4:0.3 mr/h The max. exposure would be <u>1.8 mr/wk.</u>

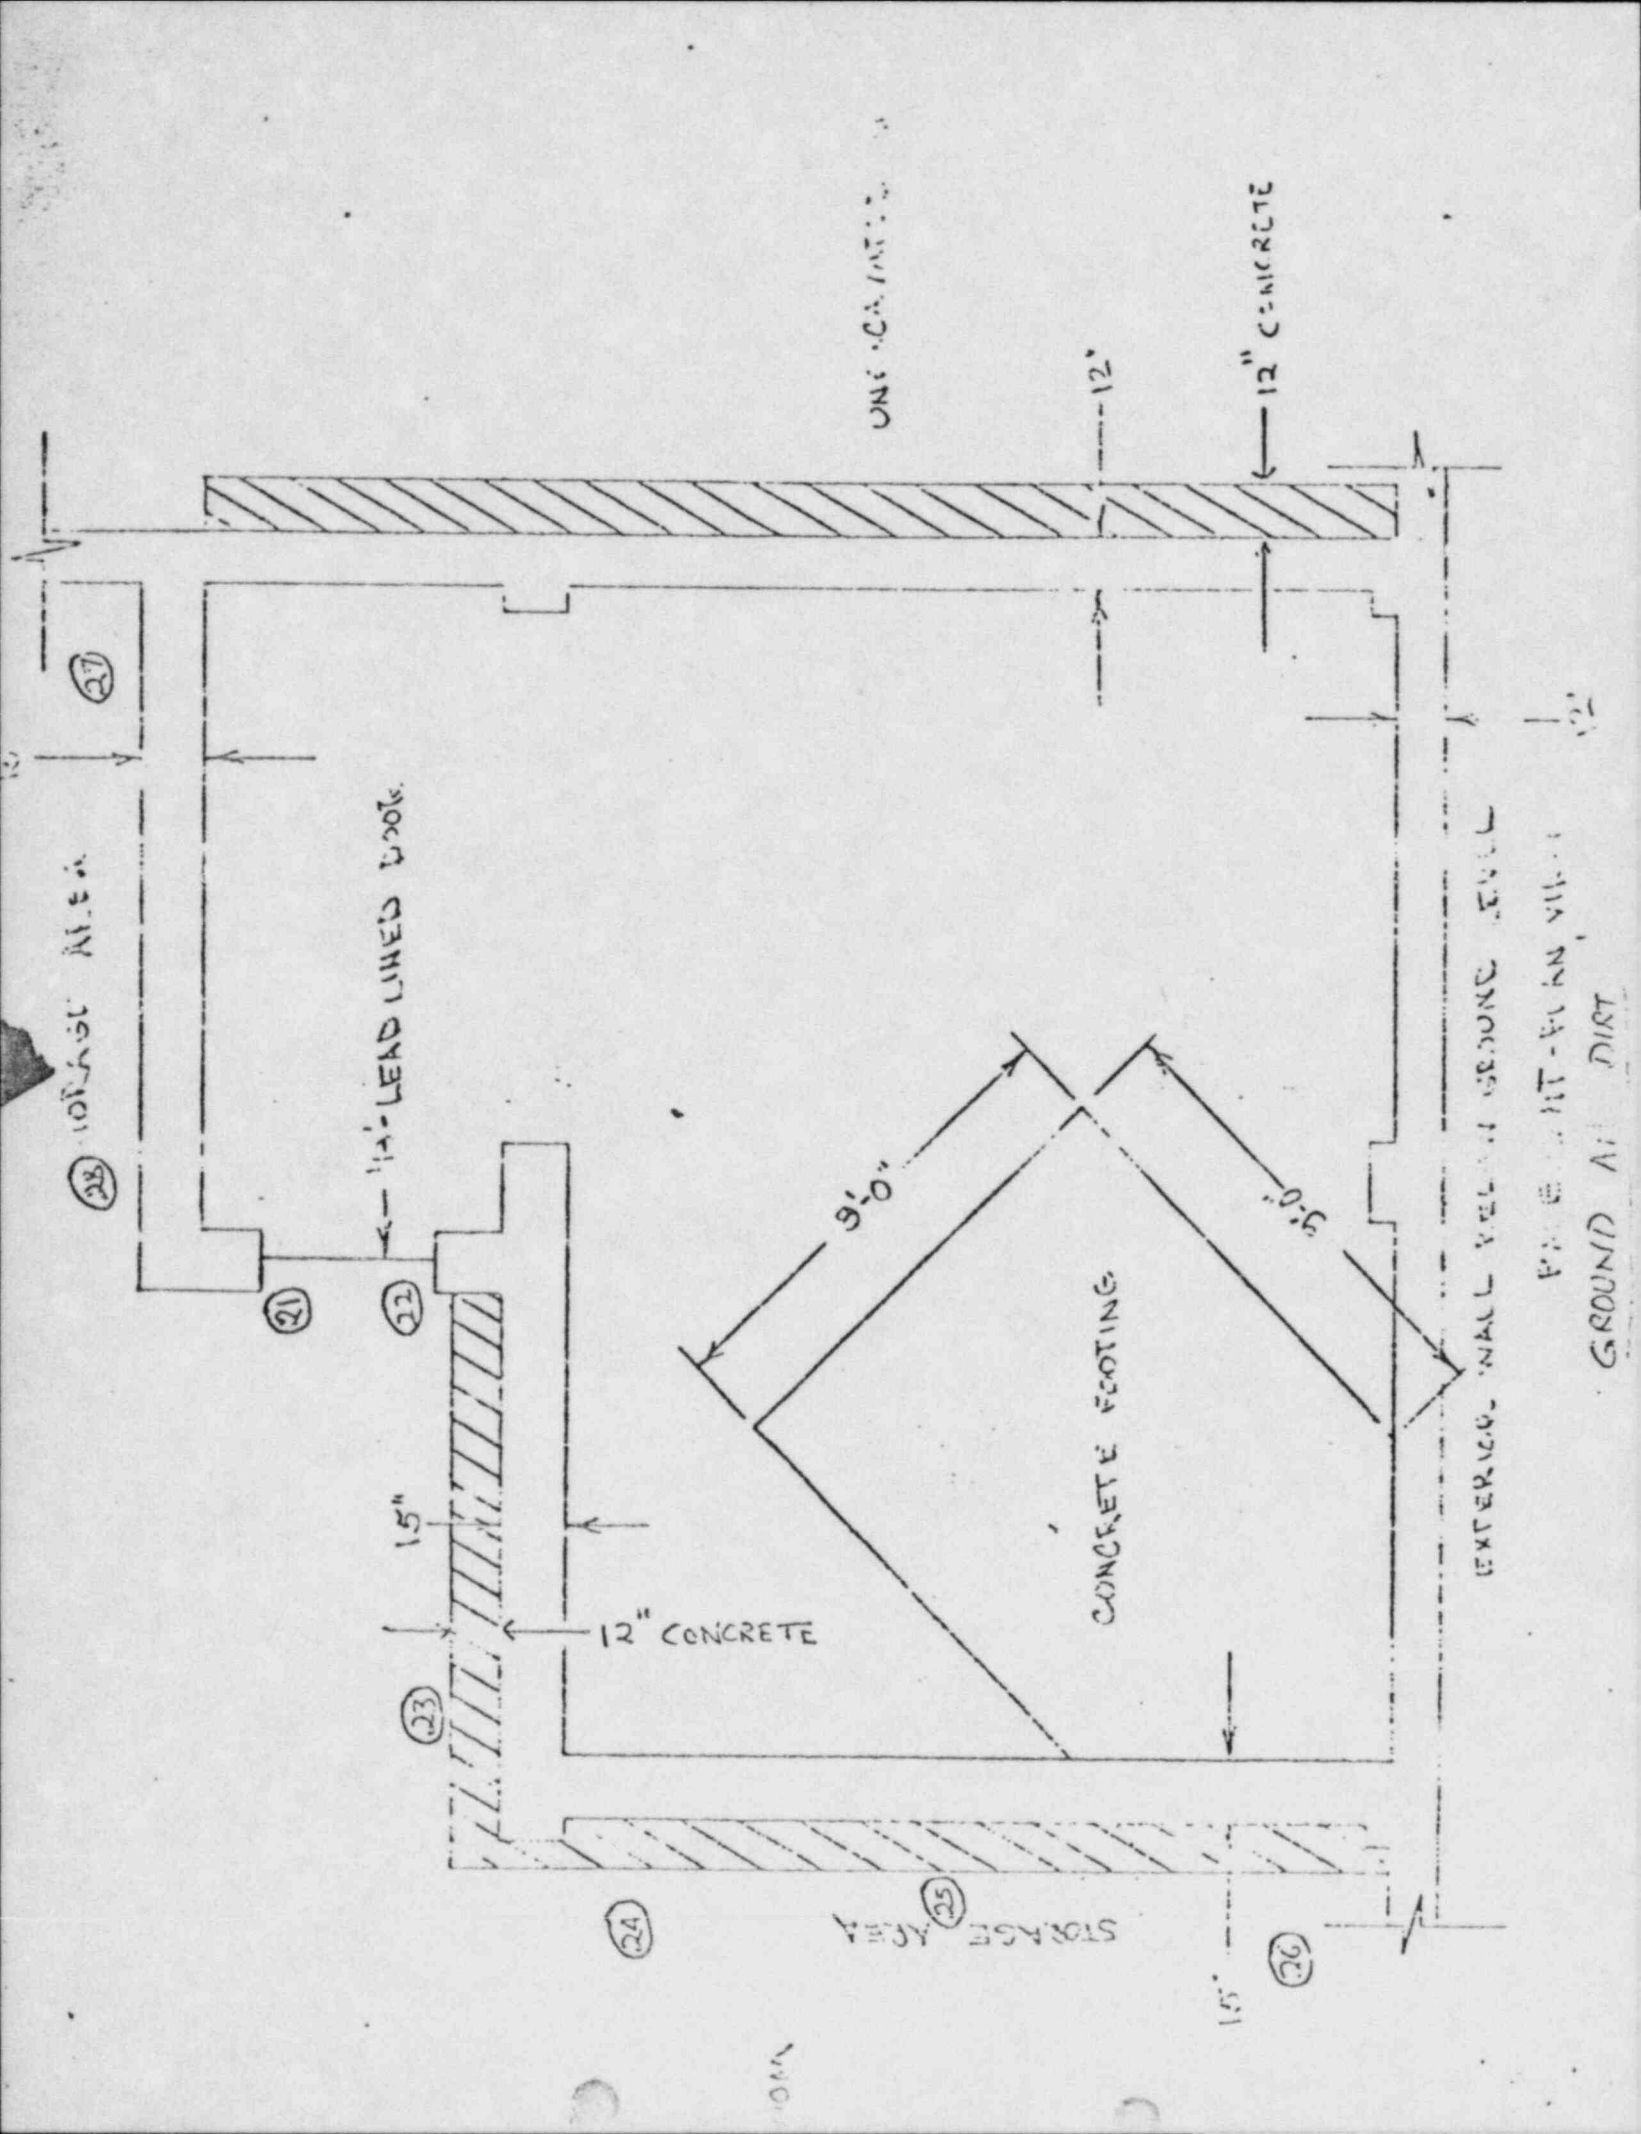
1ST FLOOR - PLAN VIEW

LOCATION	SURVEY POINTS	ESTIMATED EXPOSURE
II <u>Basement Room:</u> (Basement)	Survey points 21 through 28 in all three modes.	No measurable radiation levels detected.
III <u>Patient Rooms:</u> (First Floor)	Survey points 29 through 55 in all three modes.	No measurable radiation levels detected.
