Subject: Duane Arnold Energy Center  
Docket No: 50-331  
Op. License DPR-49  
Licensee Event Report #94-006

**LICENSEE EVENT REPORT (LER)**

TITLE (4) Reactor Water Cleanup Isolation Due to Incomplete Valve Closure Caused by Position Indicator Obstruction

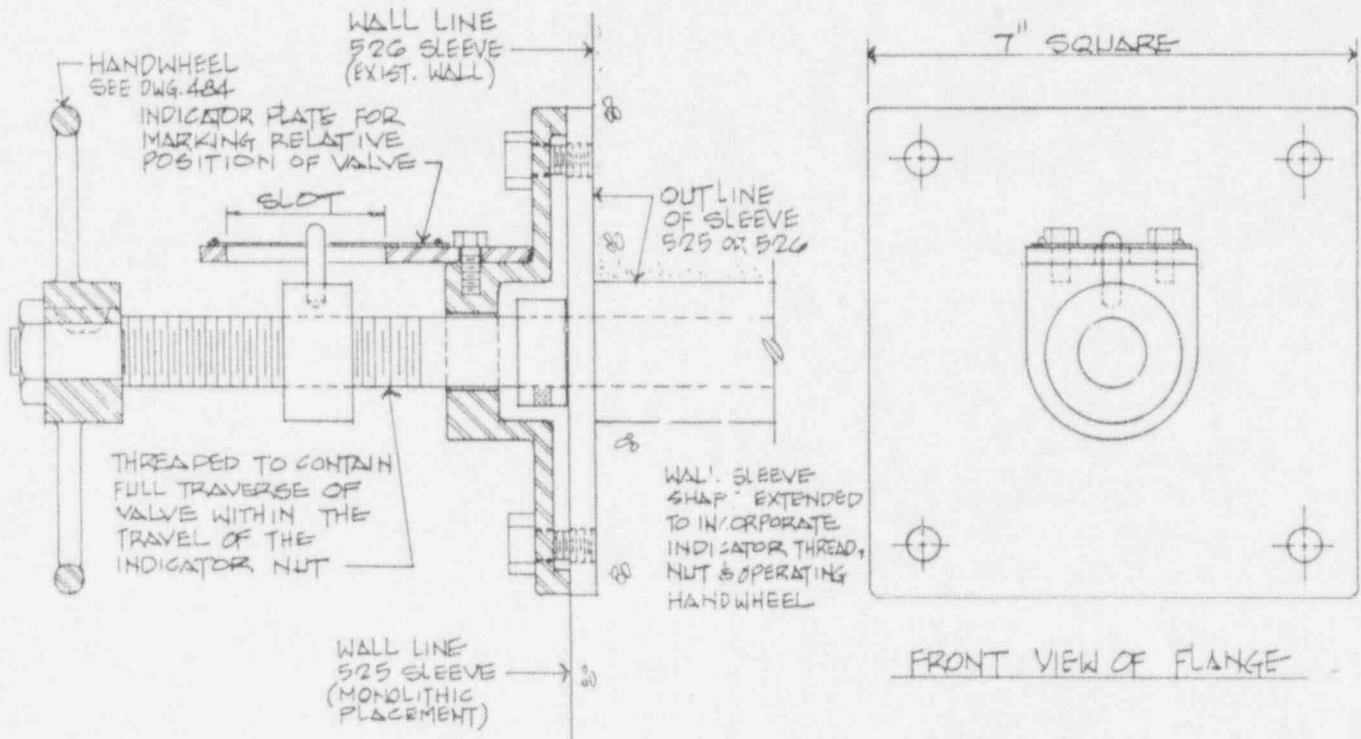
FIG. 1

A second operator was sent to the room who instructed the first operator to verify the valve positions of those valves on the tagout. Upon actions to locally check shut the "A" pump discharge valve, the position pointer on the Roto Hammer valve extension broke off, after which the valve was able to be moved 1/2 turn in the closed direction.

The cause of this event was the remote position indicator on the Roto Hammer valve extension for the "A" RWCU pump discharge valve preventing full valve closure. The position indicator, when at the end of its travel, was able to draw the stem of the remote handwheel tight, simulating valve closing torque (See Fig. 1). This and the fact that it also indicated closed, misled the operator into believing the valve was closed.

A contributing factor to the indicator problem was an improper set up of the indicator nut during previous maintenance. The indicator had been previously broken and was replaced with a new pointer and indicator nut. This work was done with the system operating and the valve in the open position. Upon installation of the new indicator nut, it was adjusted to indicate open. Subsequent cycling of this valve has shown that the position indicator travel length is insufficient to allow for full valve travel. Also, because the critical function of this valve is to isolate the pump, the position indicator should have been set up with the valve in the fully closed position. These considerations were not understood at the time the maintenance was performed.

2. The position indicator will be repaired and modified on the "A" RWCU pump discharge valve. The modification will eliminate the possibility of the position indicator inhibiting full valve travel. This action will be completed by July 30, 1994.

5. A plant page speaker will be installed in the RWCU pump room. This action will be completed by June 30, 1994.
6. A new maintenance procedure will be developed that will specify the proper means for installation and set up of the position indicators. This action will be completed by July 29, 1994.
