Report No. 50-338/94-002-00

FACILITY NAME (1)  
North Anna Units 1 & 2

TITLE (4)  
POSTULATED FAILURE OF HIGH HEAD SAFETY INJECTION PUMP DISCHARGE CHECK VALVE

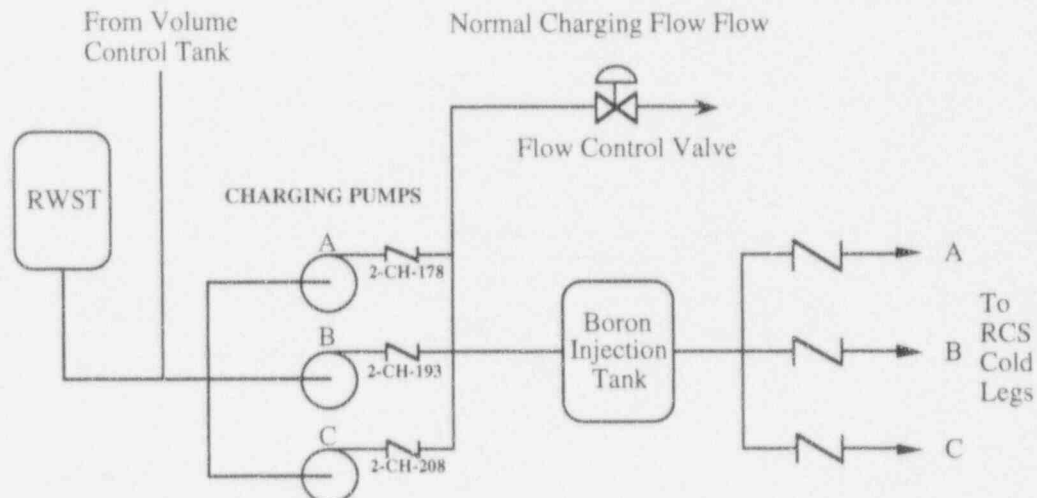
**UNIT 2 HIGH HEAD SAFETY INJECTION  
NORMAL FLOW PATH**

No significant safety consequences resulted from this event because sustained failure of a check valve to close simultaneously with a Design Basis Accident was determined to be improbable. The momentary hang-up that the check valve experienced would cause a temporary transient flow situation, but would be of minor consequence with respect to Emergency Core Cooling System (EISS System JE) performance. Therefore, the health and safety of the public are not affected by this event.
