U.S. NUCLEAR REGULATORY COMMISSION  
REGION I

Docket/  
Report No. 50-213/94-05

Facility: Haddam Neck Plant

### HADDAM NECK PLANT INSPECTION 50-213/94-05

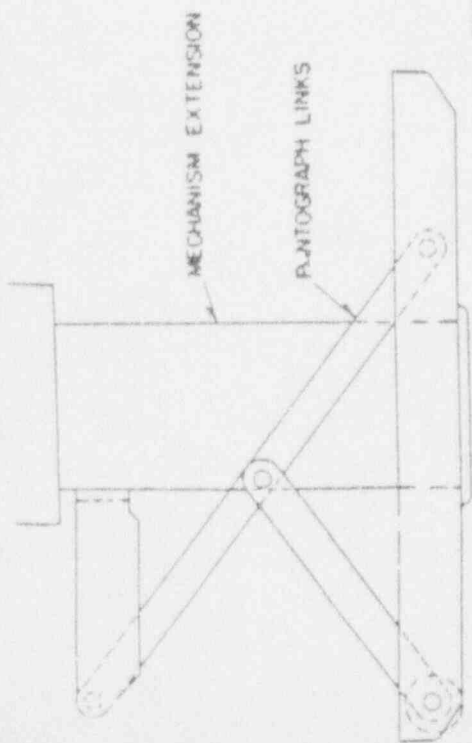
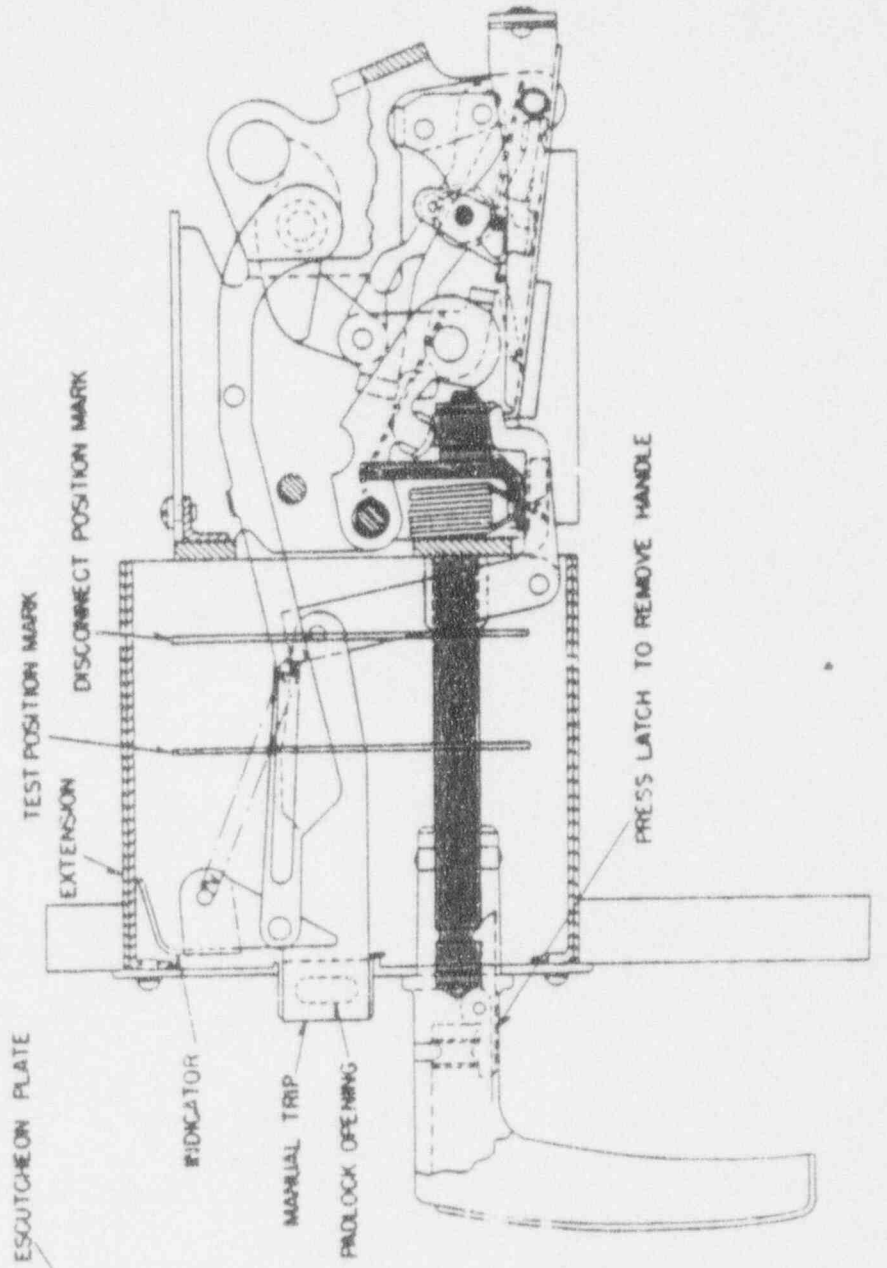
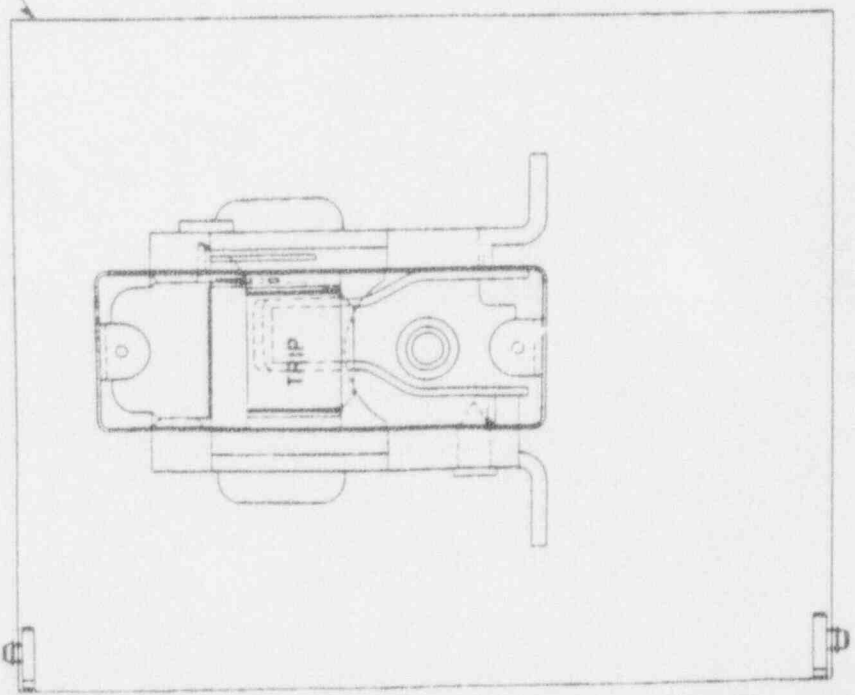
- Troubleshooting Breaker 11C:
  - Visual Inspection Revealed Snap Ring Out of Position
  - Breaker 11C Failed to Close on Bench
  - Breaker 11C Successfully Tested on Bench (5 Cycles) With New Operating Mechanism
  - Breaker 11C Inserted Back Into Switchgear and Tested Successfully
- A Similar DB-25 Breaker Failed on Bench With Its Snap Ring Intentionally Mispositioned
- Dimensional Inspection of Snap Ring and Shaft of Breaker 11C in Comparison to Design
- Tensile Test of Snap Ring in Comparison to New Item
- Historical Review Identified Similar Event During 1986 Refueling Outage (1/17/86)

- The Cause of the Failures of MCC-5 Supply Breaker 11C is the Operating Shaft Snap Ring Being Out of Position
- The Root Cause has been Determined to be Improper Installation of the Snap Ring Following Breaker Maintenance

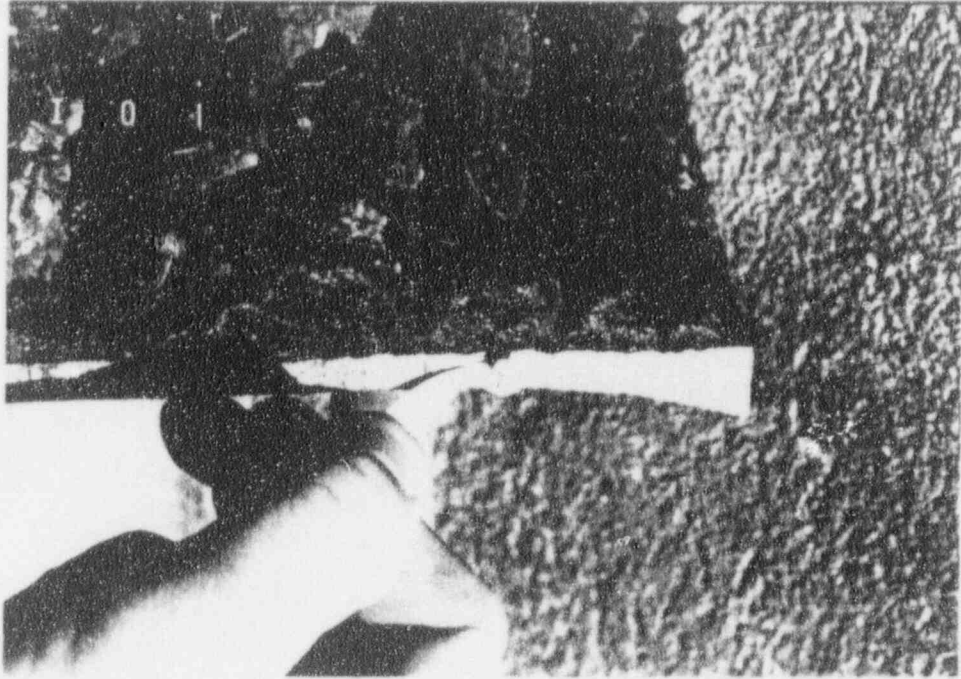
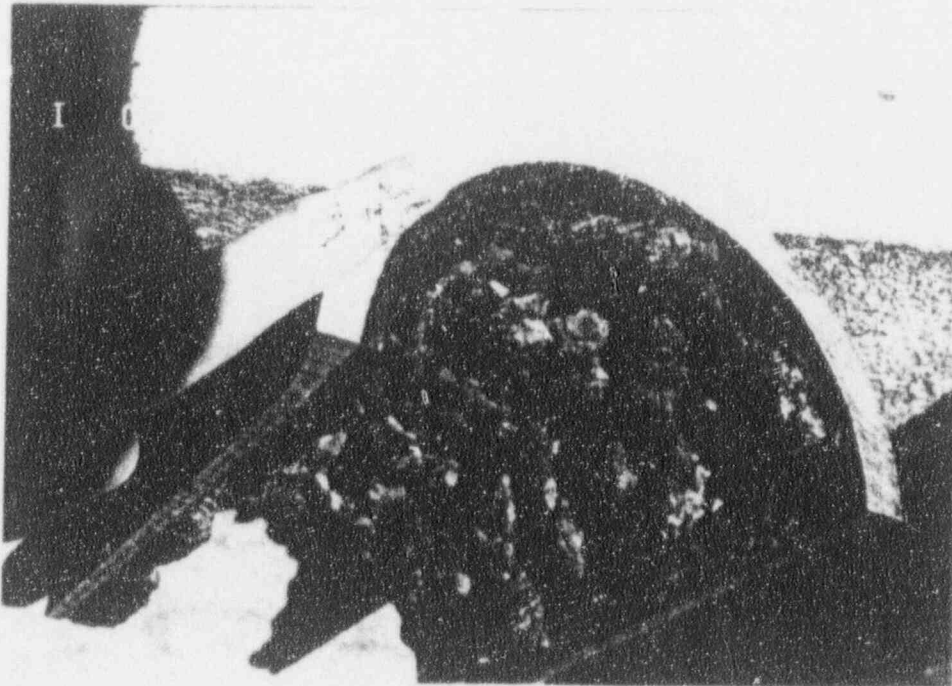
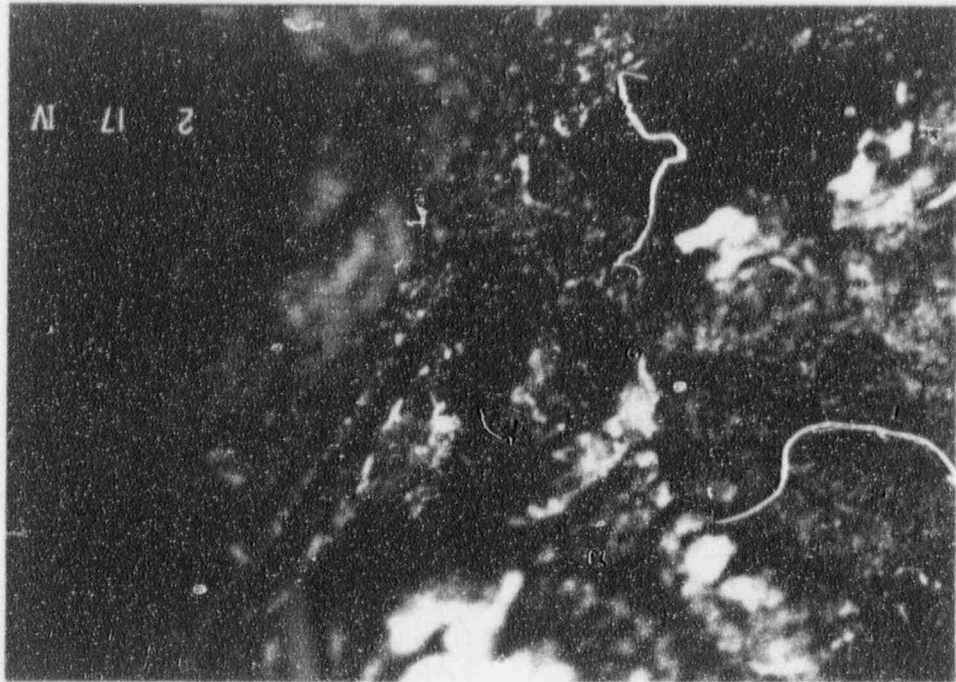
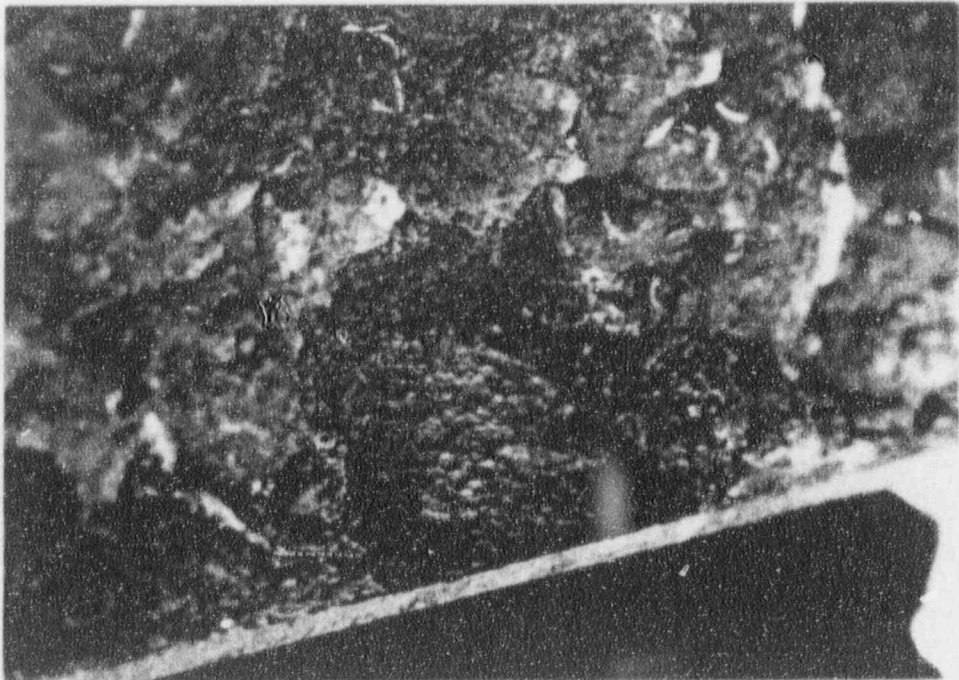
Weld #21 EDG 2/17/94

- Visual:
  - Tubercles 1/2" to 2" dia. 1/2" Thick
  - Some Attack of Base Metal Under Tubercles
  - Some Pits in Welds 1/4" Dia., 1/2" into Weld, 50% to 80% Through Wall
- Microbiological:
  - Positive Growth of Aerobic Metal Oxidizing Bacteria
  - Positive Growth of Anaerobic Acid Producing Bacteria
- Chemical Examinations:
  - Water Sample Analysis at MIC Sites Indicated Only Slightly Corrosive or Stable Water Environment

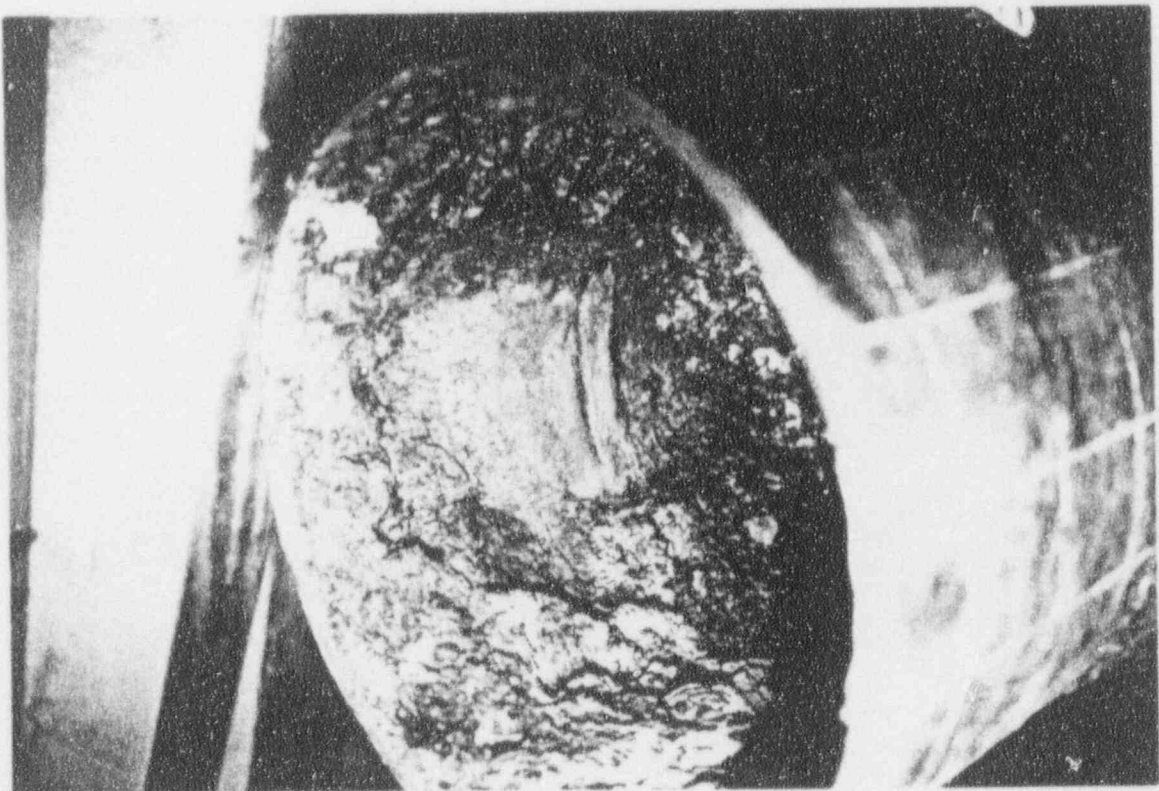
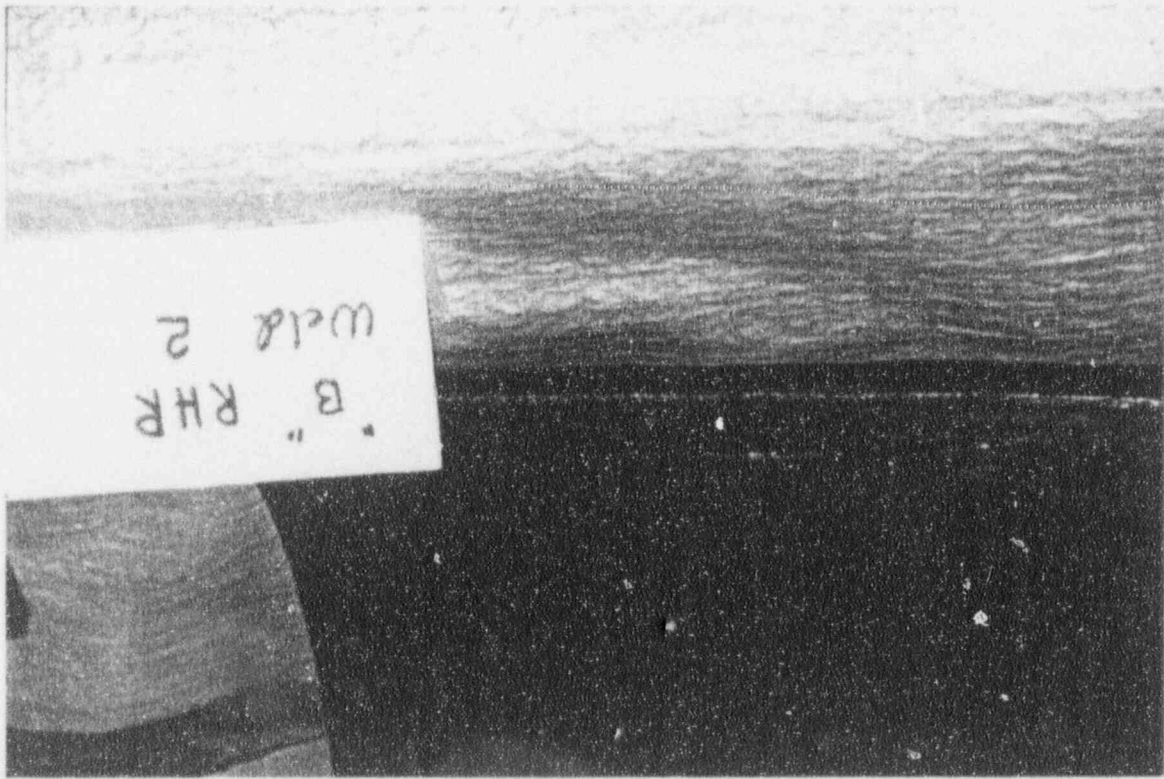
"B" RHR"  
Weld 2

Supply to RHR Heat Exchanger

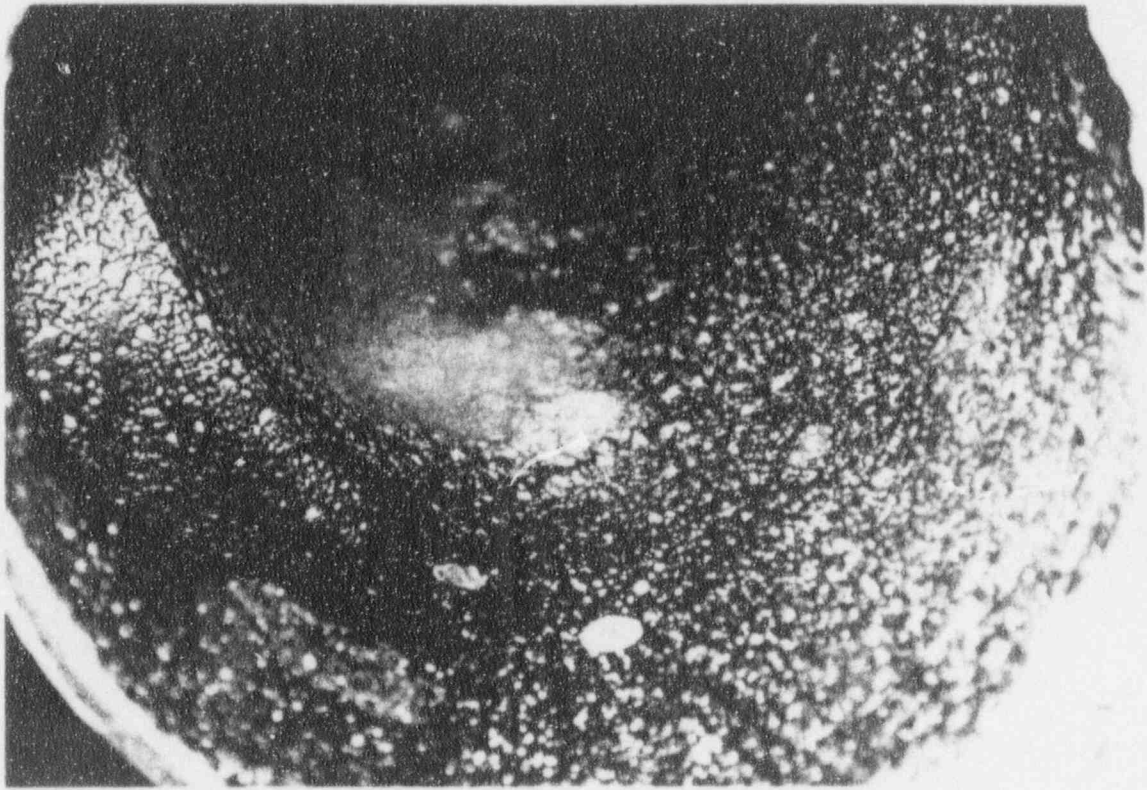
**Service Water Supply  
Header to Adams Filters and RHR Heat Exchangers**

- Passive Anaerobic Bacteria Found in Aerobic  
Environment
