Examination of Failed Studs From No. 2 Steam Generator at the Maine Yankee Nuclear Power Station

Prepared by C. Czajkowski

Brookhaven National Laboratory

Prepared for
U.S. Nuclear Regulatory
Commission

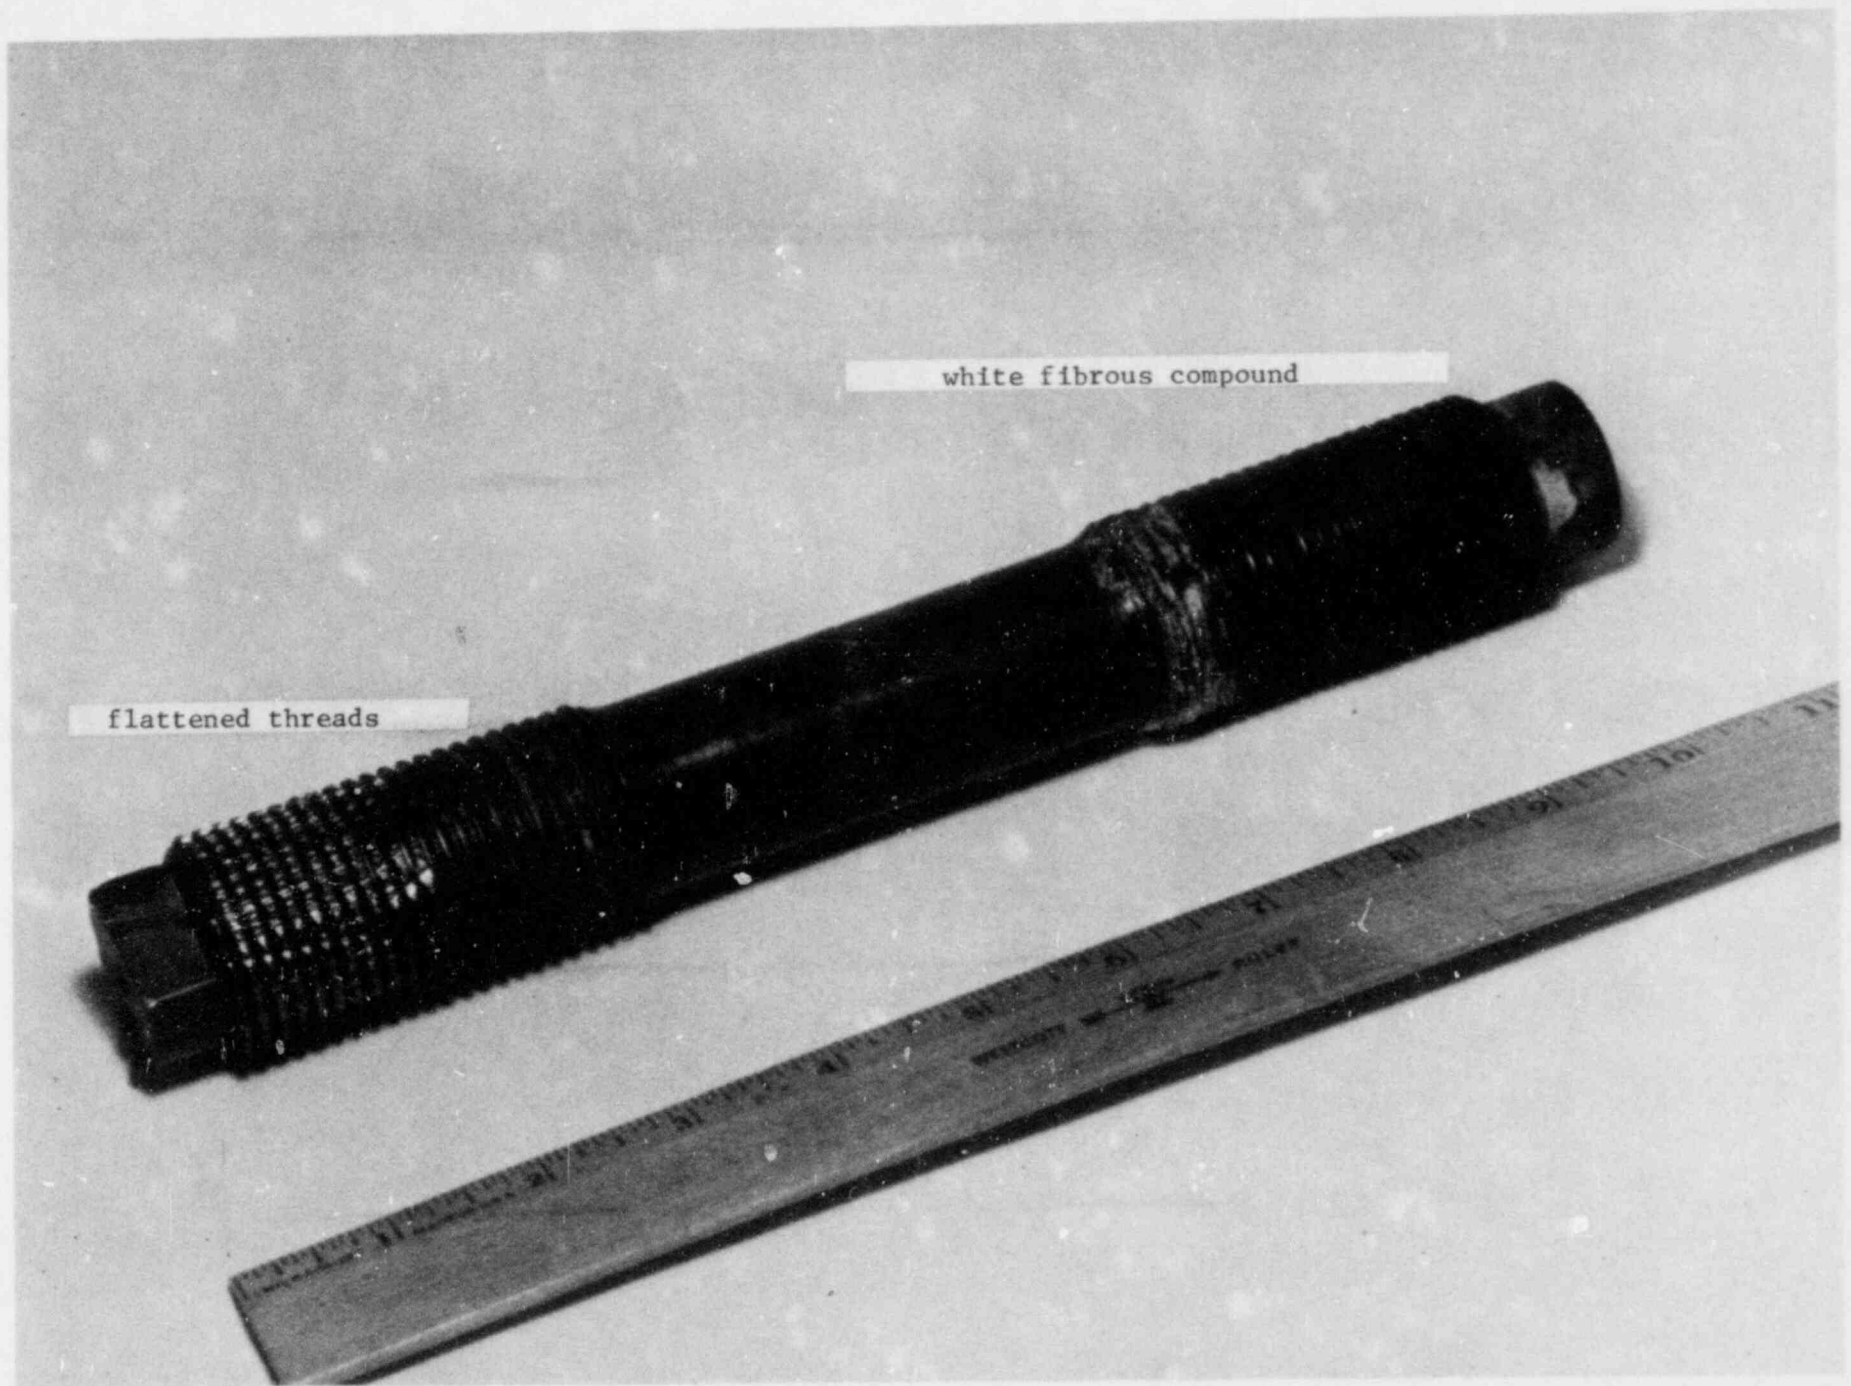
The first stud examined (Figure 1) had apparent disruption to the thread area which had the appearance of damage caused by the use of a vise grip-type tool. There was also a white fibrous type coating on the opposing thread area of the stud (discussed in the SEM section).

Dye penetrant examination was performed on the first two studs (Figures 1 and 2) using Spotcheck Brand (all Formula B) penetrant type SKL-HF/SKL-S developer type SKD-NF and cleaner/remover type SKC-NF. There were no relevant indications seen on the two studs. It should be noted that there was a tight black adherent film on the thread area of all studs examined, possibly from prior lubricant application (see SEM section).

Figure 1. Photograph of "as received" stud from Maine Yankee. (Bolt had the following numbers stamped on the ends - 2C6, #46500, 6410).

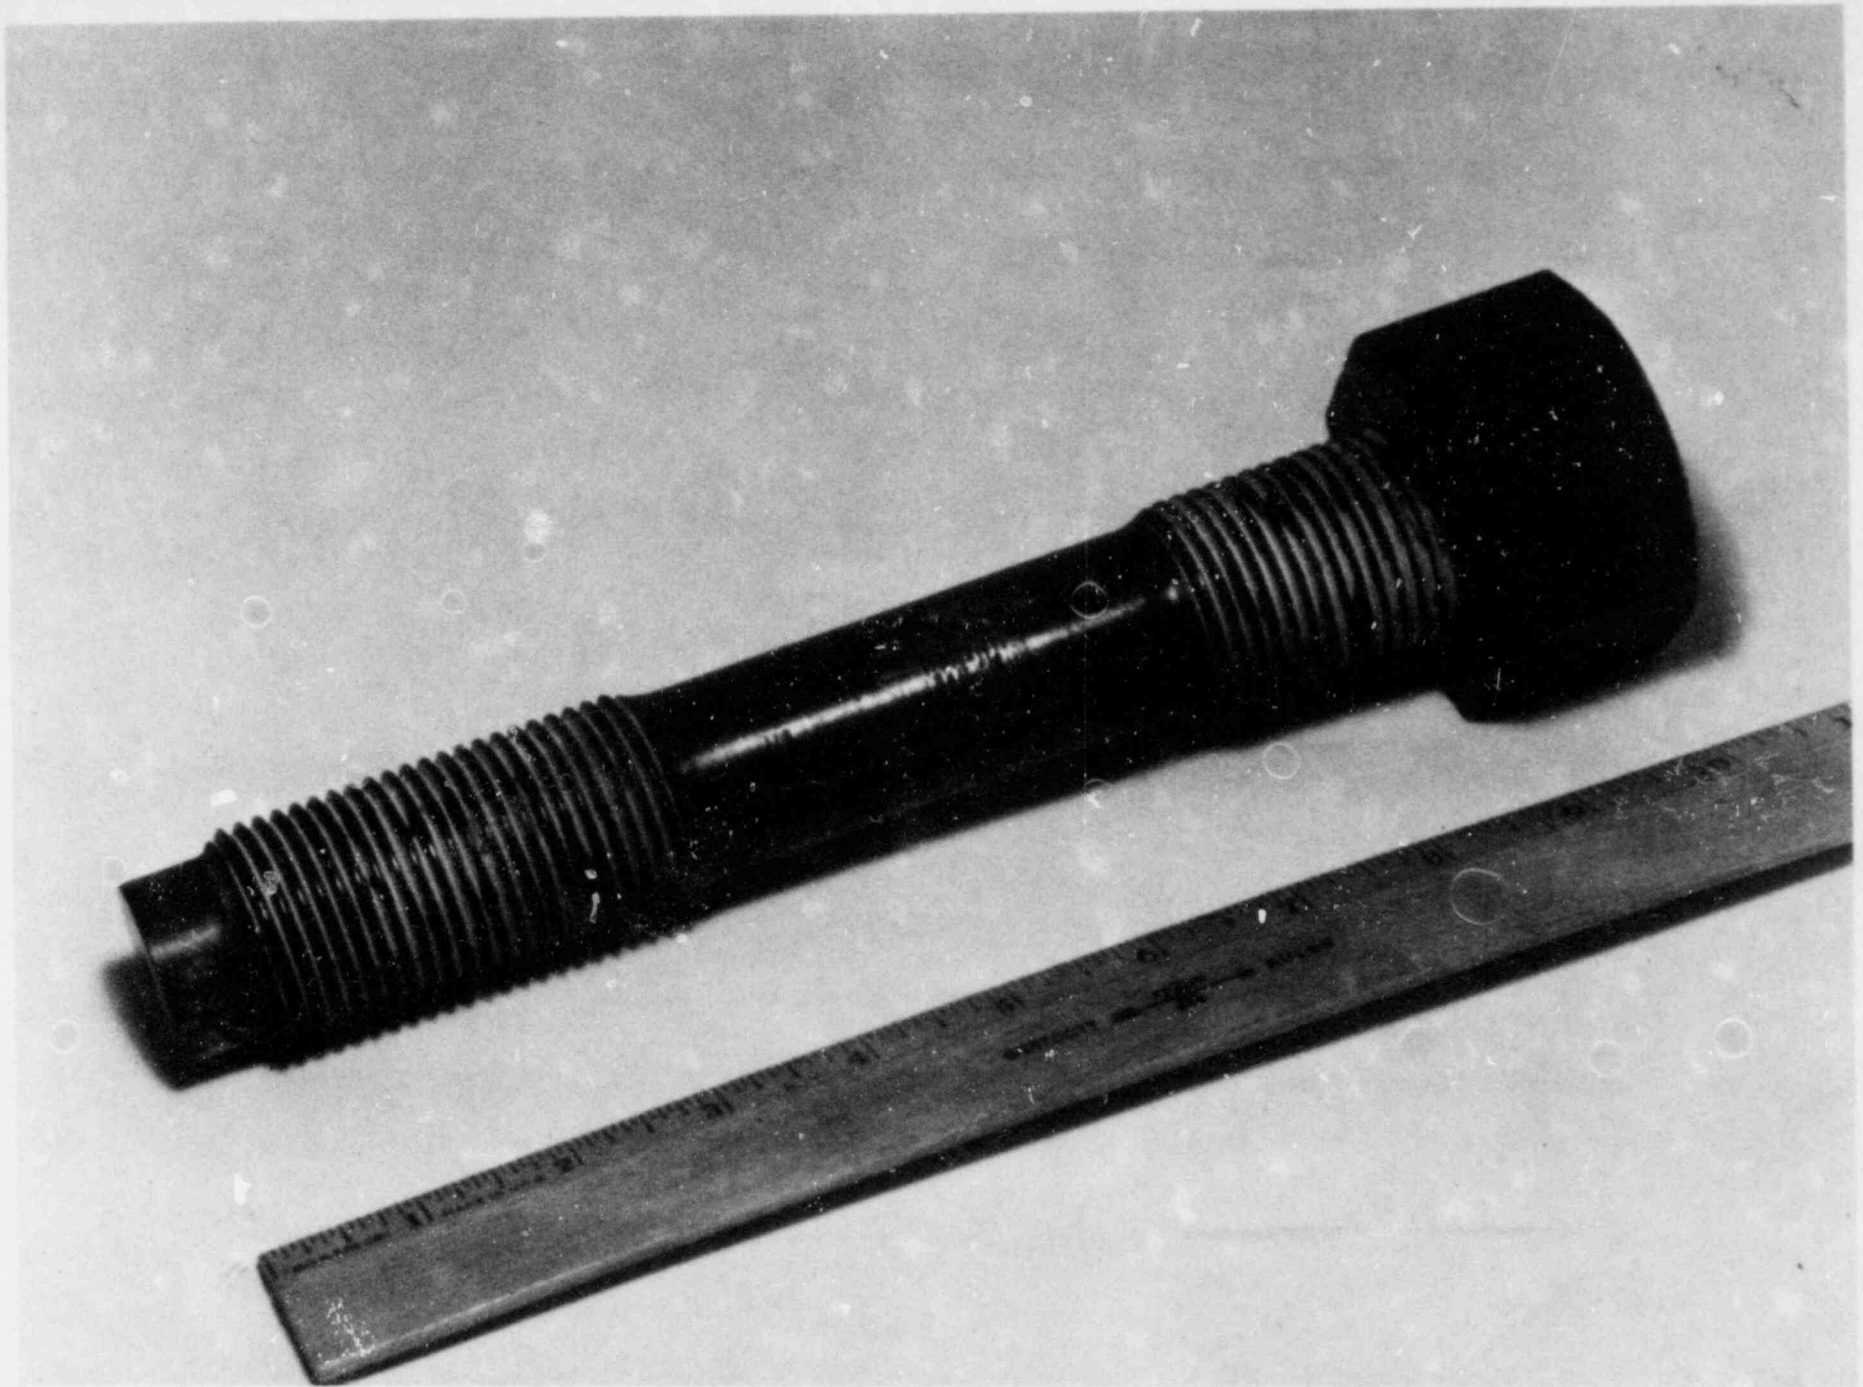
The second stud examined (Figure 2) appeared to have residue from prior dye penetrant examinations and had a nut threaded on to one end of the stud. This nut was removed prior to dye penetrant examination by cutting (due to the extremely tight fit to the stud).

Figure 2. Photograph of second stud received from Maine Yankee. Photo depicts remnants of Dye Penetrant testing. (Bolt had the following numbers stamped on the ends (2C20, #64034)).

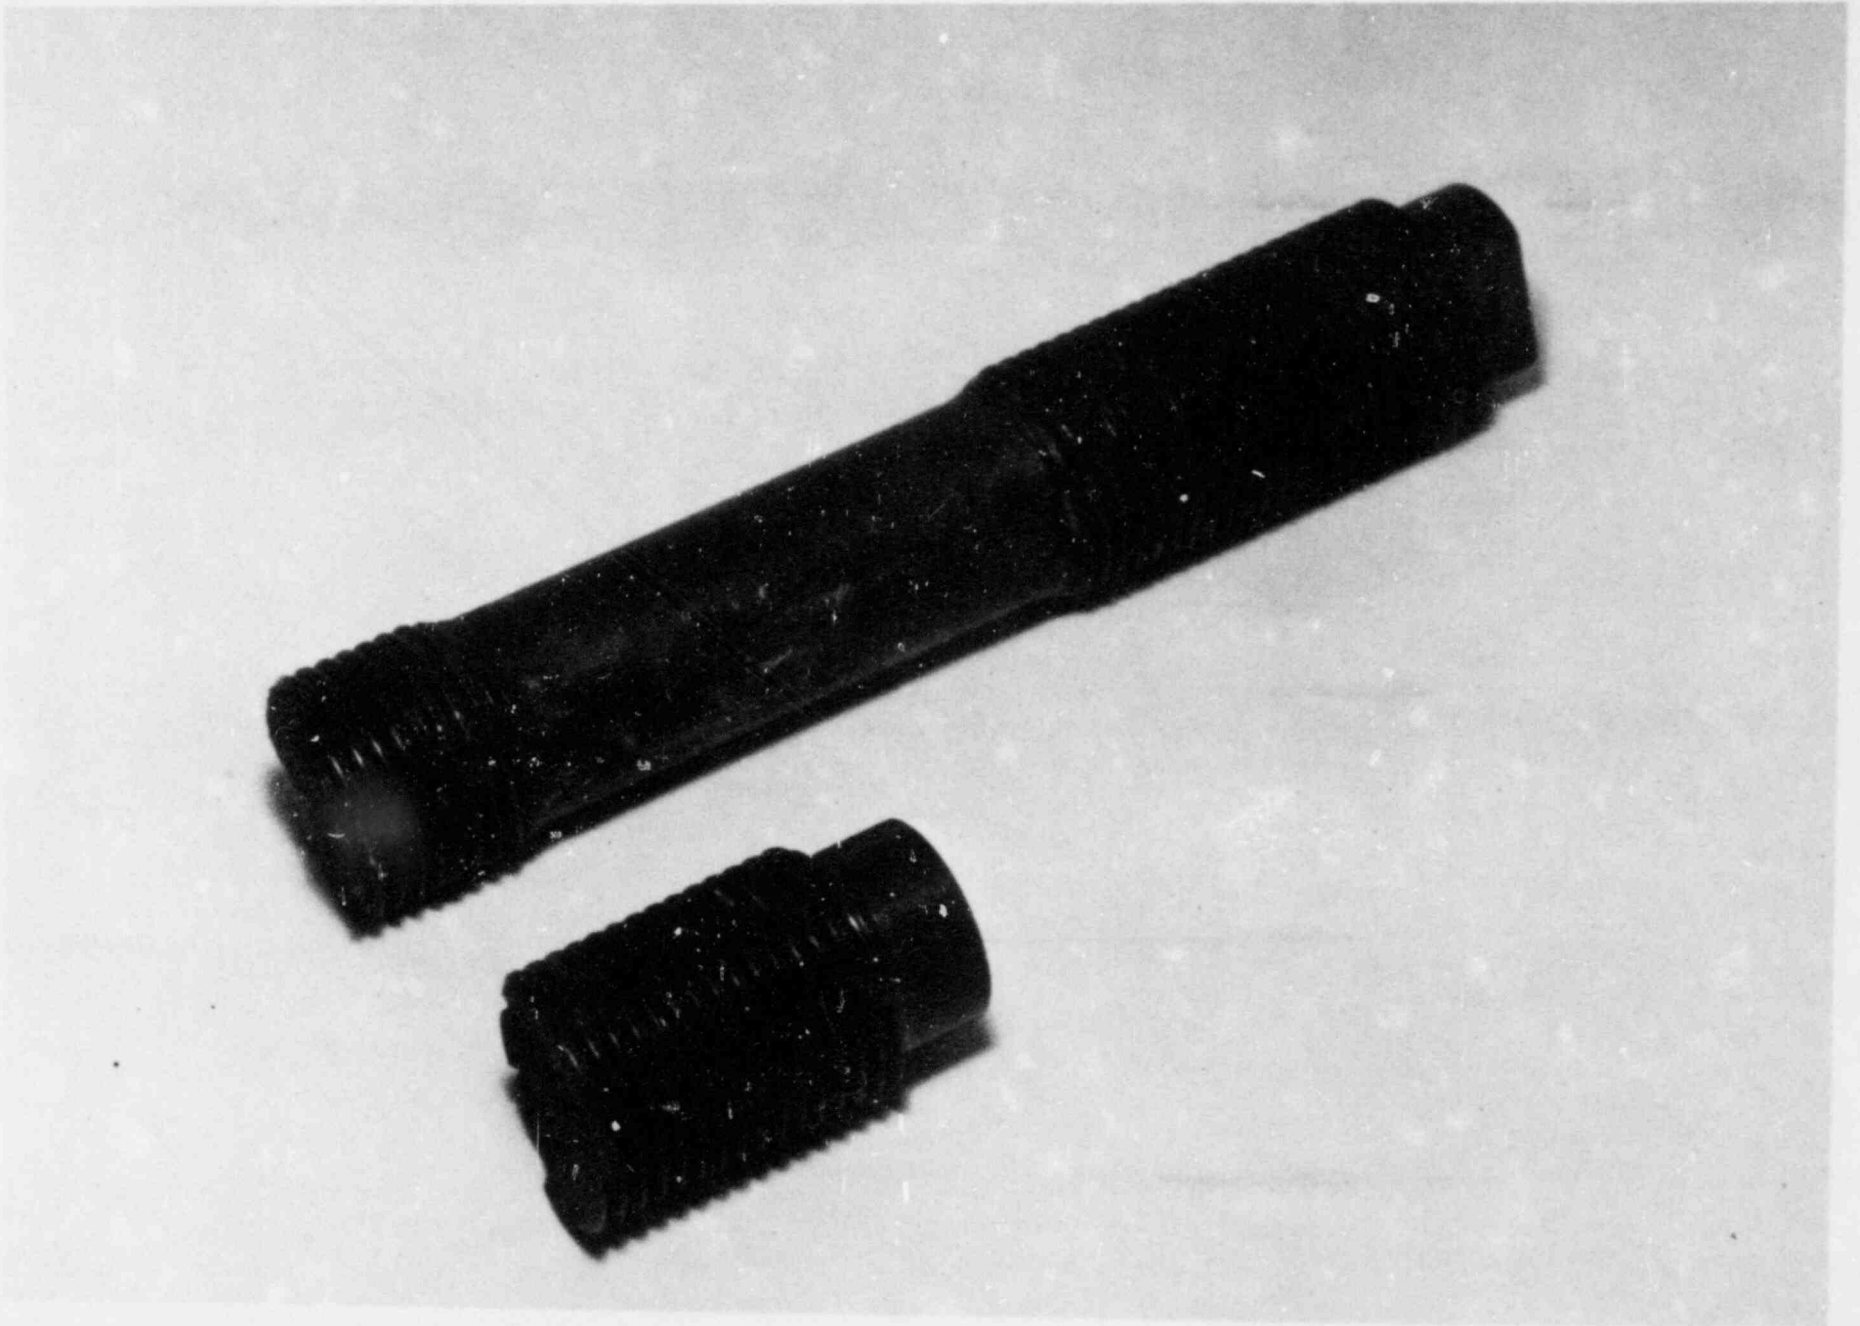
Figure 3 is a photograph of a "through cracked" stud. The crack is approximately 2 1/2" into the thread area "inserted end" of the stud. The fracture face of the stud (Figure 4) was relatively flat and had a black oxide appearance.

Figure 3. Photograph of "cracked" stud from Maine Yankee (Bolt had the following numbers stamped on the ends-2C8, 6418, #64034).

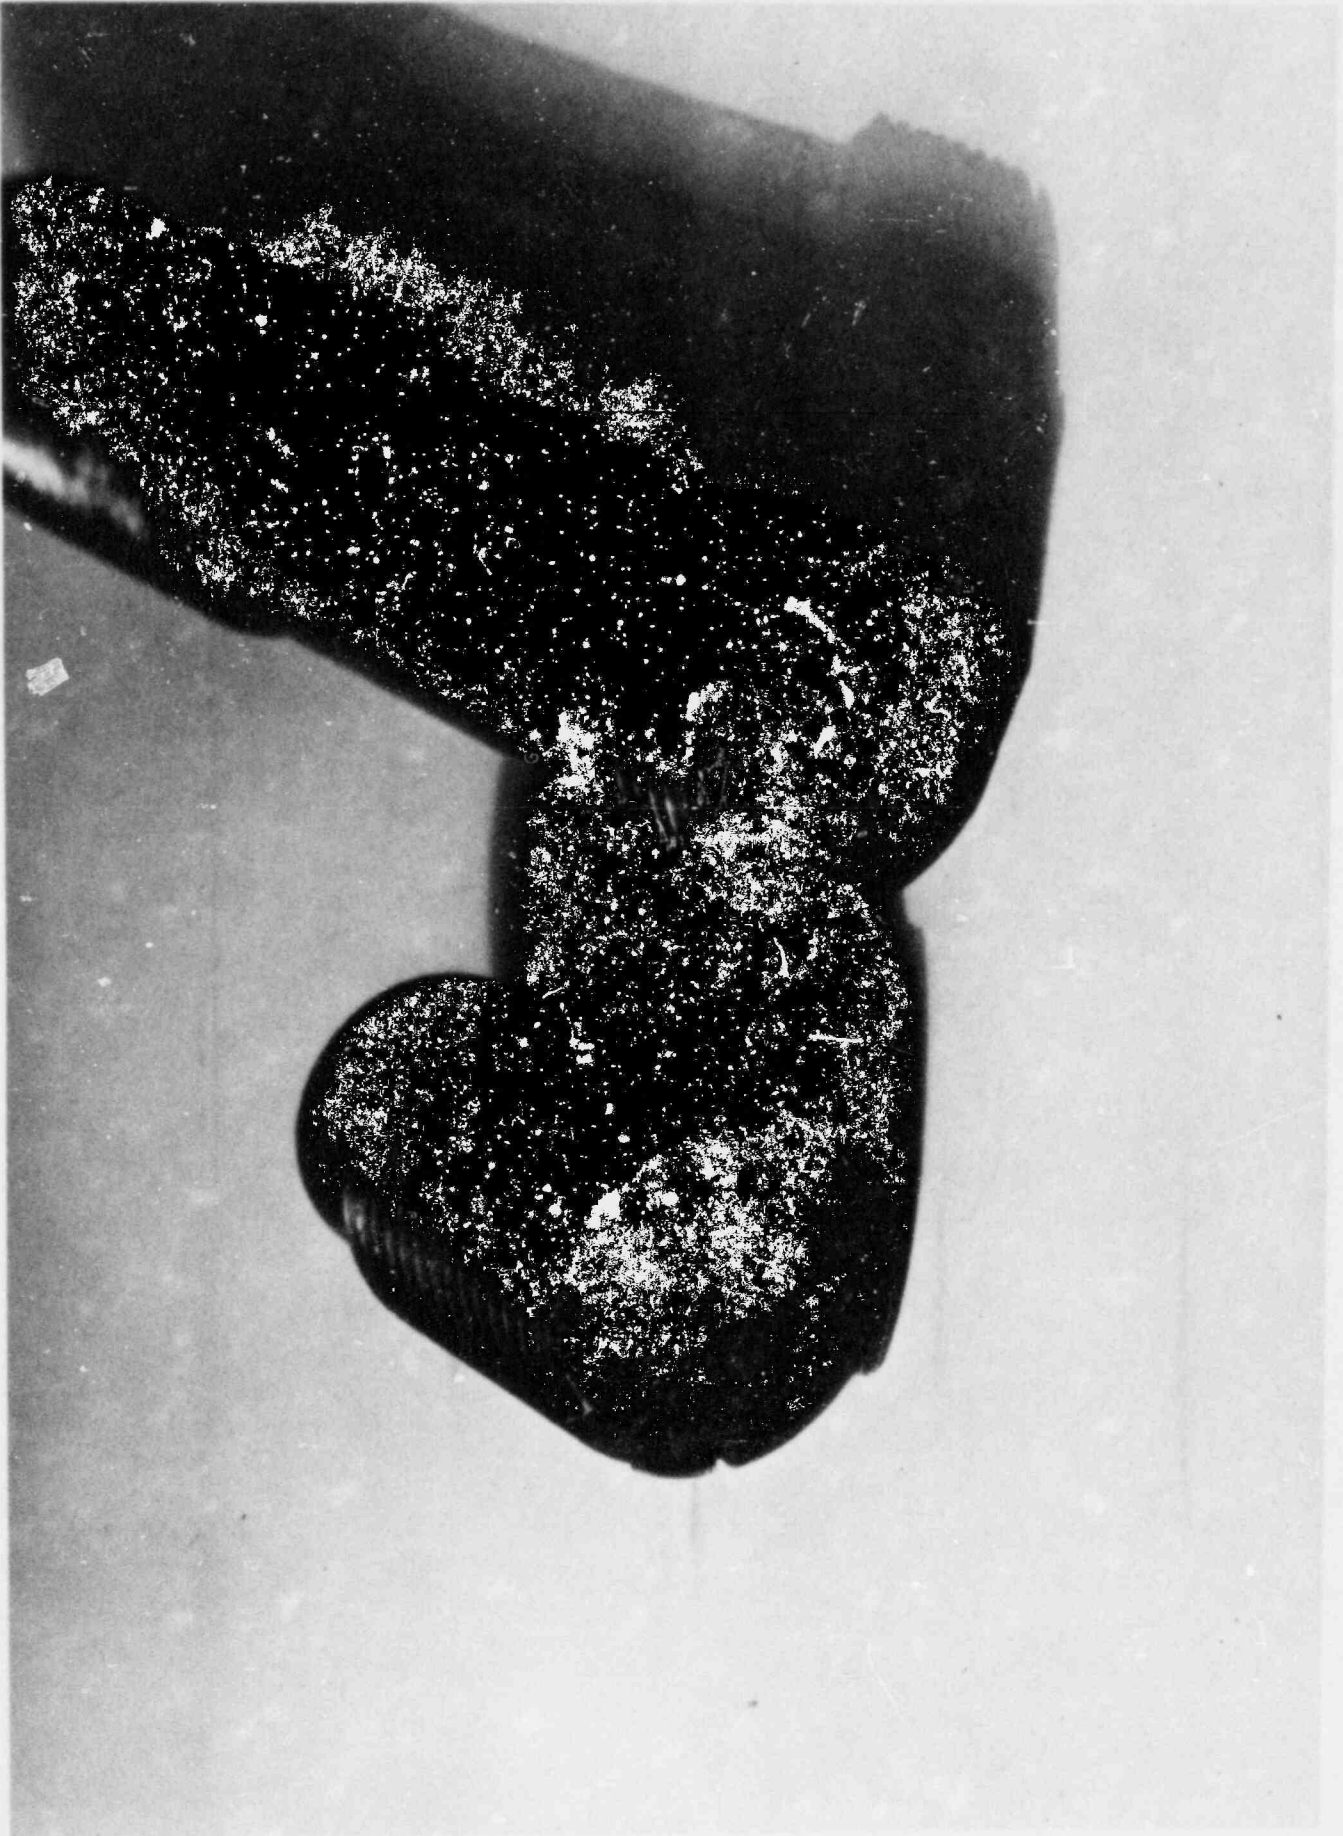
Figure 4. Frontal photograph of the fracture faces of the cracked bolt.

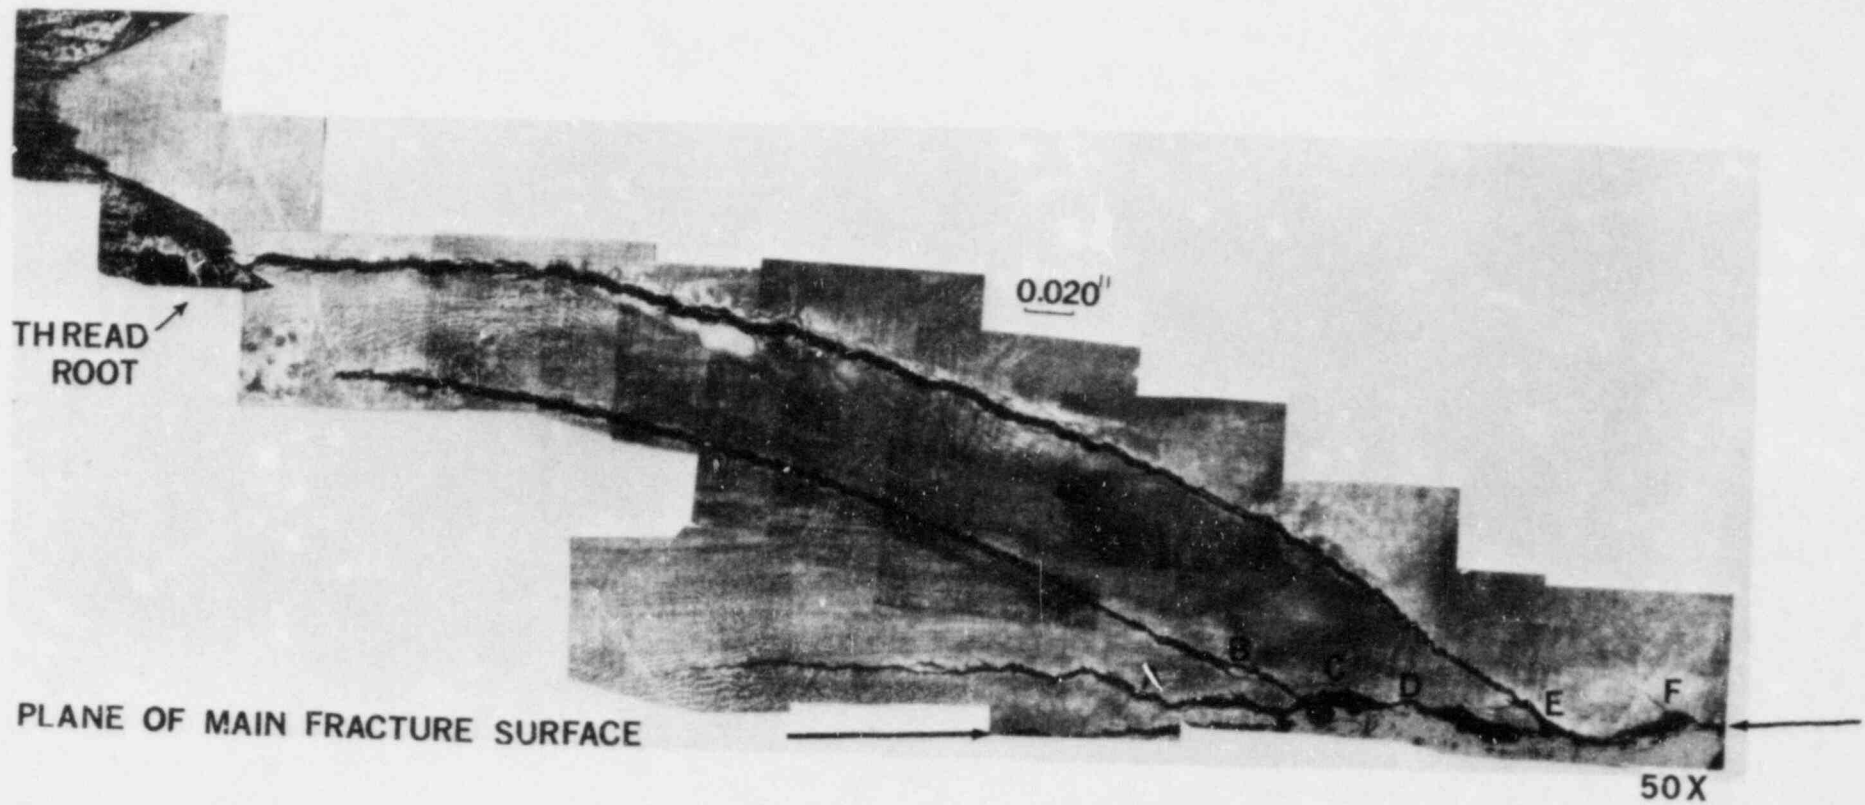
A longitudinal section was made of the small end of the cracked stud, perpendicular to the main fracture face. It was then mounted, etched and polished (Figure 5). It can be clearly seen in the photomicrograph that numerous secondary cracks are present, initiating at the main fracture (areas A-F). These cracks had some fern-like branching associated with them which is normally indicative of environmentally assisted cracking. The major secondary cracks appeared to be generally transgranular in nature. The microstructure of the stud material (Figure 6 & 7) was that of a quenched and tempered martensite with a fine grained microstructural appearance. This microstructure is typical of an ASTM A540-B24 steel (Table 1).

Figure 5. Optical photomicrograph of bolt section depicting extent of secondary cracking (areas A-F). Note fern like branching on larger secondary cracks.

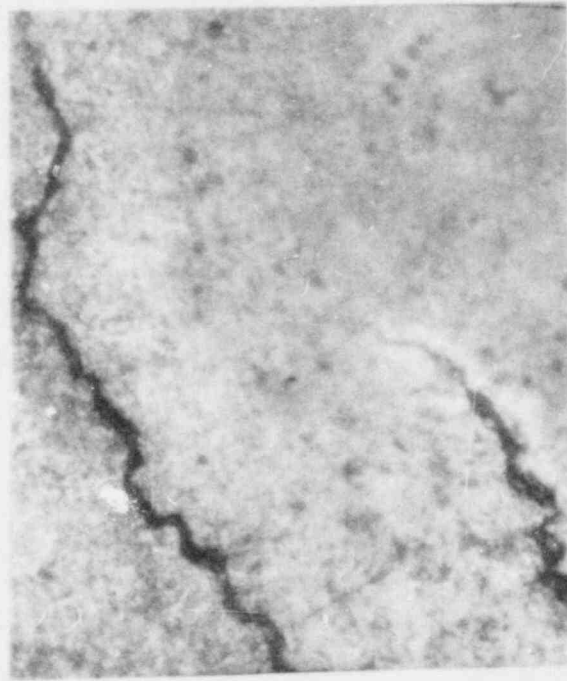
500x
Figure 6. Optical photomicrograph of a secondary crack after etching.

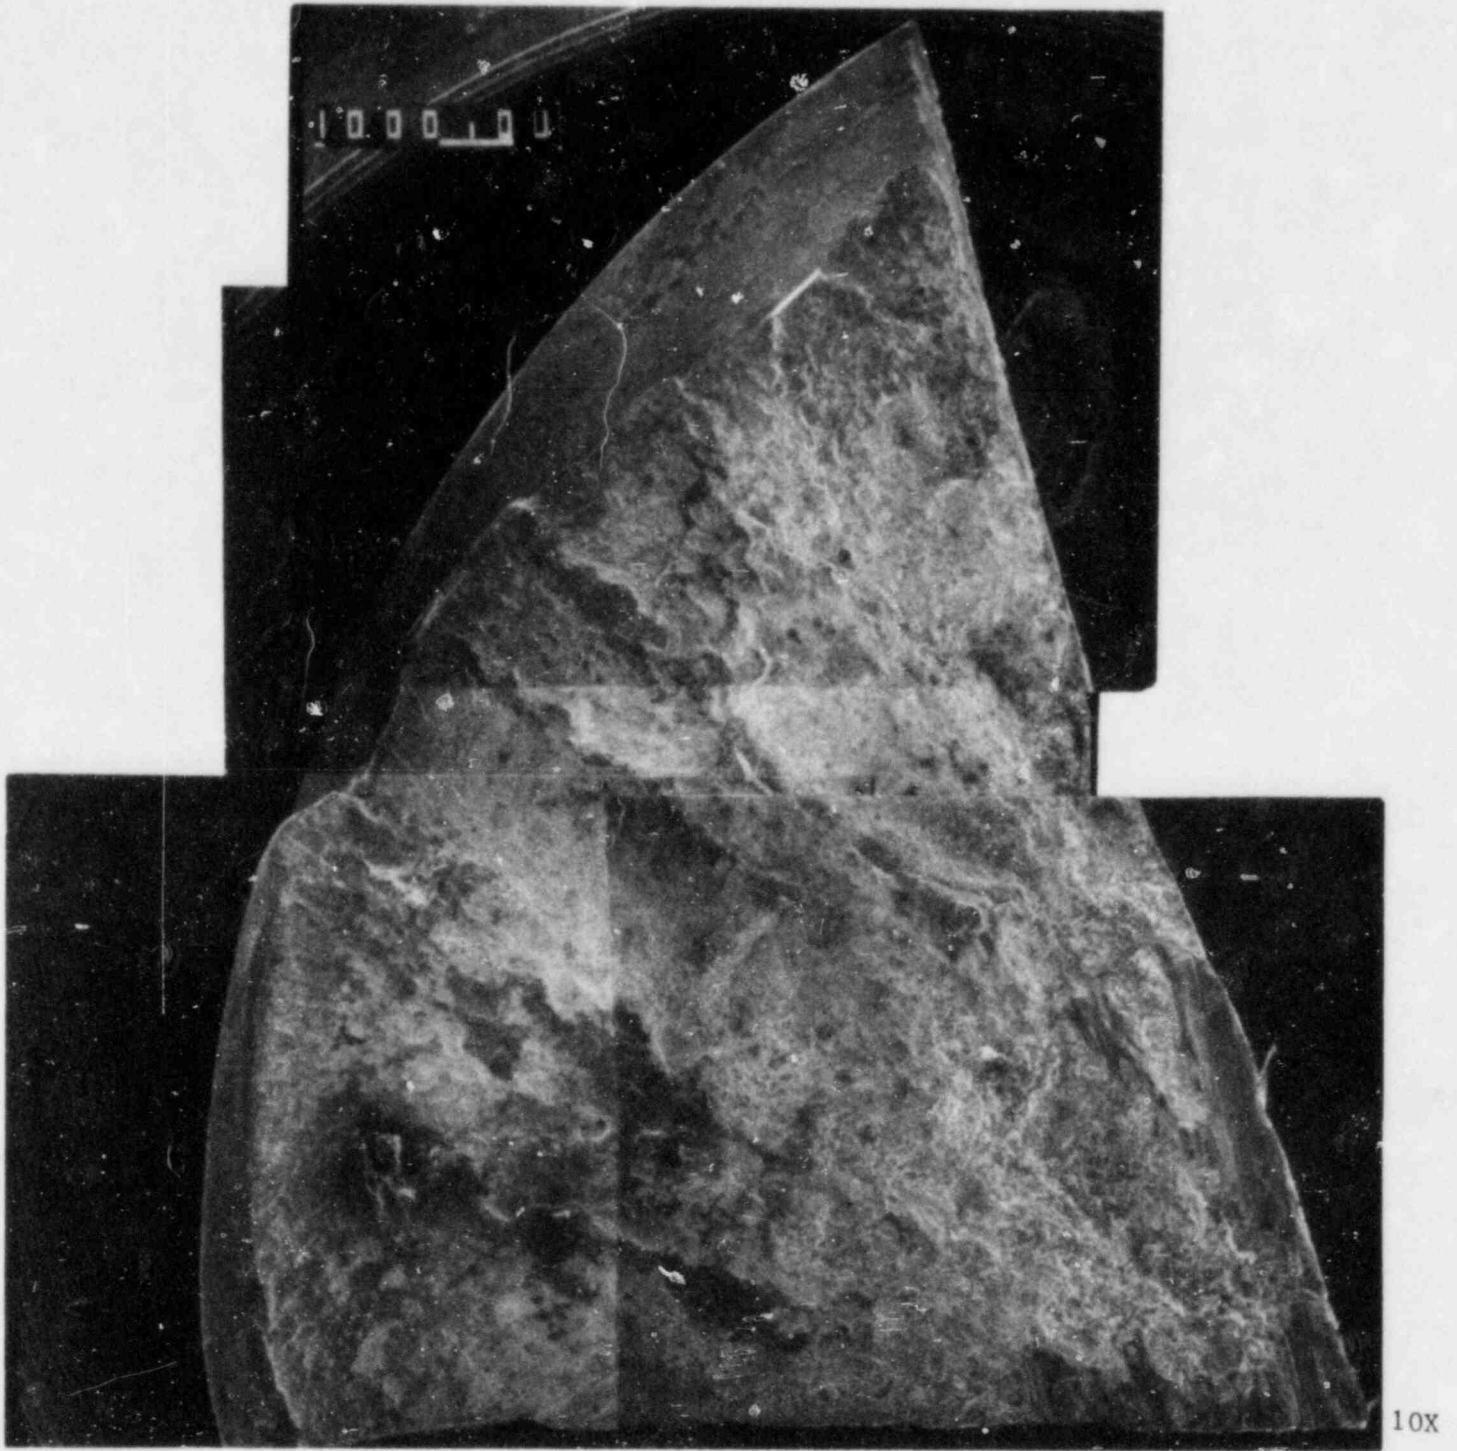
The "as received" surface of the fracture face had a very flat and heavily oxidized surface (Figure 8) with the oxide varying from a nodular type (Figure 9) to an acicular shape (Figure 10). Initial SEM observations were that the fracture face was predominantly transgranular with no evidence of any ductile tearing. After some sections were deoxidized by an Endox 215 solution, however, various areas of apparently intergranular secondary cracking were revealed (Figures 11-13). This type of secondary cracking would be a definite indication of an environmentally assisted corrosion phenomenon.

Figure 8. SEM photograph of a quadrant of the "cracked bolt " fracture face.

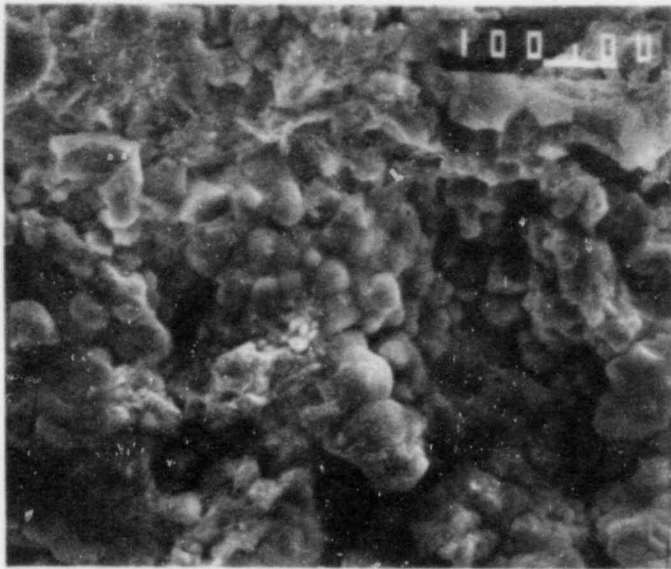
100x
Figure 9. SEM photograph of "nodular" oxide.

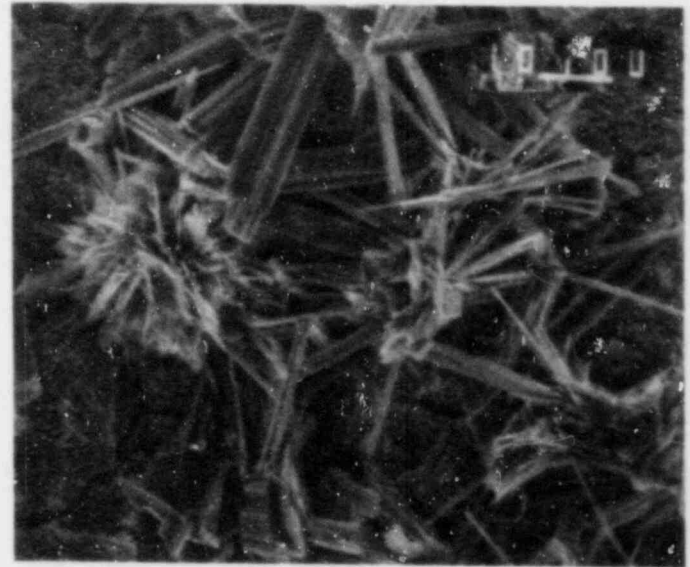
1000x
Figure 10. SEM photograph of "acicular" oxide.

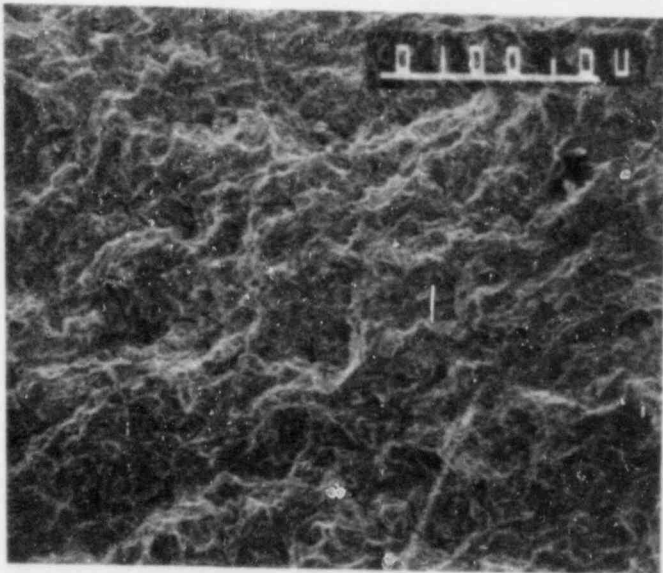
100x
Figure 11. SEM photo of fracture face prior to deoxidation treatments.

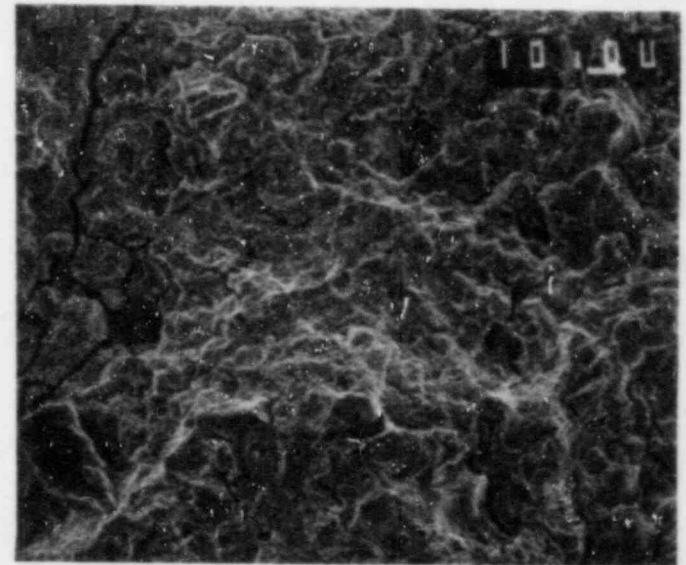
500x
Figure 12. SEM photo of fracture face depicting intergranularity of secondary cracks.

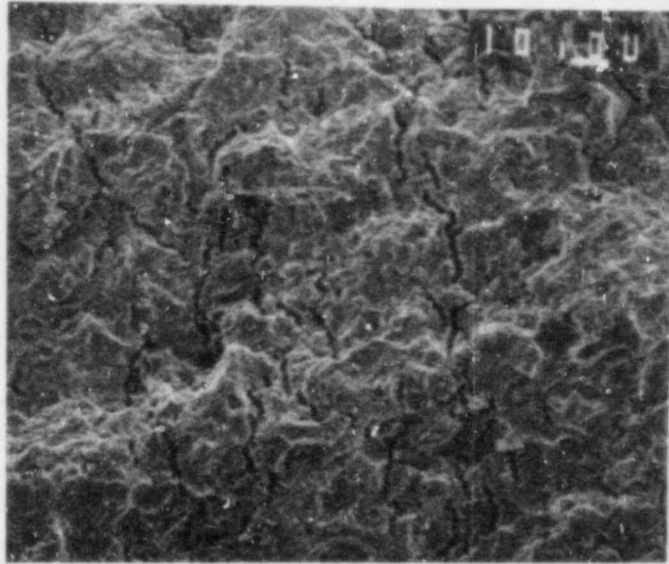
Figure 13. SEM photo of second area on the fracture face depicting secondary intergranular cracks.

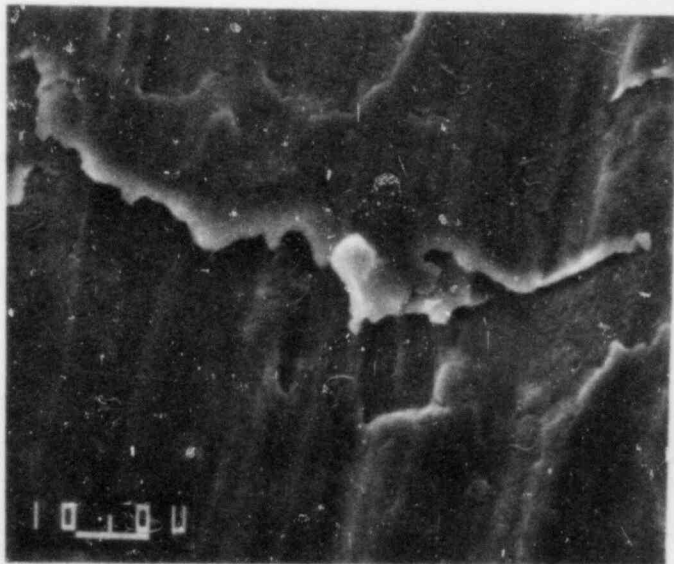
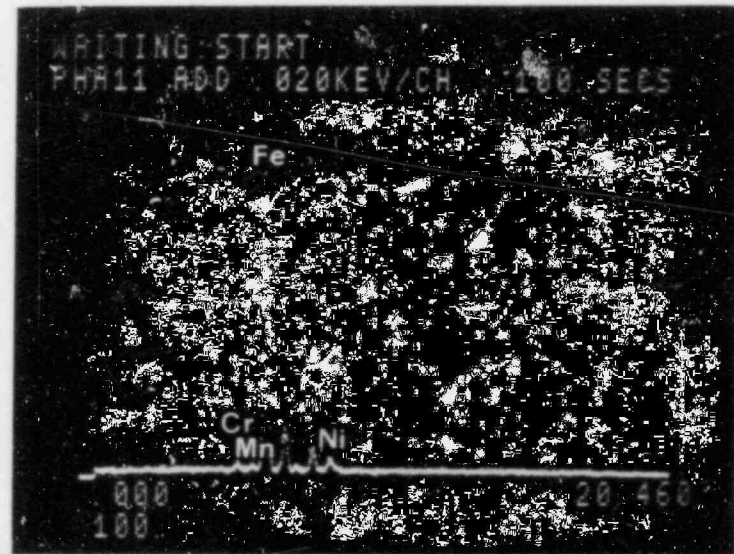
An EDS scan of the base metal was performed (Figures 14 and 15) and showed characteristic peaks of Fe, Cr, Mn and Ni. These peaks would be typical for this alloy.

Figure 14. SEM photo of base material area scanned.

Figure 15. EDS scan of base material for constituents.

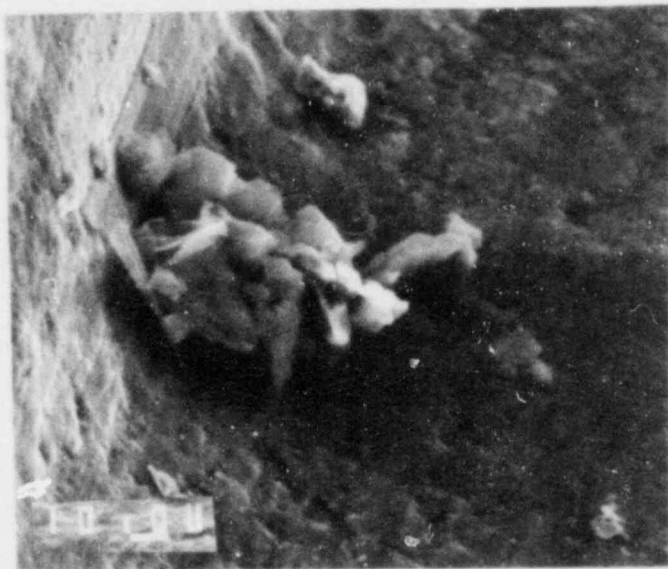
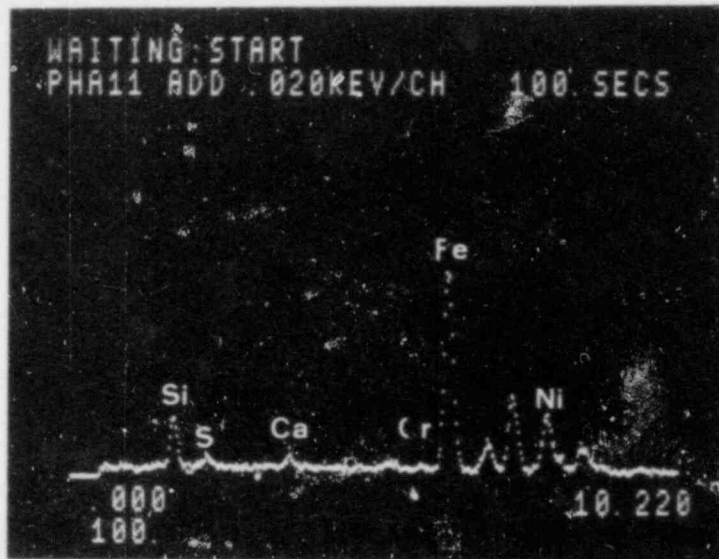
Various particles and areas of apparent material smearing were scanned for constituents using EDS. The first particle scanned from stud No. 2C6 was fibrous in appearance (Figures 16 & 17) and had quite high peaks of silicon and nickel in relation to the Fe alloy background. The scan also showed trace amounts of S, Ca and Cr. The high silicon content is probably related to the use of the silicon base Furmanite sealer used by the utility to seal the leaking stud holes. The high nickel content is attributed to the utility's use of Fel-Pro-5000, a nickel-base lubricant. (For typical certifications of materials used at Maine Yankee (see Tables 2-5.)) A second fibrous particle scanned (Figures 18 & 19), however, showed only peaks of Fe, Cr and Ni.

Figure 16. SEM photo of fibrous particulate.

Figure 17. EDS scan of fibrous particle.

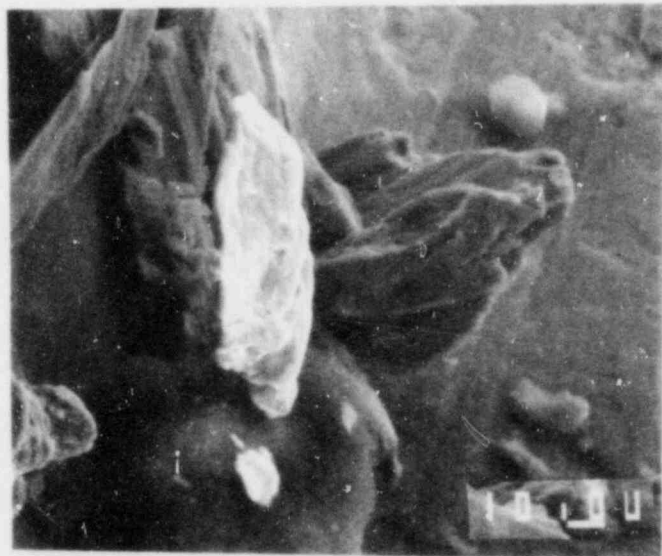
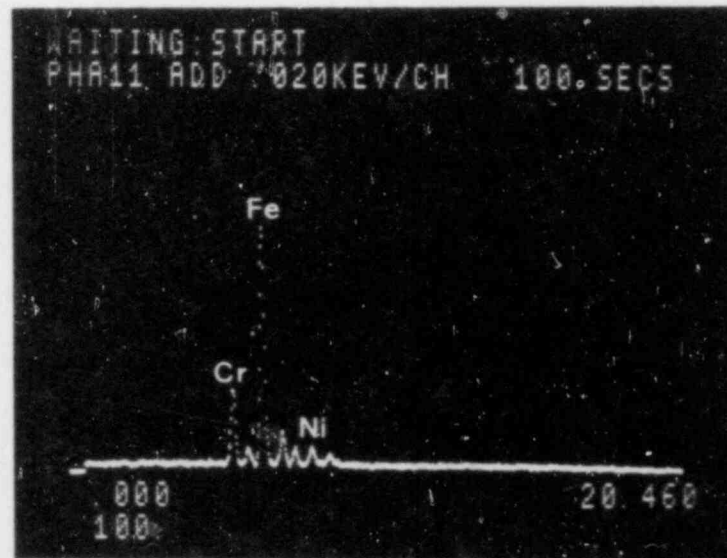
Figure 18. SEM photo of second fibrous particle.

Figure 19. Constituents of second fibrous particle scanned by EDS.

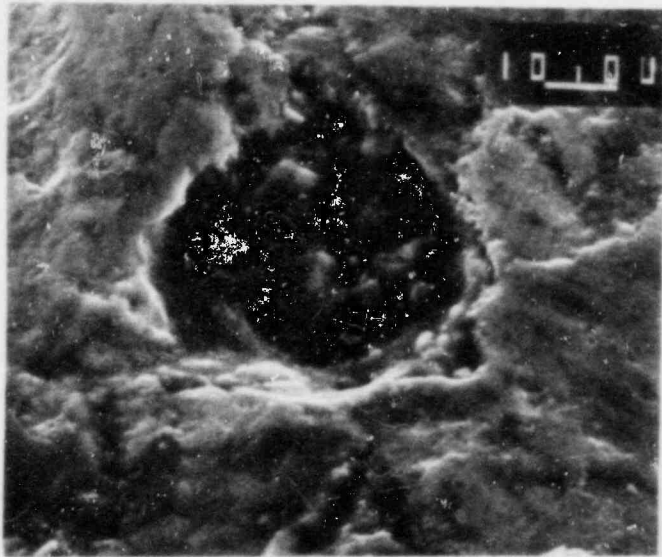
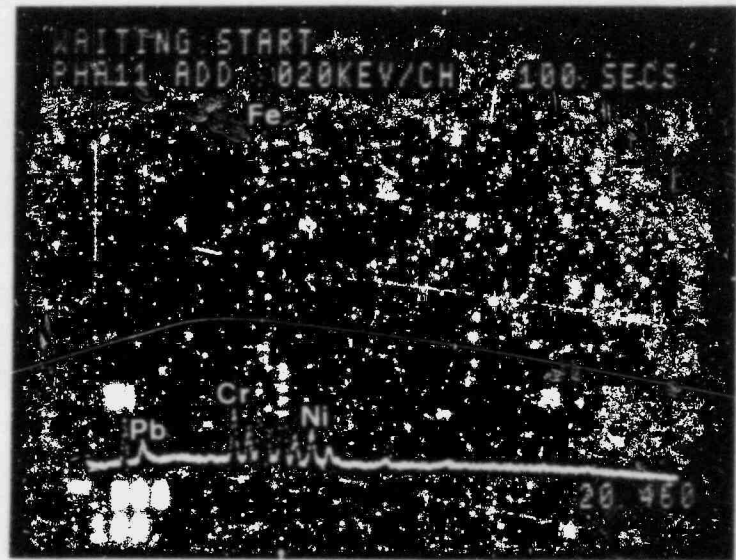
Another area scanned (Figures 20 & 21) appeared to be a pit and had a lead (Pb) peak in addition to Si, Cr, Fe and Ni. The appearance of lead may be attributed to the Fel-Pro which allows up to 25 ppm total lead in its specification.

1000x
 Figure 20. SEM photo of apparent pit on thread of the cracked stud.

Figure 21. EDS scan of pit for chemical constituents.

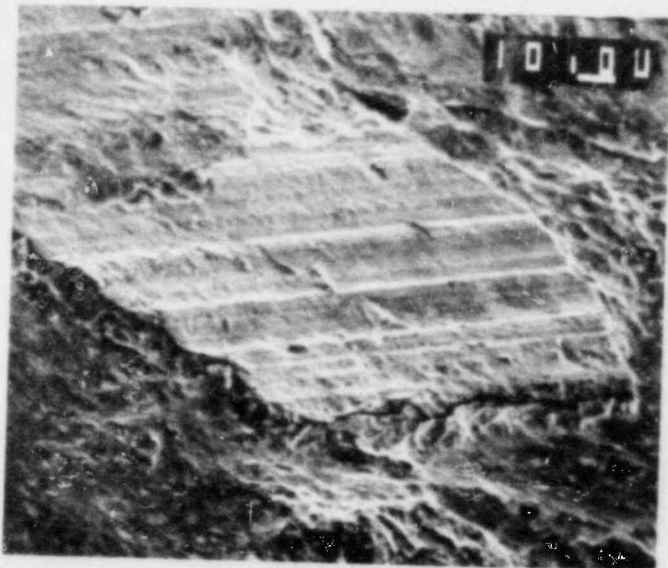
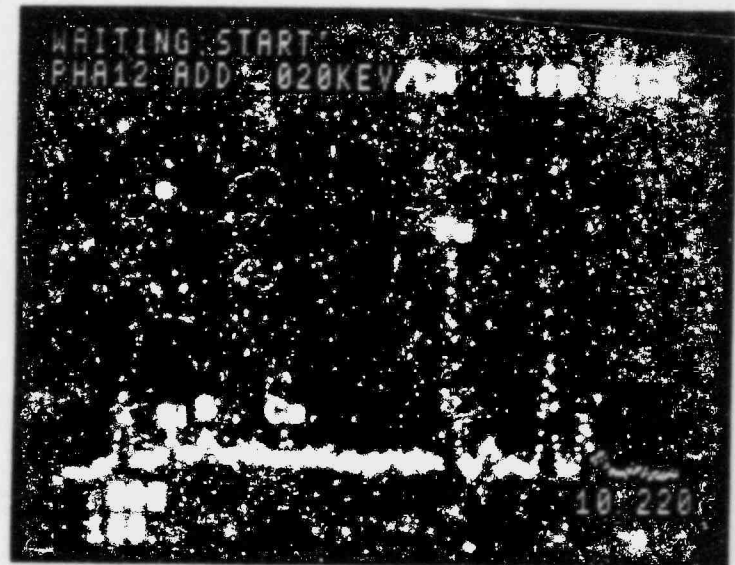
EDS analysis of a smeared area (Figures 22 & 23) showed peaks of Si, S, Ca and Fe only.

500x
 Figure 22. SEM photo of area of smeared material on thread area of the cracked bolt.

Figure 23. EDS scan of smeared material area.
