Examination of Failed Studs From No. 2 Steam Generator at the Maine Yankee Nuclear Power Station

Prepared by C. Czajkowski

Brookhaven National Laboratory

Prepared for
U.S. Nuclear Regulatory
Commission

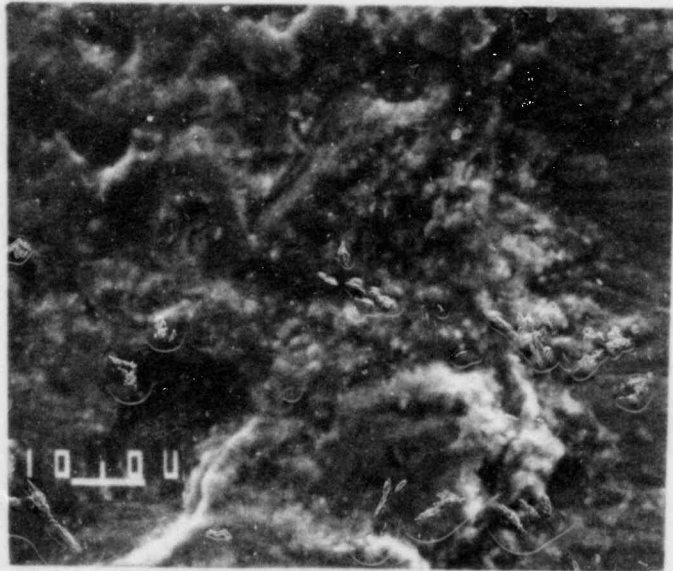
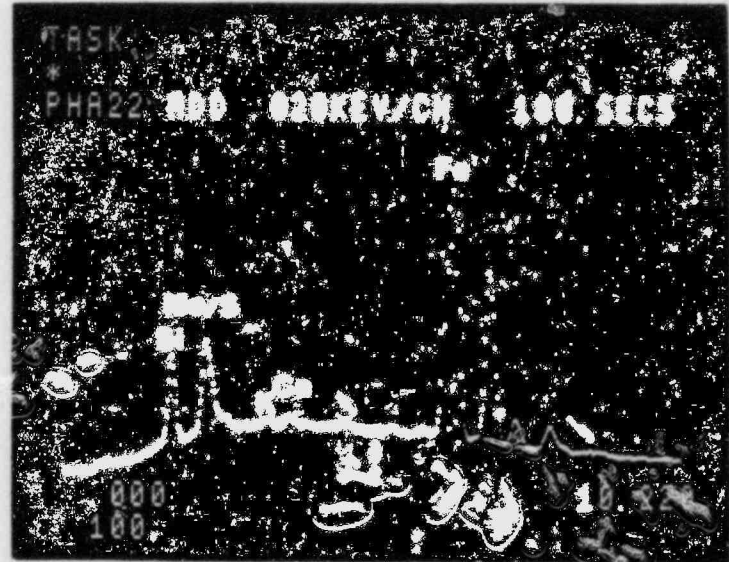
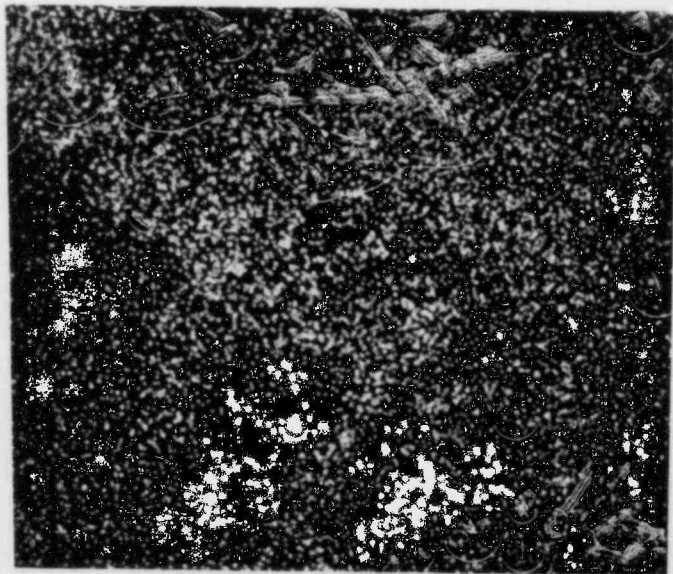
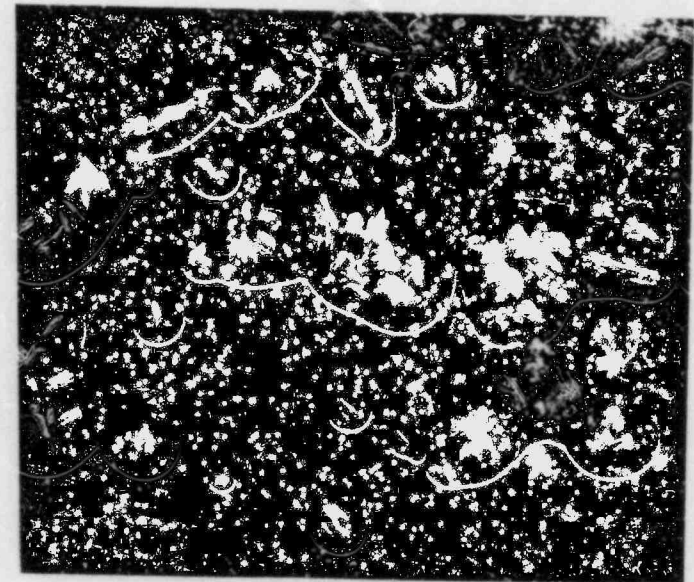
A second smeared area (Figure 24) had such a high peak in sulfur (Figure 26) that a wavelength dispersive spectrographic scan was accomplished to determine if molybdenum was present with the sulfur. It can be clearly seen (Figures 27 & 28) that this particular area is quite concentrated in Mo which is indicative that a molybdenum disulfide type lubricant may have been used sometime in the service history of the stud.

1000x
Figure 24. SEM photograph of second "smeared" area on bolt.

Figure 25. EDS scan of "smeared" area in Figure 24.

Figure 26. WDS scan of "smeared" area for molybdenum.

Figure 27. WDS scan of smeared area for sulfur.
