SUBJECT: OPERATING REACTORS EVENTS BRIEFING
 MAY 18, 1994 - BRIEFING 94-16

OPERATING REACTORS EVENTS BRIEFING 94-16

MCGUIRE, UNITS 1 AND 2

VARIOUS PLANTS

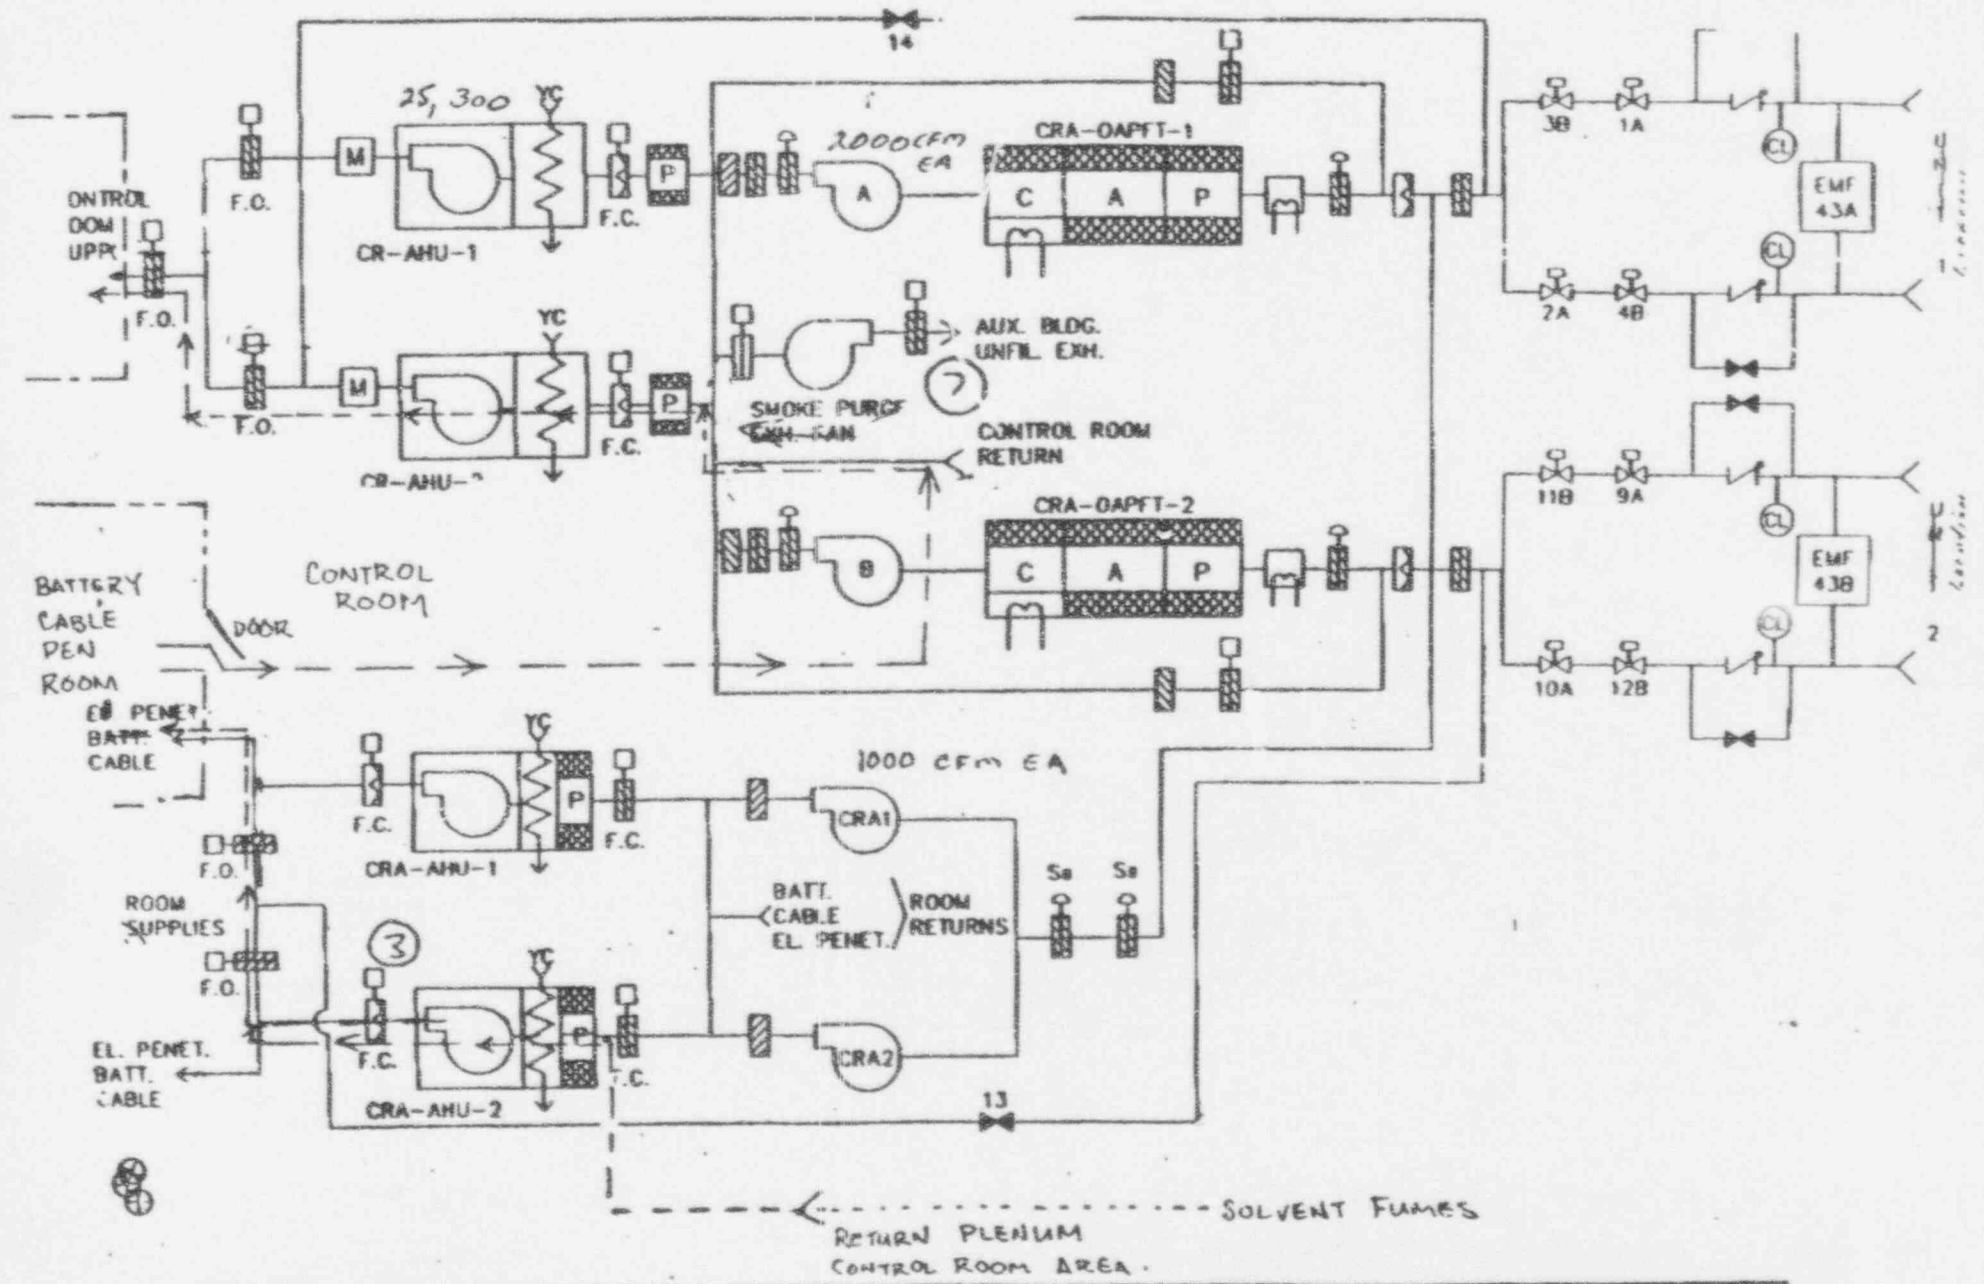
TITLE: CONTROL AREA VENTILATION SYSTEM (VC)	NOTES: SUB SYSTEM	ID. NO. MC-PSS-VC-1	DATE 8-26-91
		REF. MC-1576-1	
		DRN. BY. ARB	APR. BY. DWA
		WZDRA NO. MCPPSSVC1.DWG	TRAINING USE ONLY

- THE SHS SPECIALIST RETURNED TO THE AREA AND TOOK A SECOND SAMPLE USING A COLORIMETRIC TUBE FOR ACETONE (CALIBRATED FOR USE IN SAMPLING FOR HEXONE). THIS SAMPLE WAS TAKEN APPROXIMATELY TWO HOURS AFTER THE ORIGINAL COMPLAINT WAS MADE AND INDICATED APPROXIMATELY 2-3 PPM.
- THREE POTENTIAL MIGRATION PATHS TO THE CONTROL ROOM FOR THE SOLVENT FUMES WERE INITIALLY IDENTIFIED; HOWEVER, THE MOST LIKELY PATHWAY FROM THE CHILLER AREA TO THE CONTROL ROOM WAS THROUGH THE ELECTRICAL PENETRATIONS ROOMS. (SEE ATTACHED DIAGRAMS.)

- OPERATIONS DEPARTMENT WILL EVALUATE PROCEDURE ENHANCEMENT TO PROVIDE GUIDANCE ON WHEN TO MANUALLY ACTUATE CONTROL ROOM ISOLATION AND RECIRC VENTILATION.
- THE ENGINEERING DEPARTMENT WILL CONTINUE ITS EVALUATION OF THE LIKELY MIGRATION PATH OF THE SOLVENT INTO THE CONTROL ROOM.
- REGION II IS DRAFTING AN INFORMATION NOTICE DESCRIBING THIS EVENT.
