NUREG/CR-6095  
SAND93-1803

# Aging, Loss-of-Coolant Accident (LOCA), and High Potential Testing of Damaged Cables

Prepared by  
R. A. Vigil/SEA  
M. J. Jacobus/SNL

Sandia National Laboratories  
Operated by  
Sandia Corporation

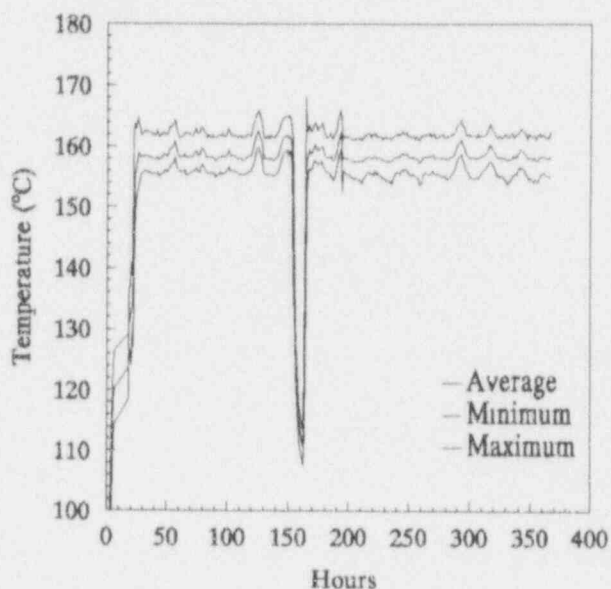
Figure 2 Thermal Aging Profile

thermal aging. Note the drop in temperature at approximately 6 days. This anomaly in temperature was caused by a failed electric circulation heater. The defective electric circulation heater was removed while the remaining electric circulation heater maintained the chamber temperature above 100°C until a new electric circulation heater was added to restore the chamber to the desired temperature. The drop in temperature existed for approximately 24 hours. The thermal aging was extended by 24 hours to compensate for this anomaly. The effect of this anomaly is an insignificant increase in the total thermal aging.

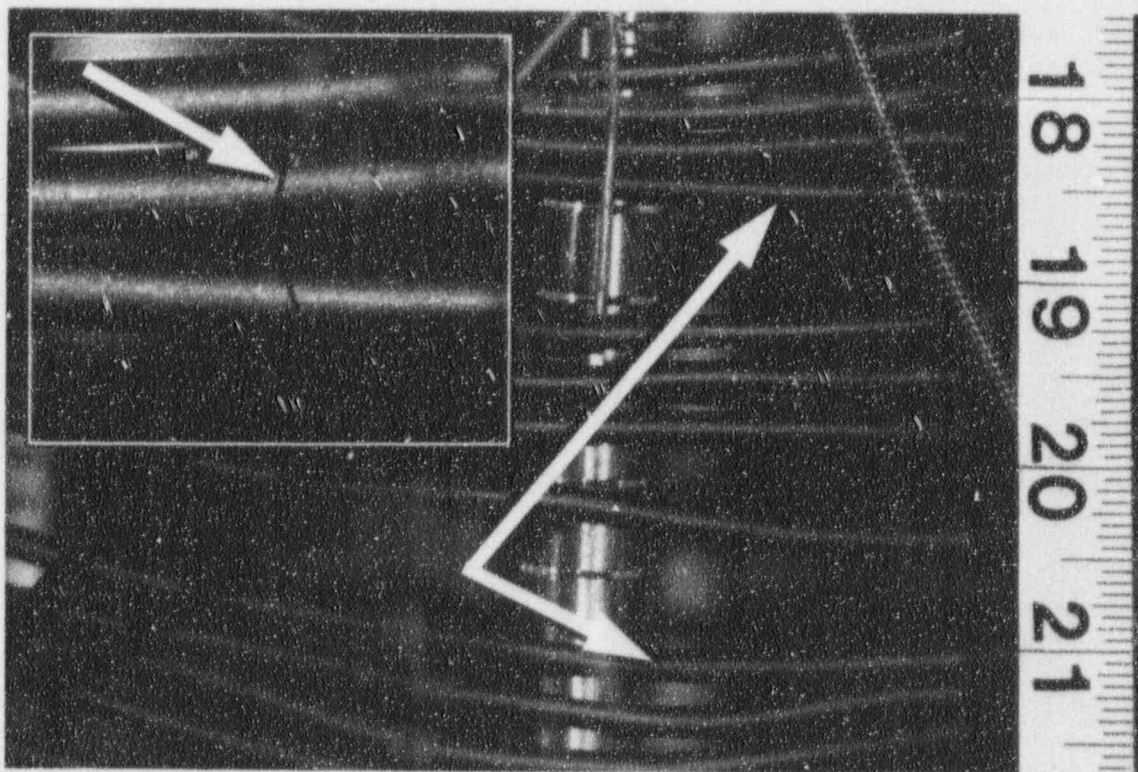
Figure 3 Cracks in Okonite Insulation After Thermal Aging

After completion of the thermal aging, a visual inspection revealed that all of the (intentionally) damaged Okonite cables had developed cracks in their insulation and/or jackets. The virgin sample did not appear to have any signs of cracks. Most of the cracks were adjacent to the damage locations, but outside the damaged area. Figure 3 is a photograph of these cracks in several of the Okonite cables. The cracks were circumferential and most were through to the conductor, although some cracks were apparent only in the CSPE jacket (especially on the cable with the least amount of damage). No cracks through to the conductor were noted on the cable with the least amount of damage. The exact cause of the cracks is unknown, but a major factor appears to be thermal aging of the bonded jacket material, followed by jacket cracking that propagated to the insulation. The bending of the cables around the test mandrel also appears to be a significant factor. The cracks were clearly not caused by sample preparation or handling during testing. Samples were carefully prepared using minimal clamping pressure and inspected after milling. There was no sample handling after aging. Because of these failures and other subsequent accident

Because of the cracks in the Okonite cables, we expected that all the damaged Okonite cables, except for the undamaged cable and the cable with the least amount of damage, would fail early in the LOCA test. In fact, the undamaged cable was one of the first cables to blow a 1 A fuse after the chamber environment became saturated steam at approximately 11 hours from the start of the LOCA exposure. (The undamaged cable blew its fuse at about 14 hours into the test as shown in Table 5.) The last surviving Okonite cable sample blew its 1 A fuse at approximately 182 hours into the LOCA simulation. Other cables that were known to have cracks through to the conductor did not blow 1 A fuses until as late as 137 hours into the LOCA test. Had chemical spray been present during the test, these cables would have almost certainly all blown fuses earlier because of the enhanced ground plane. These failures would probably have occurred soon after the chemical spray was started.

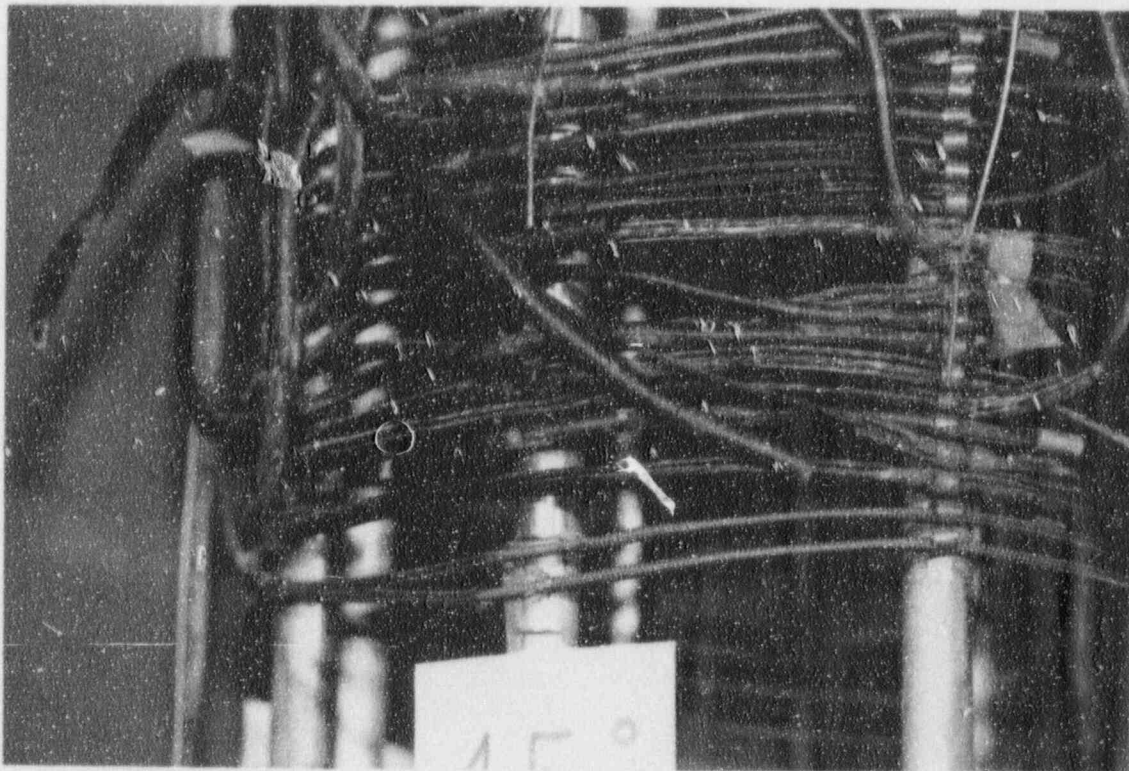
Figure 6 Okonite Cable Failures After LOCA Simulation

It was evident during the post-LOCA inspection that the Okonite cables had clearly deteriorated grossly during the LOCA exposure. All the Okonite cables had longitudinal cracks over much of their length, exposing the center conductor as shown in Figure 6. In addition, identical undamaged single conductor Okonite Okolon cables that were used as cable ties in the test chamber exhibited the same type of extensive longitudinal cracking. Because of the nature of these failures and comparison with previous testing (discussed later), we believe that the failure rate of the Okonite Okolon cables under our test conditions is essentially 100%. Because of their unexpected failures, no data for the minimum insulation thickness necessary to survive aging and accident tests can be determined for the Okonite cables. The observed failures were very similar in appearance to a failure of an Okonite cable and several failures of another cable that had bonded CSPE jackets in previous testing at Sandia [5].

Cable Number	Time of Blown Fuse (hours)	Cable Number	Time of Blown Fuse (hours)
21	102	26	90
22	137	27	122
23	50	28	97
24	11	29	182
25	81	30	14

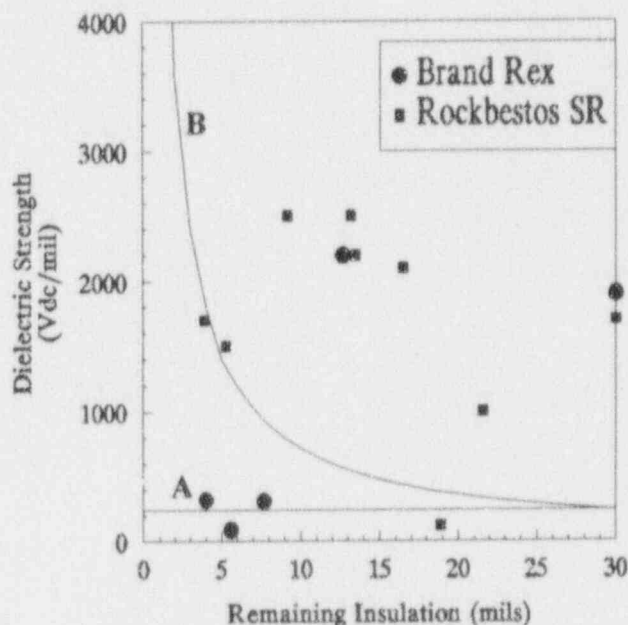
Figure 8 Dielectric Strength Based on Nominal Remaining Insulation Thickness

The results of these post-LOCA breakdown tests are given in Tables 6 and 7. Figure 8 presents the dielectric strength data in Vdc/mil of remaining insulation versus remaining insulation thickness for the Brand Rex and Rockbestos cables. Note that the two Brand Rex cables that passed the accident test with less than 7 mils of insulation remaining (samples 2 and 6) both had breakdown voltages less than the 600 Vac rating of the cable (considering 600 Vac to be equivalent to 1800 Vdc). In addition, the breakdown voltage in Vdc/mil for these two cables was much lower than the expected breakdown voltage of this material after LOCA (i.e. about 14000 kVac for an undamaged cable [6] or the equivalent of about 1800 Vdc/mil). If the cables had been energized with ac potential and/or if the applied voltage had been higher (but still within the rating of the cable), it is possible that these cables would have also failed during the accident exposure. However, unlike the cables that immediately failed the post-LOCA dielectric

tests, neither of these two cables had any indication of problems during the LOCA simulation. There appears to be a clear difference in breakdown voltage in Vdc/mil between the Brand Rex cables with less than 8 mils of insulation remaining and those with greater than 12 mils remaining. With less than 8 mils remaining, the breakdown voltage did not exceed 320 Vdc/mil, while above 12 mils the breakdown voltage was not less than 1900 Vdc/mil.

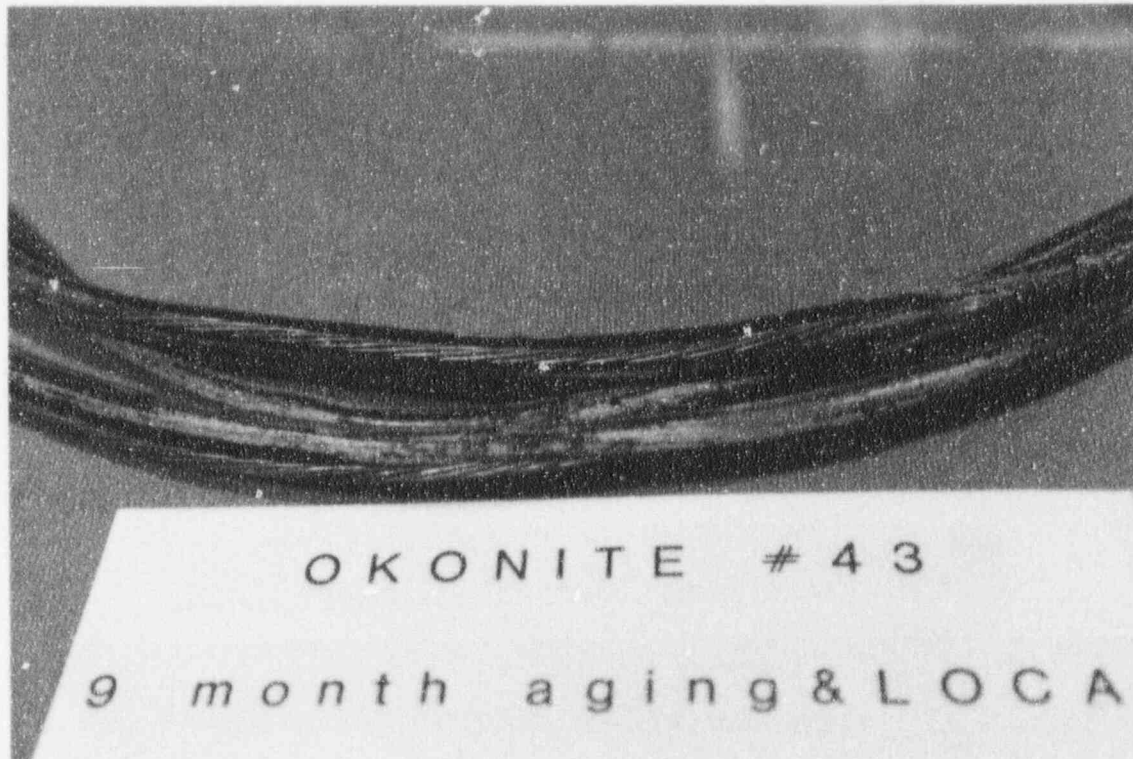
Figure B-1 Failure of Okonite Cable Sample from Reference B-1 Test Program

Because the sample that failed was aged to the maximum extent and a significant number of samples were less severely aged and did not fail, a connection with the degree of aging is strongly suggested.

Based on the analysis of equivalent thermal aging times, the fact that all of the cables had identical longitudinal cracking during the steam exposure is not very surprising. Since there is an almost certain connection between the failures and the degree of aging, we would expect the Okonite cables to fail a test where the thermal aging that was used in this test program was combined with **no radiation aging** and followed by a 110 Mrad accident exposure and the steam profile used in this test. Thus, although the application of the total radiation dose prior to thermal aging is perhaps more
