INVESTIGATION REPORT NOS. 50-324/80-44 and 50-325/80-46

SUBJECT: Carolina Power and Light Company
Brunswick Steam Electric Plant
Southport, North Carolina

Possible Failure to Report Unmonitored and Uncontrolled
Radioactivity Releases

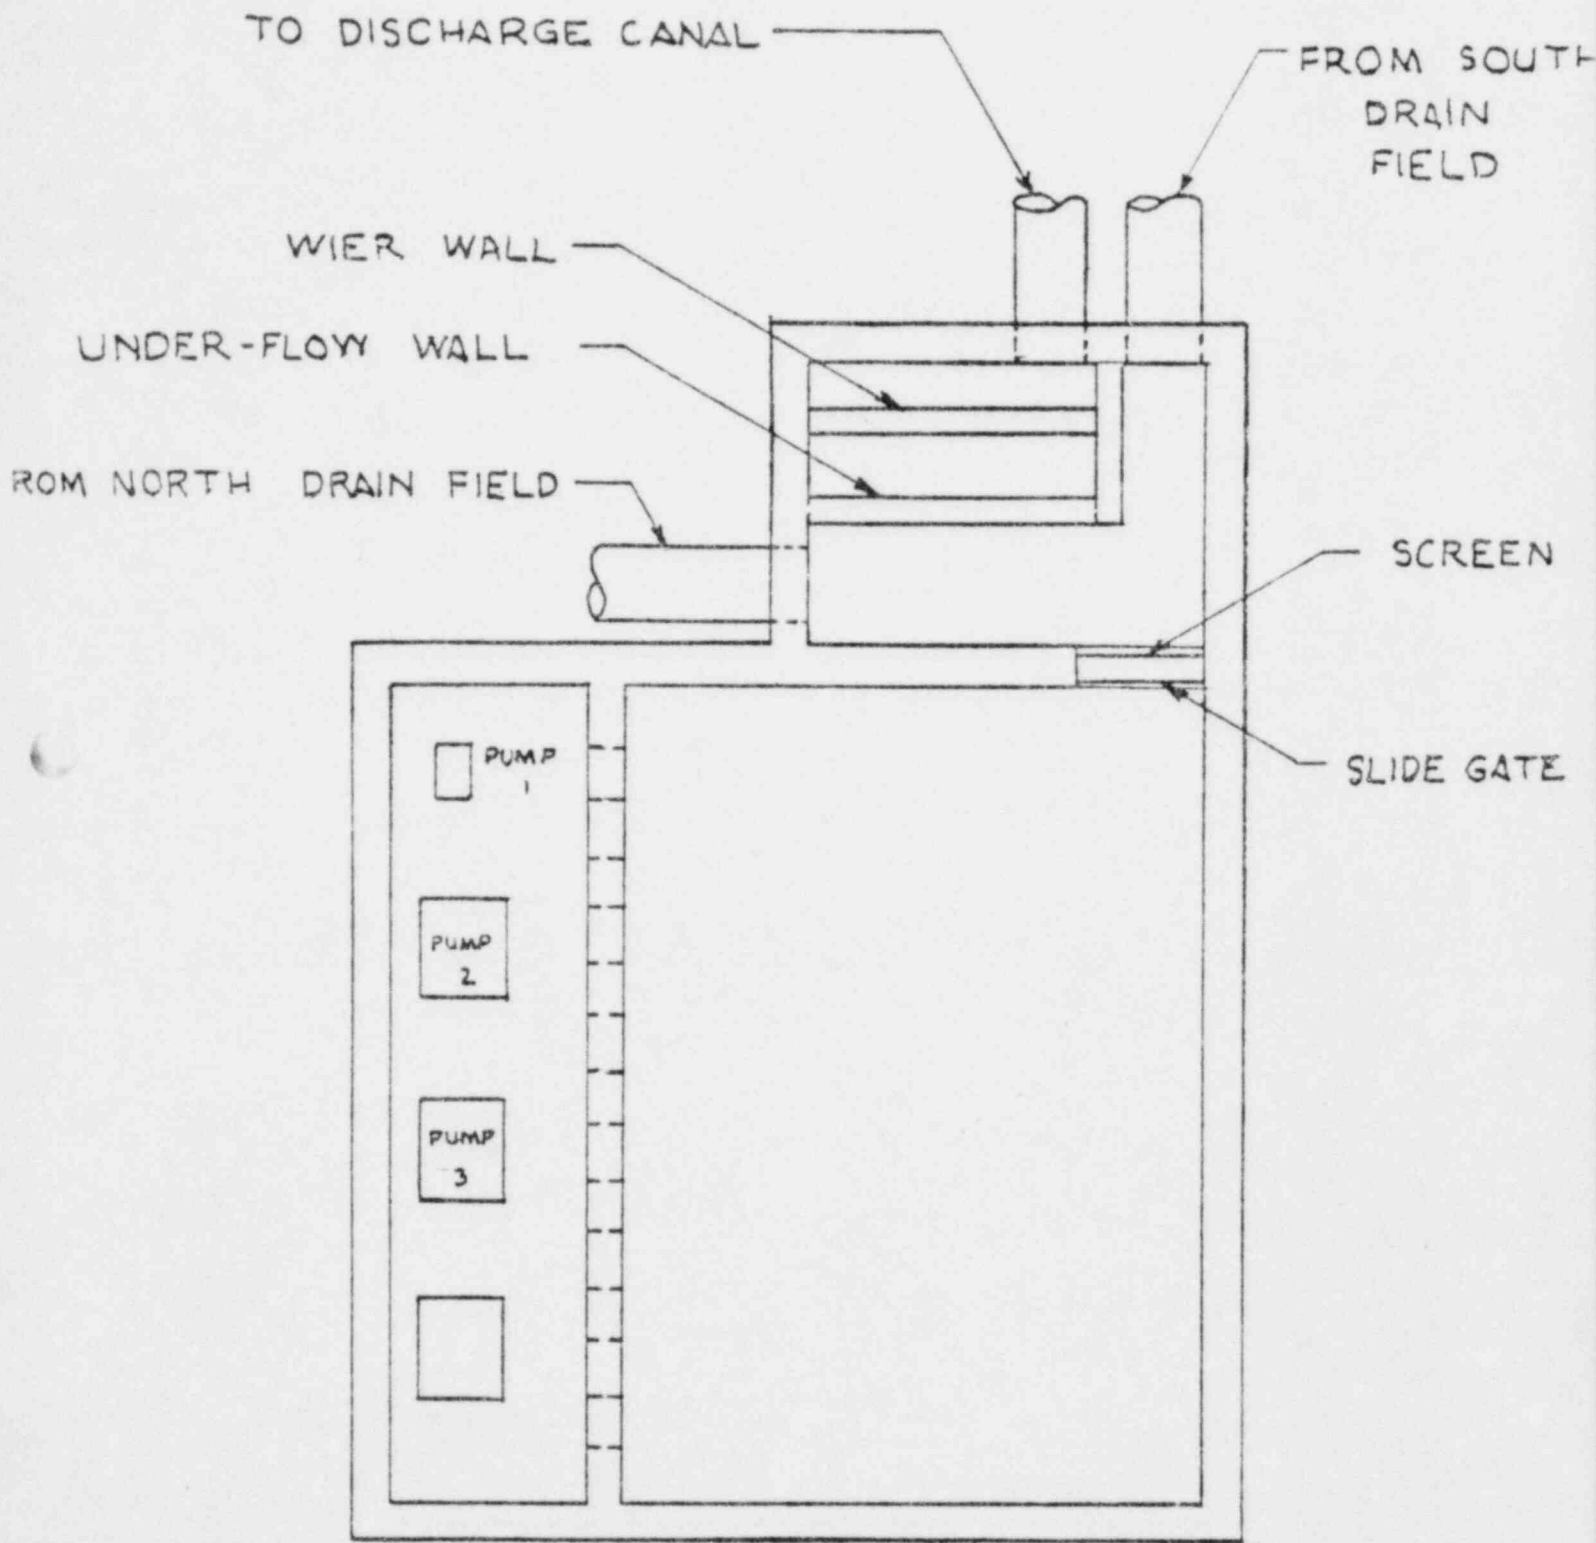
FIGURE 2 PUMP BASIN - PLAN

Storm drainage from the BSEP site is directed into a concrete structure referred to as the storm drain collector basin (SDCB). The SDCB has a capacity of approximately 100,000 gallons and in addition to collecting surface water from the site it also receives the cooling tower blowdown and makeup water treatment system discharges. The basin has a removable gate at one end which, if opened, would allow gravity flow from the basin, through a culvert to the discharge canal. Overfilling the basin causes water to flow over the removable gate and on to the discharge canal. The basin is also equipped with two 1200-gpm pumps to pump the basin contents to the stabilization pond. A drawing of the SDCB is shown in Exhibit 1.

Information obtained during the investigation disclosed that during the time period July-August 1980 leakage of water into nearby electrical cable tunnels was determined to originate from cracks in the concrete collector basin. In late August licensee personnel also observed water running from the basin weir wall and into the pipe leading to the discharge canal. Weekly sample data provided by the licensee in the enclosure to the January 22, 1981, letter to Region II indicates a continuing average concentration of radioactivity in water in the collector basin in the range $1.0E-6$ to $1.0E-7$ $\mu\text{Ci/ml}$ between June 25, 1980 and November 23, 1980 and reaching values as high as $1.0E-4$ $\mu\text{Ci/ml}$ on two occasions.

Repair work was initiated once the cracks were found; however, as late as November 12, 1980, the collector basin was still leaking and effort to locate and repair cracks was continuing. The enclosure to the licensee's January 22 letter indicates that all cracks have been repaired and further, that the pipe to the discharge canal has been plugged to eliminate that pathway.
