Subject: Crystal River Unit 3
Docket No. 50-302
Operating License No. DPR-72
Relief from ASME Section XI, Article IWB-2000

SUBJECT: Reactor Vessel Inlet Nozzle Examination

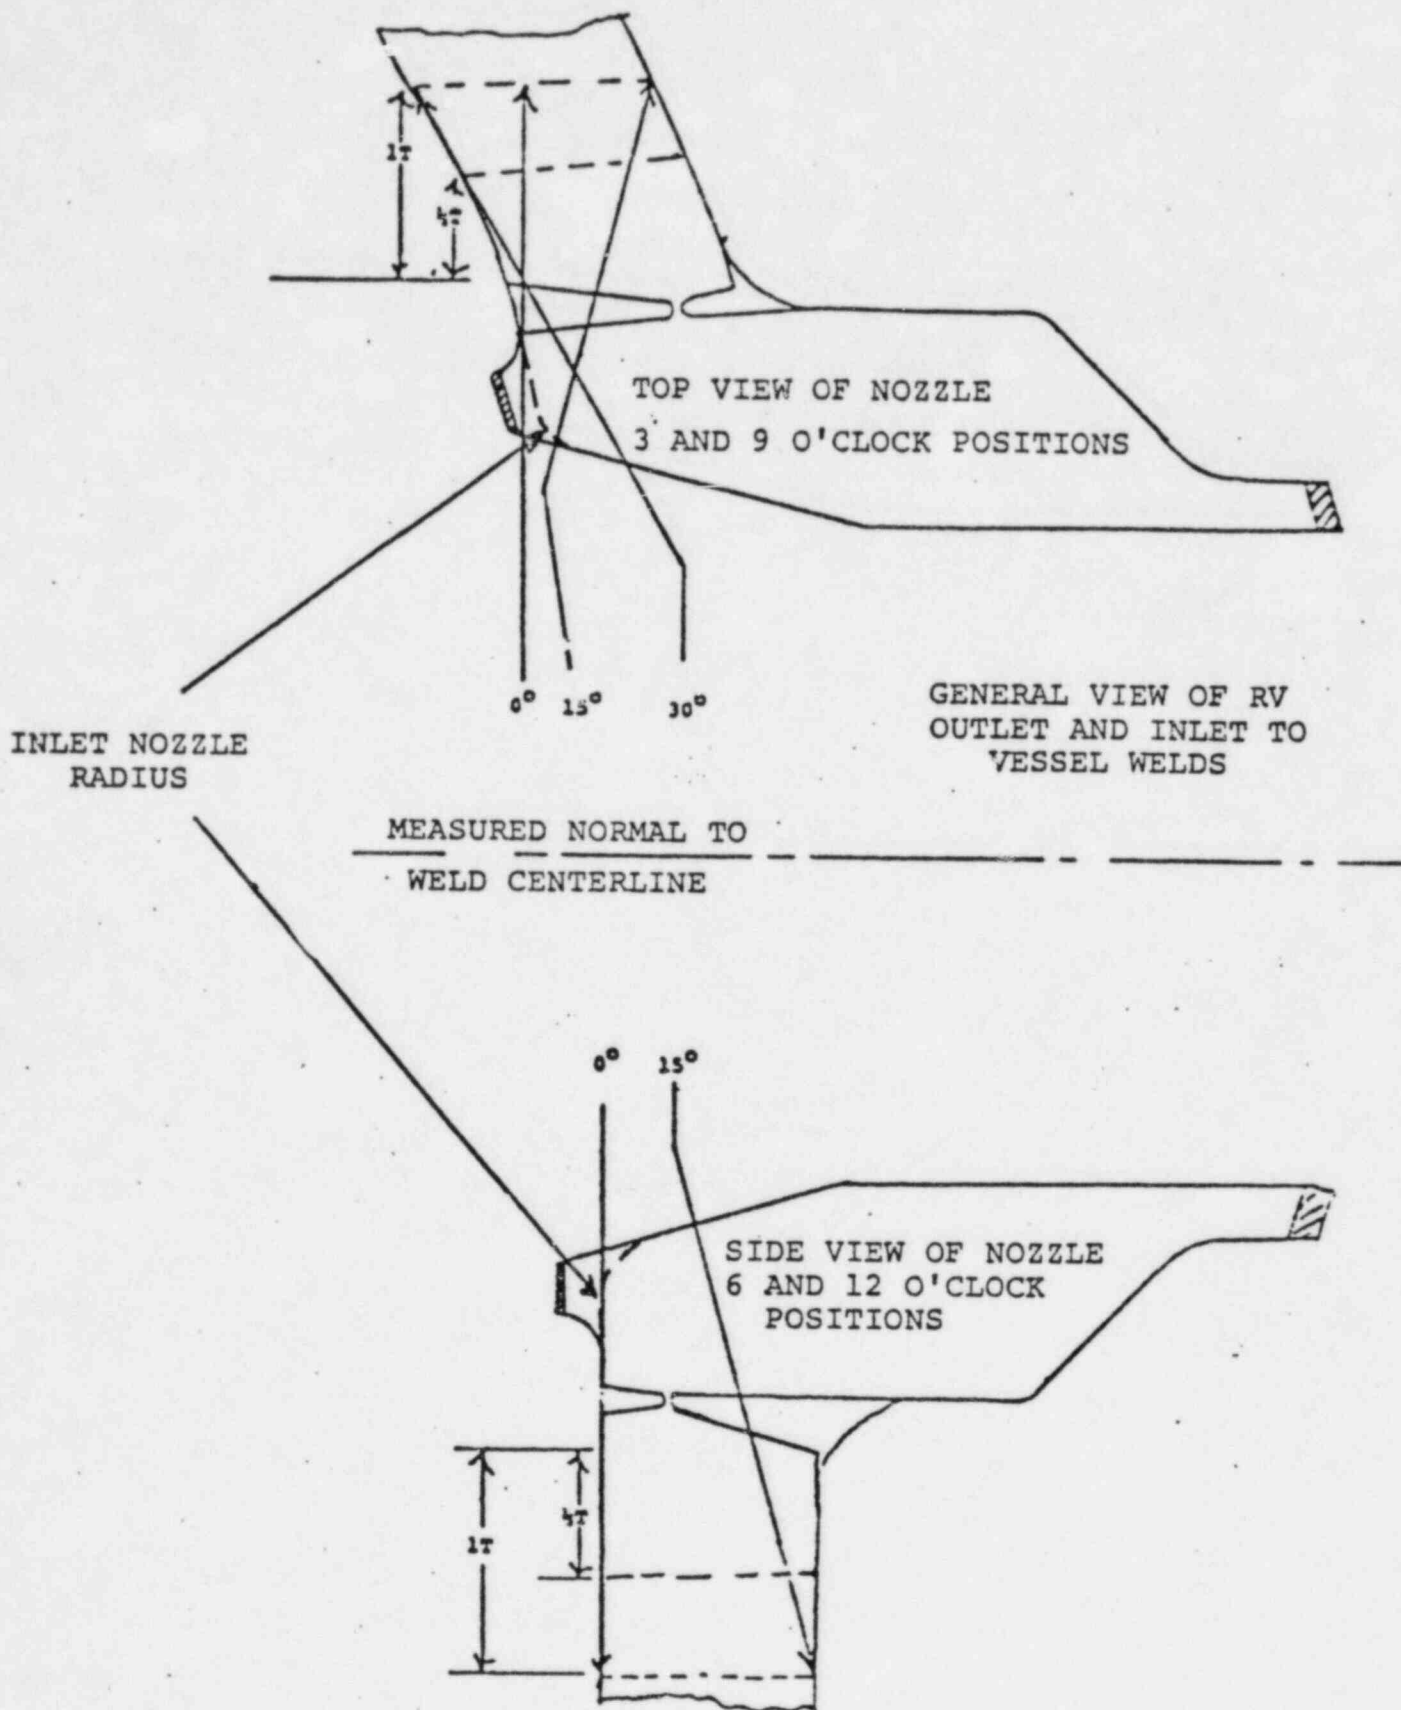
FIGURE 1 - ILLUSTRATION SHOWING ANGLES NEEDED TO
 COVER NOZZLE-TO-VESSEL WELD ON B&W 177FA
 VESSELS

Upon investigation of the reasons for not detecting the reflectors, it was discovered that neither examination fully covered the entire examination volume due to the curvature of the vessel at the 3 and 9 O'clock positions and between these points on the nozzles. The normal illustrations used to represent the nozzle-to-vessel weld usually show the intersection at 12 and 6 O'clock positions where vessel curvature is not a problem.

The examinations from the bore should have included the two prior described angles as well as a 30° angle to the weld to pick up the remaining volume. This is illustrated in Figure 1 where the angles are shown for an outlet and inlet nozzle. All three angles are needed to completely scan the examination volume. At Crystal River, the initial evaluation showed that a sufficient beam path might not be available to calibrate to the depth of the examination volume from inside the bore for the 30 degree angle. It was decided to cover this area by using 45 and 60 degree beams from inside the vessel-normal to the weld using the nozzle belt vessel calibration block.

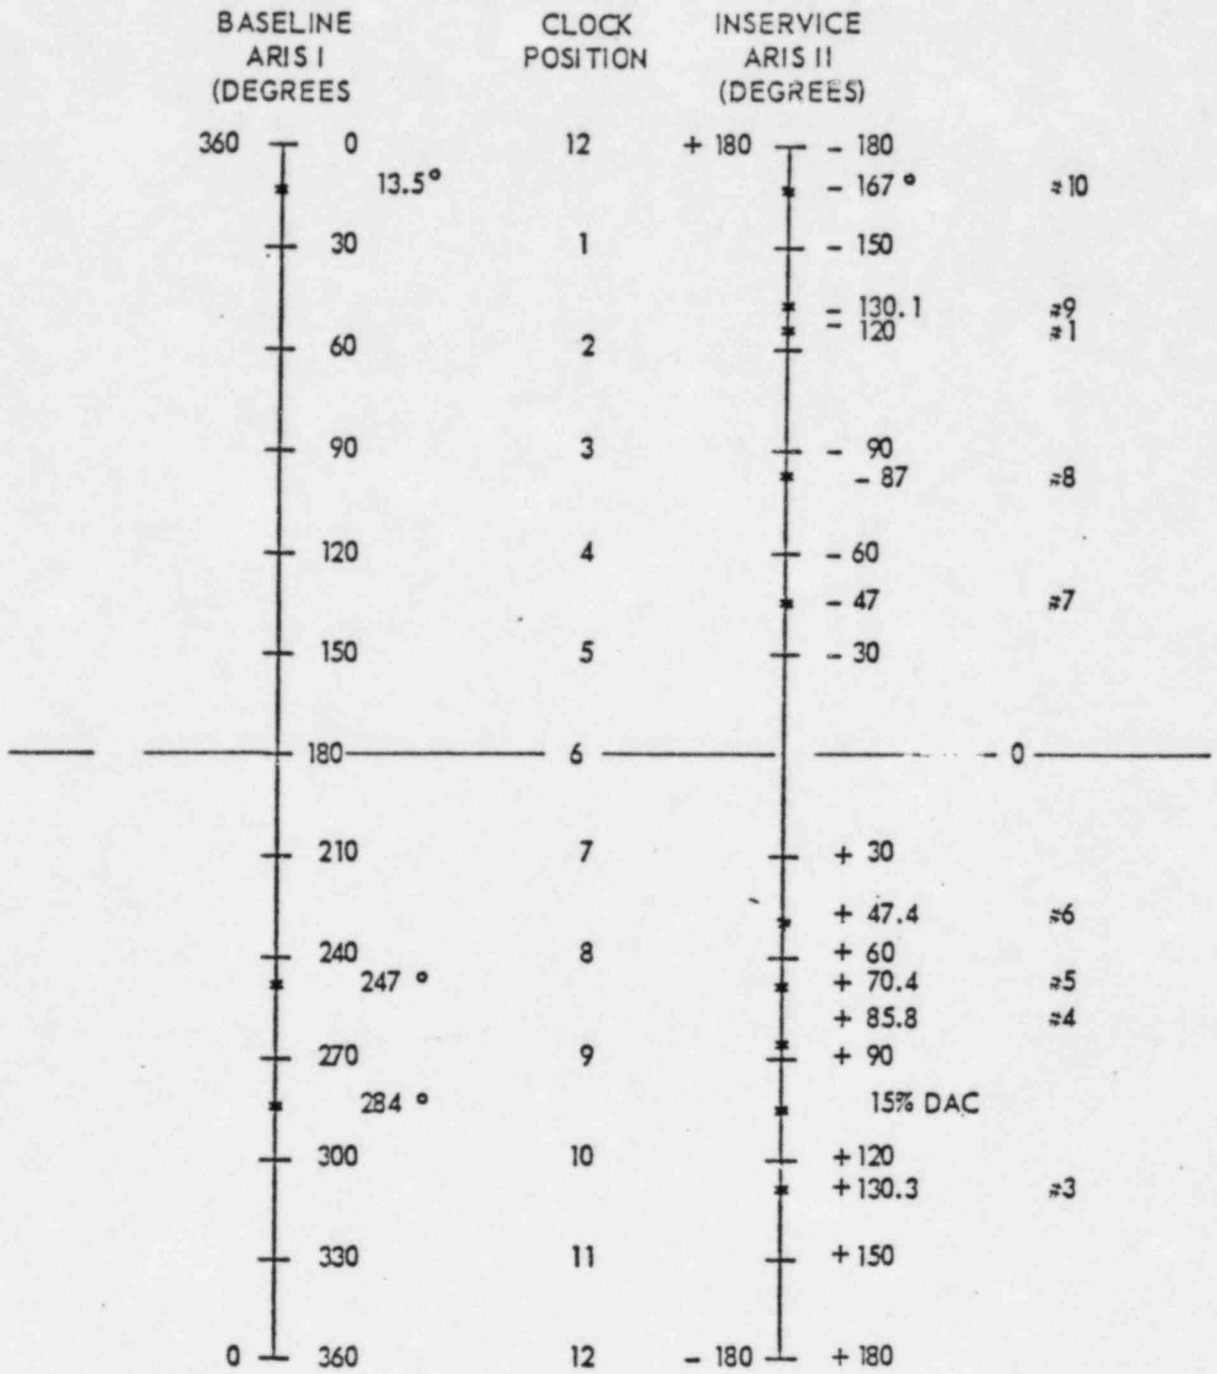
FIGURE 2

The results of the original examination at a 15 degree angle to the weld did not reveal any of the three (3) indications originally found in the baseline examination of the inlet nozzle-to-vessel weld between the Z-W axes of the vessel. The subsequent examination with the normal to weld beam revealed two (2) indications which exceeded 50 percent of reference level and seven (7) other indications which exceeded 20 percent of the reference level. The three (3) baseline indications exceeded the reference level with the largest being 125 percent. All indication defect dimensions are acceptable to the defect standards of the 1974 Section XI Edition including addenda through Summer 1975.

The indication locations from the baseline are plotted in Figure 2. The reference system used in the first automated system (ARIS-I) for nozzles had 0 degrees at the top of the nozzle and proceeded clockwise to 360° at the zero position. The three (3) indications were located at 13.3, 247.9, and 284.0 degrees as shown in Figure 2. The calibration block used for these examinations was 40705, a block mounted adjacent to the nozzle arm.

The nine indication locations on the nozzle for the inservice examinations are shown in Figure 2 for the reference system used on the second generation automated inspection device, ARIS-II. This system uses a different reference system with 0 degrees at the bottom of the nozzle and clockwise rotation being degrees positive and counterclockwise being degrees negative; 180 degrees positive and negative are the same point on the top of the nozzle. The nine (9) indications detected are plotted in Figure 2 along with a smaller indication. The location of the indications exceeding 20% DAC are -167.9; -130.1, -124.3, -87, -47, +47.4, +70.4, +85.8, and 130.3 degrees with a 15% DAC indication at 104 degrees. This latter indication was found after the 20% indications were plotted and no indications appeared corresponding to this reference location. Although the reference level of the indications vary from baseline to inservice, the locations of baseline indications are confirmed with indications located which correspond to the same positions. However, the inservice indications do not correspond in amplitude with the baseline readings. Indications on the baseline and inservice inspections are located in depth near the root of the weld near the mid plane. Figure 1 illustrates the weld preparation.

In the operation of the nozzle arm on the ARIS-I device, no provision was available for maximizing the beam angularity perpendicular with the calibration holes. This provides the possibility of the examination to be overly sensitive, but on the conservative side. The feature to maximize the calibration hole indication on the ARIS-II device is included. We believe that this feature accounts for the difference in sensitivity between the baseline and inservice examinations.

COMPARISON OF BASELINE AND INSERVICE INDICATIONS FOR THEIR RELATIVE CLOCK POSITIONS IN INLET NOZZLE BETWEEN Z-W AXES.

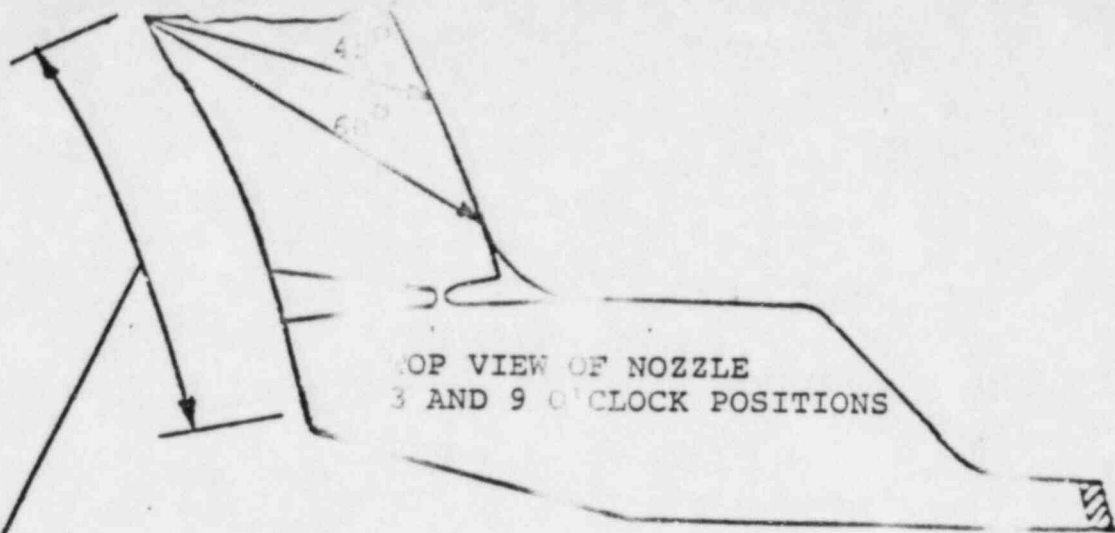
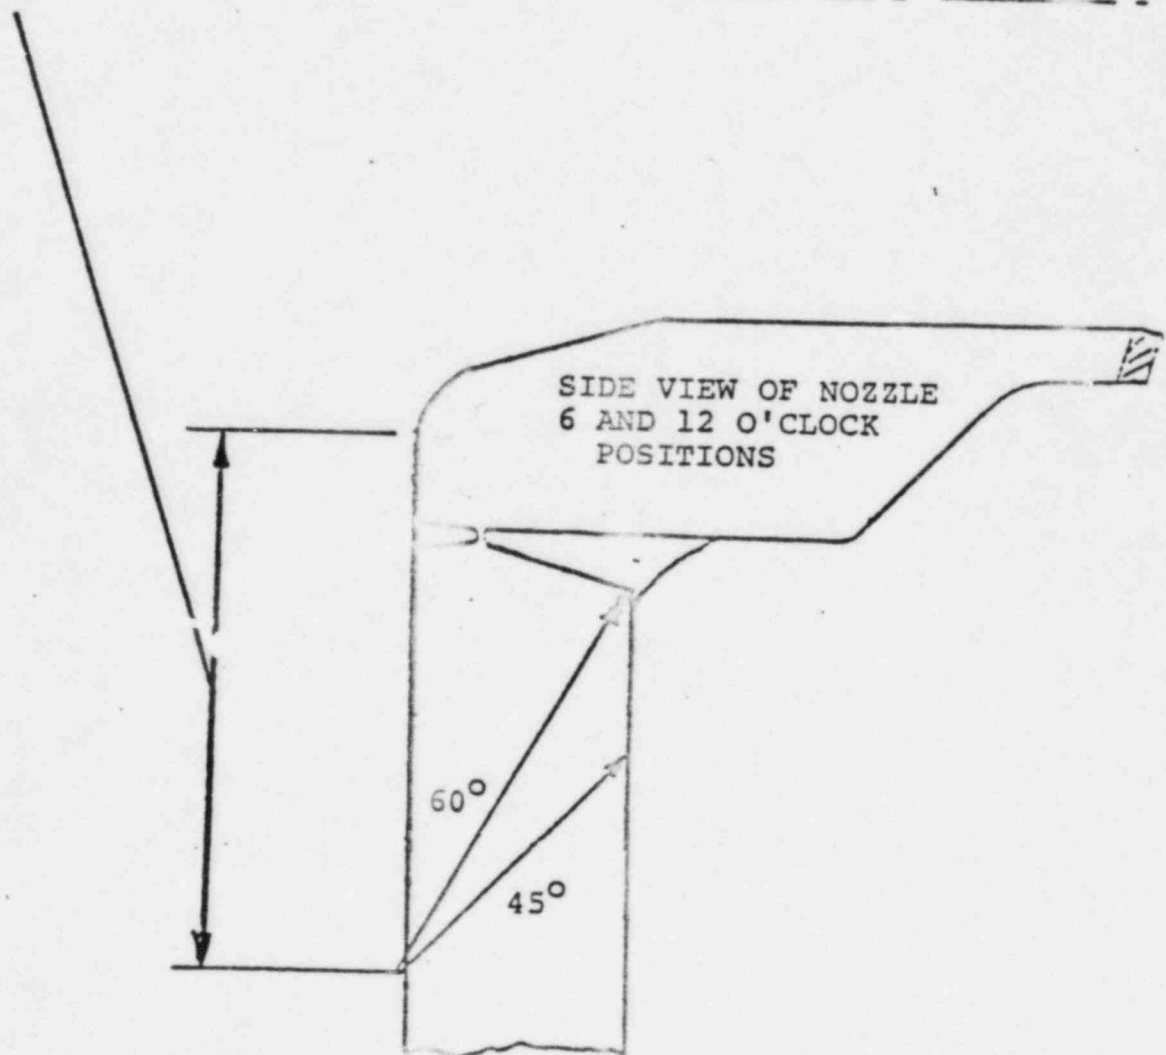
FIGURE 3 - ILLUSTRATION SHOWING ANGLE BEAM COVERAGE FROM INSIDE THE VESSEL ON THE NOZZLE-TO-VESSEL WELD

The 45 and 60 degree subsequent inservice examinations to cover the inner portion of the weld are illustrated in Figure 3. Only one small indication was detected with these angle beams and it was acceptable.

AREA SCANNED WITH
45 & 60 DEGREE ANGLE
BEAMS INCLUDES 1T
OUTBOARD OF WELD, SKETCH
NOT TO SCALE
