SUBJECT: Calvert Cliffs Nuclear Power Plant
Unit Nos. 1 and 2; Docket Nos. 50-317 and 50-318;
License Nos. DPR 53 and DPR 69
Licensee Event Report 94-005
Partial Loss of Offsite Power Caused by a 13.8 kV Voltage
Regulator Fault

LICENSEE EVENT REPORT (LER)

TITLE (4)
Partial Loss of Offsite Power Caused by a 13.8 kV Voltage Regulator Fault

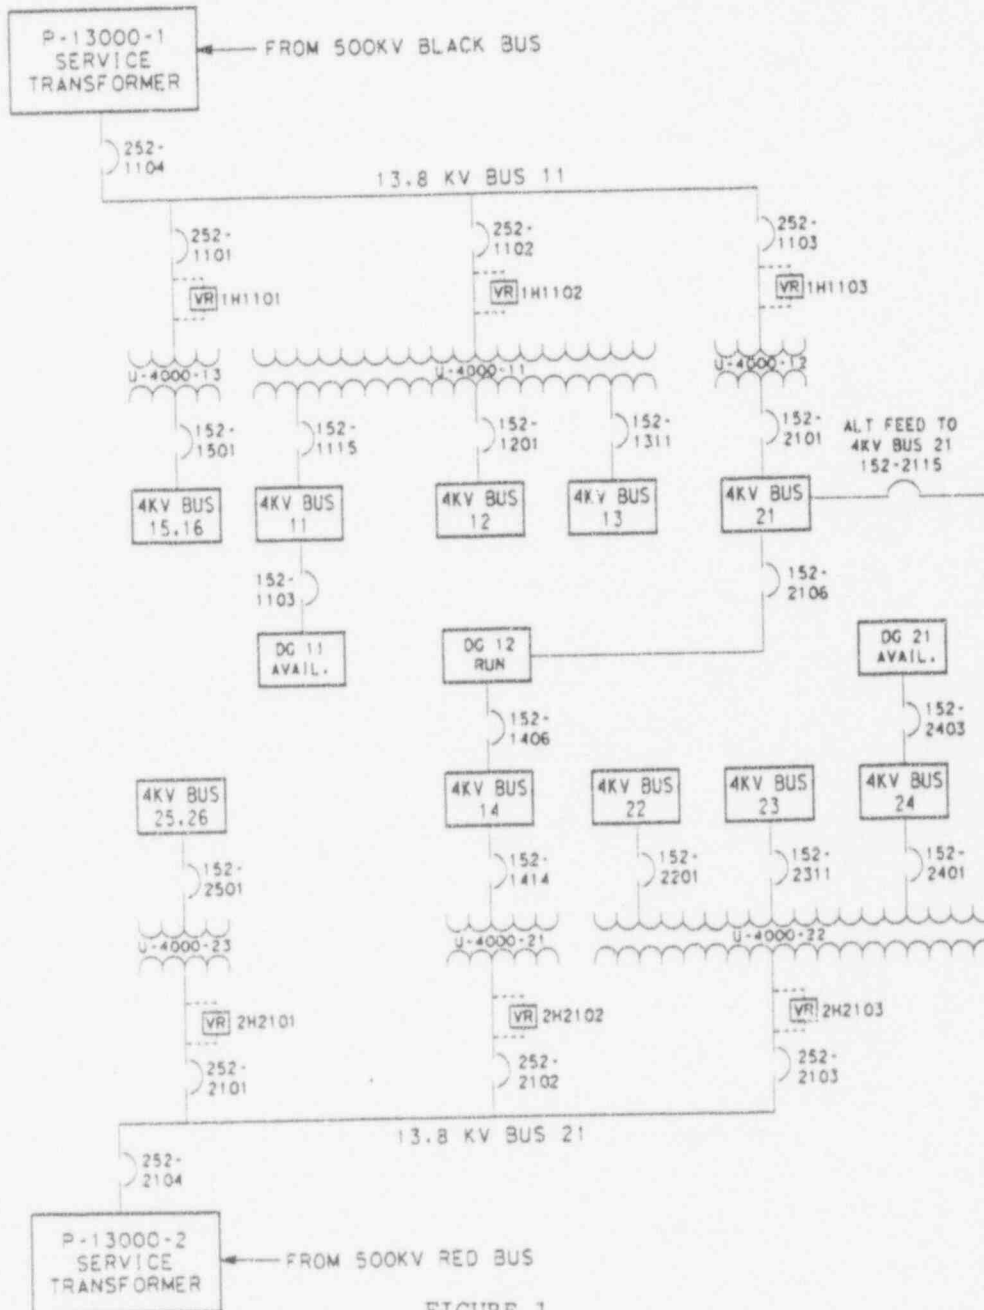
FIGURE 1

When the 13.8 kV service Bus 11 feeder breakers opened (252-1101, 1102, 1103) power was lost to 13.8 to 4 kV Unit Service Transformers (UST) U-4000-13, 11, and 12, respectively (see Figure 1). This resulted in a loss of power to Unit 1 4180 volt non-safety Busses 15 and 16 and Unit 2 4180 volt safety Bus 21. The loss of power to safety Bus 21 caused its undervoltage relays to actuate, sending an ESFAS actuation signal to start EDG 12. Emergency Diesel Generator 12 started and loaded safety Bus 21 as designed and ran until it was secured at 1718 hours. Power to Unit 1 4180 volt Busses 15 and 16 was restored at 1724 hours by closing alternate feeder breaker 152-1604 to UST U-4000-23 which is supplied from 13 kV Service Bus 21.
